# Action Item C Local Program Report to the SCC

## **Town of Cary**

Subject: Sedimentation and Erosion Control Local Program Review

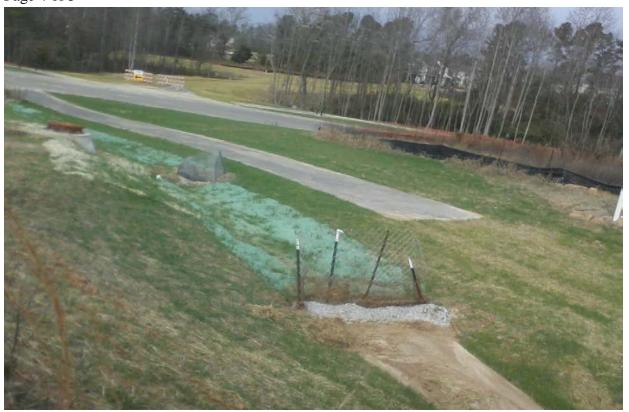
This site is a 12 acre residential project. The file for this project included an FRO, inspection reports, check, calculations, 401 authorization, and an approval letter. The erosion and sediment control plan was approved and was adequate. The last inspection was on 11/25/2014 and the site was out of compliance and a Notice of Violation was sent. The site was active at the time of the inspection and was in compliance.

- 1) Continue to provide adequate ground cover on all bare and inactive areas.
- 2) Mulch light in some locations and should be anchored.

Site 1 – Check dam with lined channel

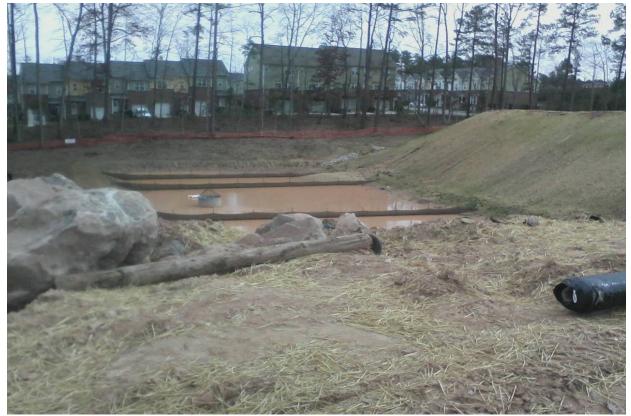
This site is a 13.4 acre commercial project. The file for this project included an FRO, inspection reports, check, calculations, 401 authorization, and an approval letter. The erosion and sediment control plan was approved and was adequate. The last inspection was conducted on 12/03/2014 and the site was out of compliance. The site was active at the time of the inspection and was in compliance.

Continue to provide adequate ground cover on all bare and inactive areas, including the inactive stockpile.

Site 2 – Temporary Skimmer Sediment Basin

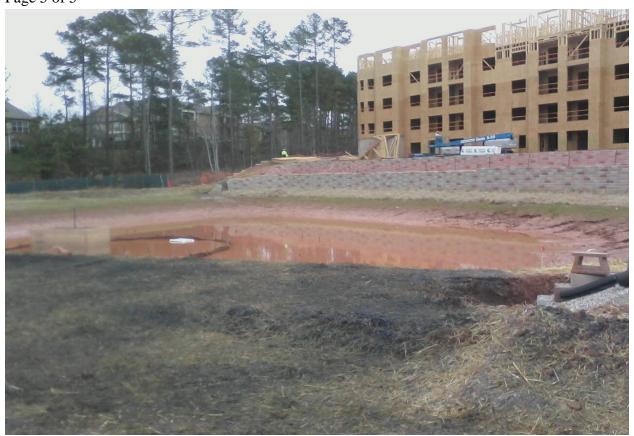
This site is a 18.5 acre residential project. The file for this project included an FRO, inspection reports, calculations and an approval letter. The erosion and sediment control plan was approved and was adequate. The last inspection was conducted on 12/2/2014 and the site in compliance. The site was active at the time of the inspection and in compliance.

- 1) Self-inspection/monitoring reports were very thorough and descriptive.
- 2) Repair area disturbed by Time Warner Cable.
- 3) Re-install diversion berm at end of work day to divert runoff toward basin/inlets.
- 4) Continue to provide adequate ground cover on all bare and inactive areas.

Site 3 – Temporary Skimmer Basin downstream of apartment building.

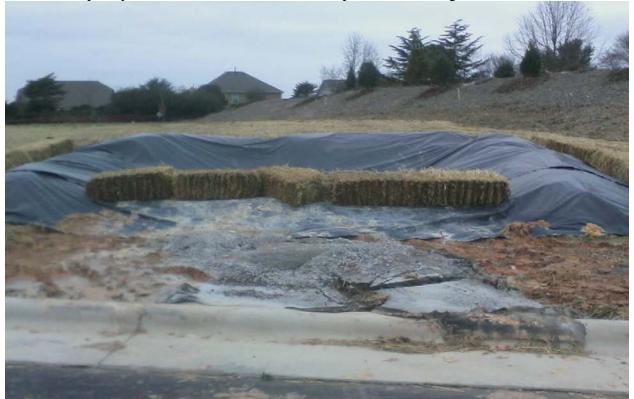
This site is a 2.62 acre residential project. The file for this project included an FRO, inspection reports, correspondence, calculations, and an approval letter. The erosion and sediment control plan was approved and was adequate. The last inspection was conducted on 12/3/2014 and the site was out of compliance. The site has not received any Notice of Violations. The site was active at the time of the inspection and was out of compliance. Violations included failure to follow approved plan, failure to take all reasonable measures, failure to provide adequate groundcover, and failure to maintain measures.

Site 4 – Improperly installed concrete washout area.

- 1) Complete stabilization requested per previous inspection report.
- 2) Re-install concrete washout area per plan.

- 1) Provide J-Hook and silt fence outlet downstream of stockpile area or storage for runoff concentrating on opposite side of ROW.
- 2) Continue to provide adequate ground cover on all bare and inactive areas.

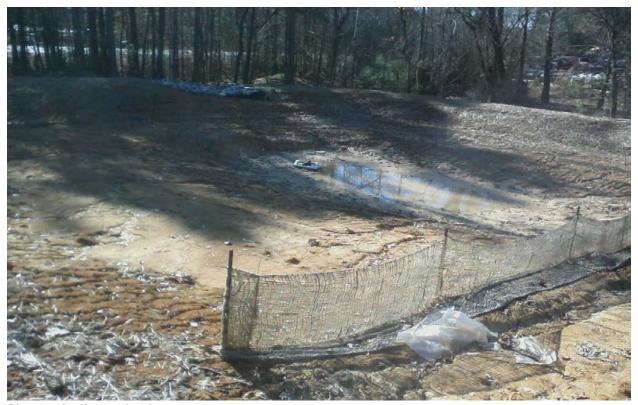
This site is a 1.9 acre commercial project. The file for this project included an FRO, inspection reports, check, calculations, certificate of compliance, and an approval letter. The erosion and sediment control plan was approved and was adequate. The last inspection was on 10/15/2014 and the site was in compliance. The site was active at the time of the inspection and was out of compliance. Violations included failure to follow approved plan, failure to maintain erosion control measures, and failure to take all reasonable measures.

Site 1 – Sediment Basin

- 1) Provide concrete washout area for site.
- 2) Construction entrance needs clean stone and maintenance
- 3) Slight offsite (on property) deposition at silt fence should be recovered/stabilized.
- 4) Temporary diversion needs re-installation *since directed at last baffle before skimmer*.

1) Continue to provide adequate ground cover on all bare and inactive areas.

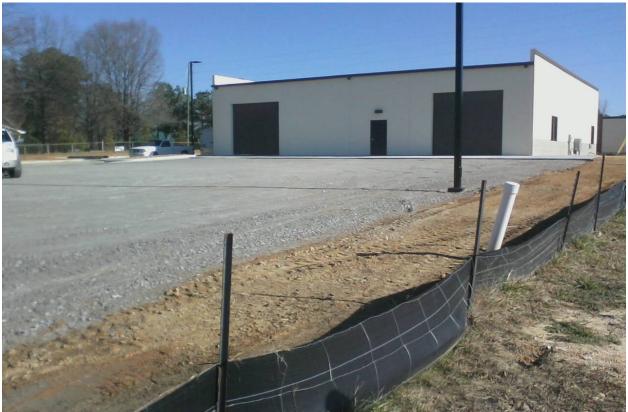
This site is a 0.9 acre industrial project. The file for this project included an FRO, inspection reports, check, calculations, and an approval letter. The erosion and sediment control plan was approved and was adequate. The last inspection was conducted on 11/17/2014 and the site was in compliance. The site was active at the time of the inspection and was in compliance.

Site 2 – Final site preparation underway with ABC stone and seedbed preparation.

1) Continue to provide adequate ground cover on all bare and inactive areas.

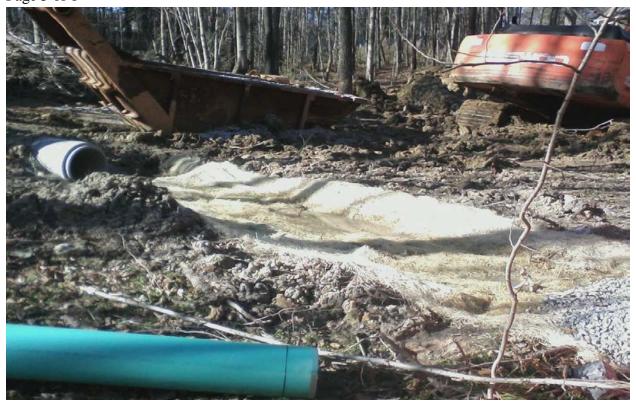
This site is a 9.2 acre residential project. The file for this project included an FRO, inspection reports, calculations and an approval letter. The erosion and sediment control plan was approved and was adequate. The last inspection was conducted on 11/24/2014 and the site in compliance. The site was active at the time of the inspection and out of compliance. Violations included failure to follow approved plan, failure to take all reasonable measures, and failure to maintain erosion control measures.

Site 3 – Temporary Skimmer Basin downstream of apartment building.

- 1) Install all diversions/berms per plan to convey runoff to sediment basins.
- 2) Stabilize the temporary diversions and the temporary sediment basins.

1) Provide adequate ground cover on all bare and inactive areas.

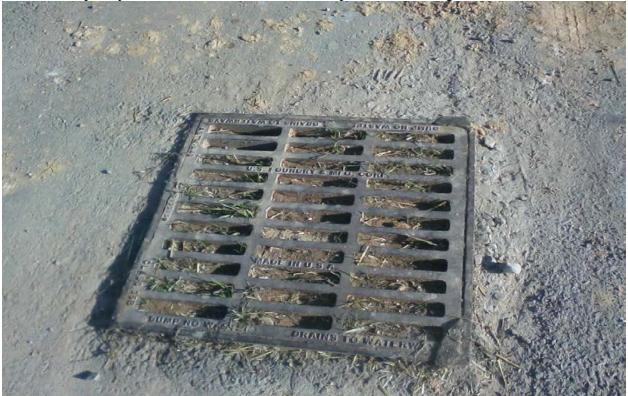
This site is a 3.5 acre residential project. The file for this project included an FRO, inspection reports, correspondence, calculations, and an approval letter. The erosion and sediment control plan was approved and was adequate. The last inspection was conducted on 11/26/2014 and the site was out of compliance. Based on this inspection, the Town of Apex issued a Notice of Violation on 12/31/2014. The site was active at the time of the inspection and was out of compliance. Violations included failure to follow approved plan, failure to take all reasonable measures, failure to provide adequate groundcover, and failure to maintain measures.

- 1) Some stabilization has been performed since previous inspection and some sweeping of adjacent streets.
- 2) Continue to provide adequate ground cover on all bare and inactive areas.

Site 4 – Inlet shows continued lack of maintenance with grass actively growing.

- 1) Maintain inlet protection and perimeter silt fence. Re-install silt fence where damaged.
- 2) Remove sediment from alley and street.

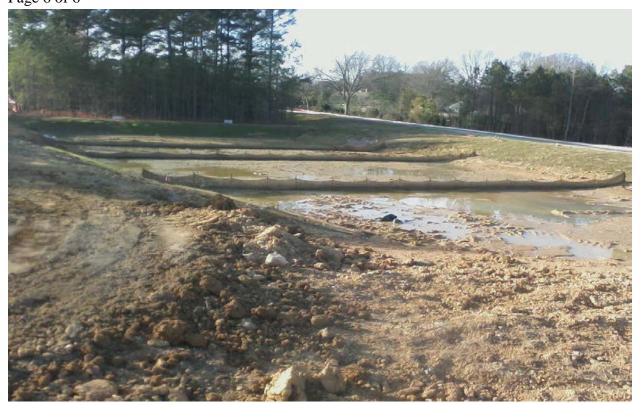
This site is a 7.3 acre institutional project. The file for this project included an FRO, inspection reports, correspondence, calculations, and an approval letter. The erosion and sediment control plan was approved and was adequate. The last inspection was conducted on 11/17/14 and the site was out of compliance. The site was active at the time of the inspection and was in compliance.

Site 5 – Temporary skimmer basin to be converted to permanent Stormwater BMP nearer the end of construction.

- 1) Continue to monitor discharge of skimmer outlet to downstream pond.
- 2) Continue to provide adequate ground cover on all bare and inactive areas.

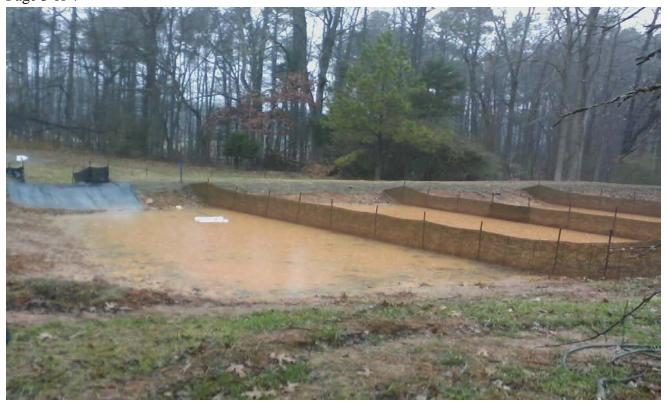
This site is an 8.5 acre institutional project. The file for this project included an FRO, inspection reports, GIS maps, check, calculations, certificate of compliance, and an approval letter. The erosion and sediment control plan was approved and was adequate. The last inspection was on 11/5/2014 and the site was in compliance. The site was not active at the time of the inspection and was in compliance.

Site 1 – Sediment Basin

- 1) Continue to provide adequate ground cover on all bare and inactive areas.
- 2) Provide stabilization in ditch.

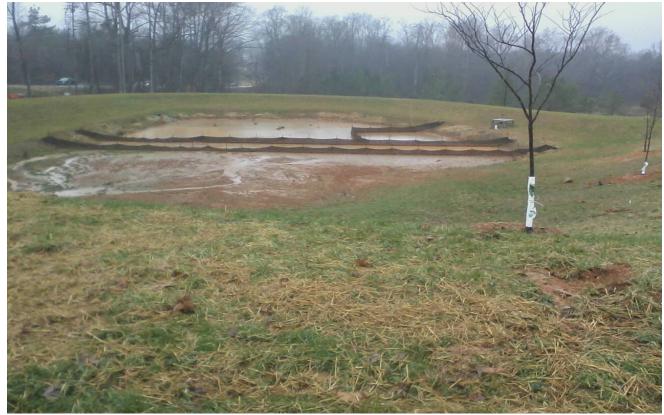
This site is a 25.3 acre residential project. The file for this project included an FRO, inspection reports, check, calculations, and an approval letter. The erosion and sediment control plan was approved and was adequate. The last inspection was conducted on 12/11/2014 and the site was in compliance. The site was active at the time of the inspection and was in compliance.

1) Continue to provide adequate ground cover on all bare and inactive areas as construction progresses. Site currently has very good perimeter groundcover.

Site 2 – Good stabilization on temporary skimmer basin to be converted to permanent Stormwater BMP.

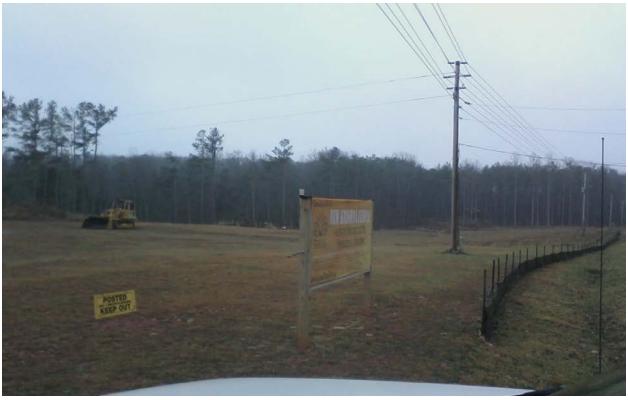
This site is a 6.67 acre institutional project. The file for this project was not as thorough as the others. The plan was received and reviewed in 2007. The erosion and sediment control plan was approved and was adequate. The last inspection was conducted on 7/22/2014 and the site was in compliance. The site was not active at the time of the inspection and was found in compliance.

Site 3 – Ground cover established while site remains idle until additional funds raised .

1) Site has great groundcover (dormant), consider overseeding or drilling with seasonal small grain seed.

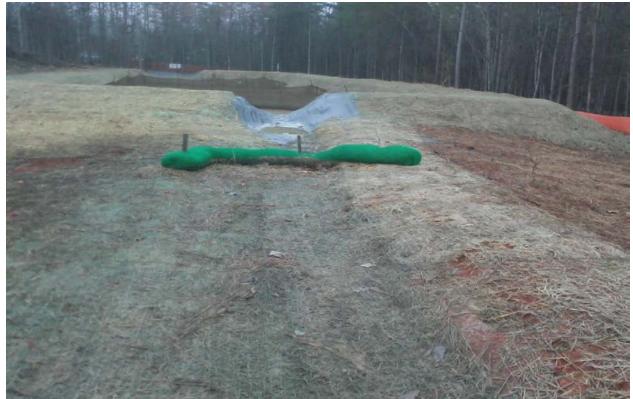
This site is a 42.0 acre industrial project. The file for this project included an FRO, inspection reports, GIS maps, stream/buffer determination, correspondence, calculations, and an approval letter. The erosion and sediment control plan was approved and was adequate. The last inspection was conducted on 12/15/2014 and the site was out of compliance. The site was active at the time of the inspection and was out of compliance.

Site 4 – Perimeter controls have been stabilized or seeded and provided with mulch or rolled erosion control product.

1) Continue maintenance and to provide adequate ground cover on all bare and inactive areas, especially access road slope leading to substation.
