# Briles Stream Restoration Monitoring Report Year 2 of 5 (2010)

Randolph County, North Carolina

Project ID No. 047

Submitted November 2010

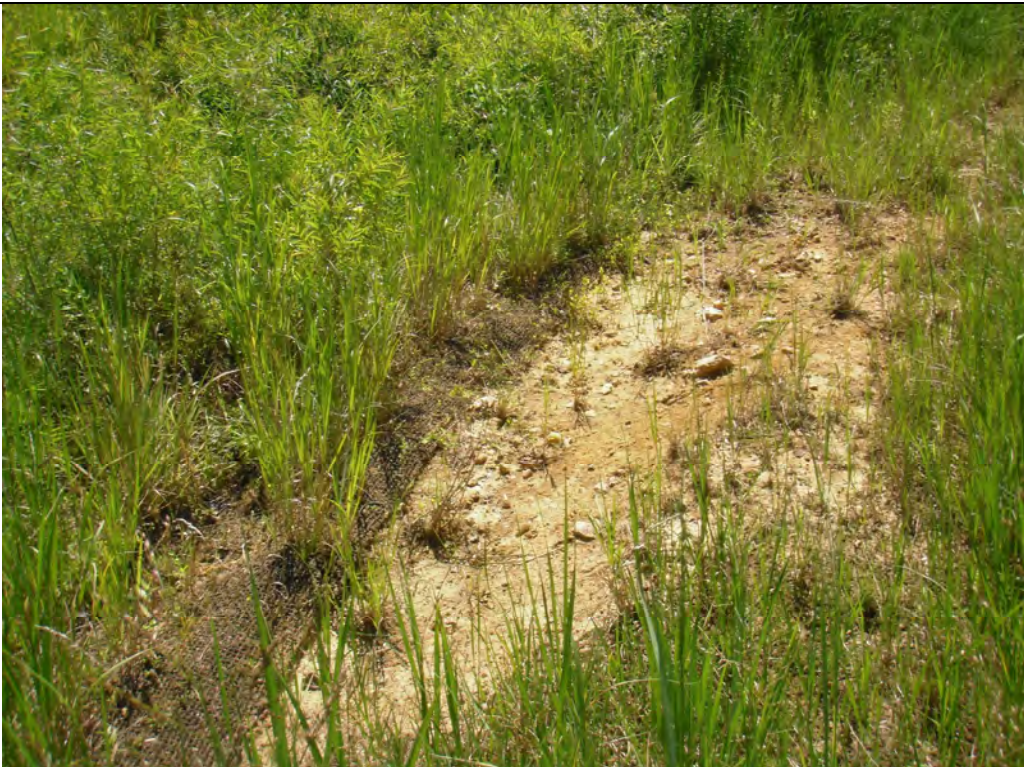
VP1: Cattails (Invasive)  
Taken: 2010
