Morgan Creek Stream Restoration Site

Haywood County, North Carolina

MONITORING REPORT 2011 (YEAR 3)

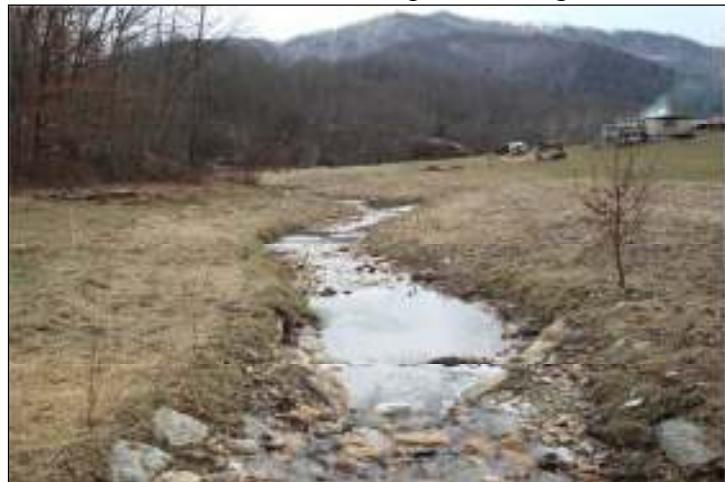
Photo No. 72

Photo Point 9
Piped crossing at easement break, facing downstream

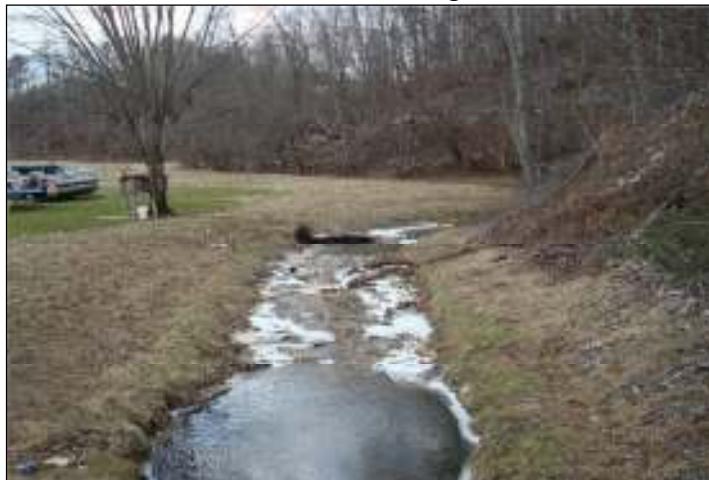
Photo No. 76

Photo Point 10
Morgan Creek from D/S pipe inlet, facing upstream
