OAKLEY CROSSROADS STREAM & BUFFER RESTORATION

FINAL AS-BUILT & BASELINE MONITORING REPORT

Pitt County, North Carolina SCO Project Number 050659701 EEP Project Number 273

Status of Plan: Final Submission Date: August 2011 Data Collection Completed: June 2011

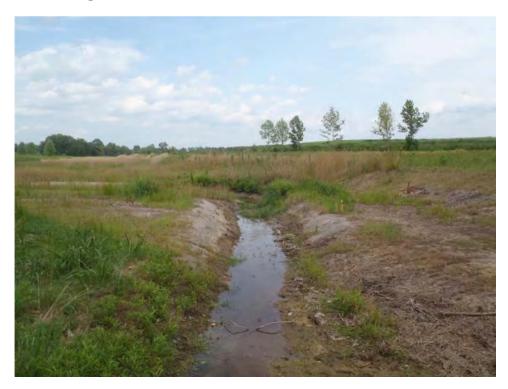
Photo Station S1 – Stream channel looking downstream at cross-section 1 Station 00+72 - Priority 2 (6/19/2011 Year 0)

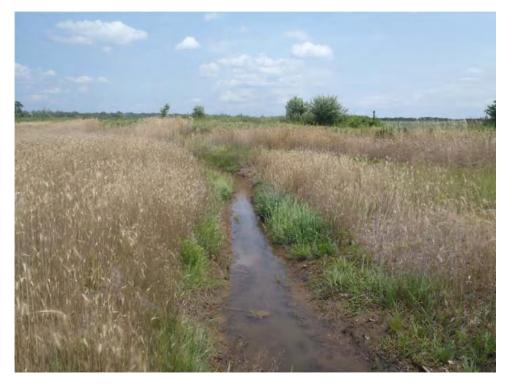
Photo Station S2 –Stream channel looking downstream at cross-section 2 Station 06+17 – Priority 2 (6/19/2011 Year 0)

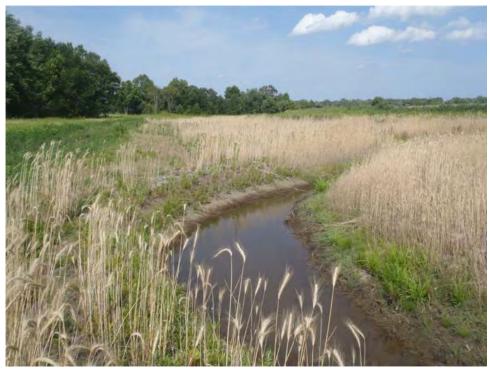
Photo Station S3 – Stream channel looking downstream at cross-section 3 Station 12+59 – Priority 2 (6/19/2011 Year 0)

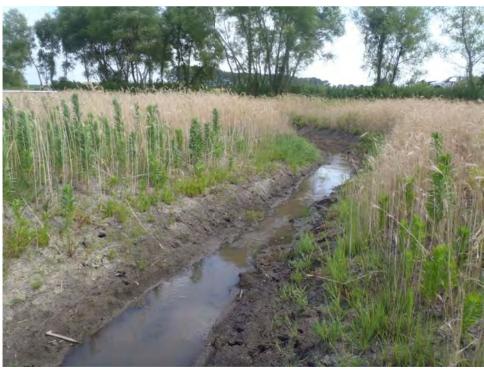
Photo Station S4 – Stream channel looking downstream at cross-section 4 Station 28+46 – Priority 2 (6/19/2011 Year 0)

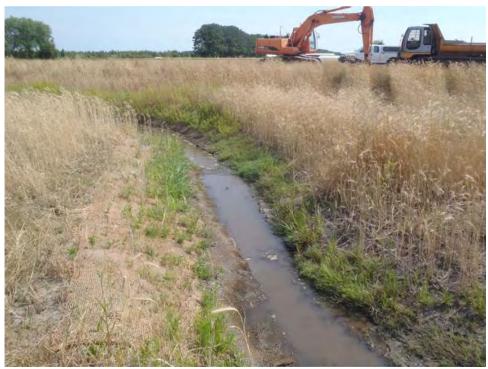
Photo Station S6 – Stream channel looking downstream at cross-section 6 Station 35+24 – Priority 2 (6/19/2011 Year 0)

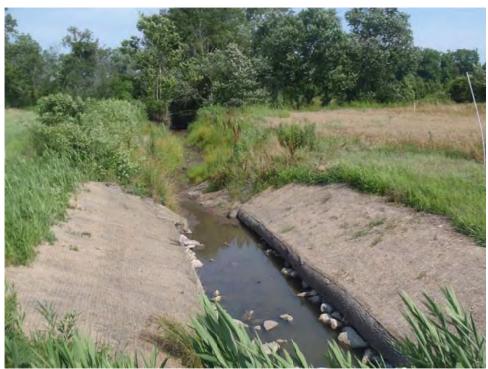
Photo Station S7 – Stream channel looking downstream at cross-section 7 Station 38+71 – Enhancement 2 (6/19/2011 Year 0)

Also during the Final Walk-Through, it was noted that livestakes per Change Order 3 had not been planted. The intended planting areas per Change Order 3 (upstream and downstream of the Taylor and Briley culverts and near cross-section 7) will be planted between January and March of 2012, as per NCEEP's Vegetation Agreement with Ecosystems Grading Solutions, Inc. Livestake density in other areas of the site were not assessed during the Final Walk-Through and will instead be handled at the end of the warranty period.
