# **MY1 MONITORING REPORT**

# Wits End Stream and Wetland Mitigation Site

Union County, North Carolina Yadkin River Basin Cataloging Unit 03040105

> Data Collection: March - November 2023 Submission: February 2024

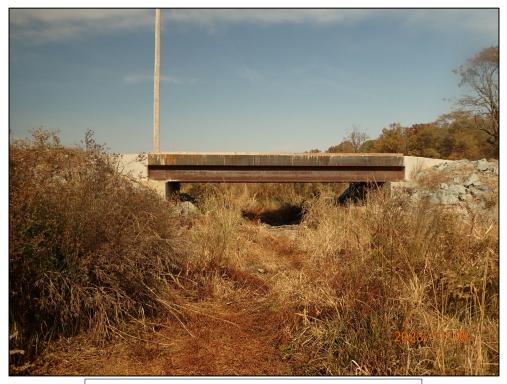
Bridge Crossing on Waxhaw Branch, taken November 8, 2023

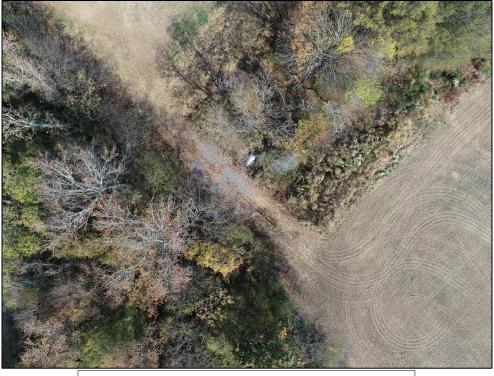
Forded Crossing UT 2, taken May November 8, 2023

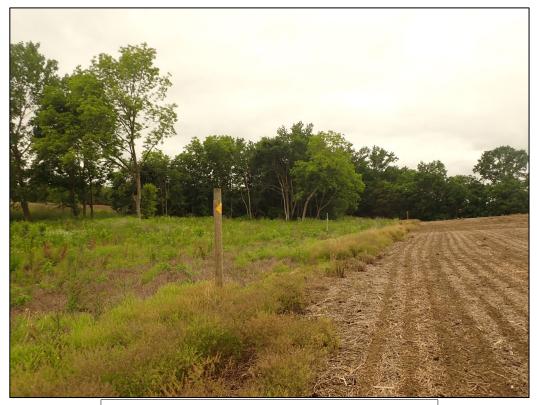
Easement Boundary Signage, taken February 6, 2023

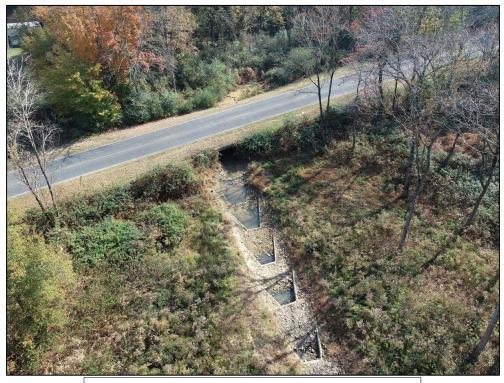
- Beaver activity is present downstream of the Site, across Snyder Store Road, to the point that a portion of the outfall structure was inundated at times during the year. RS will continue to monitor beaver activity, but at this point, the observed activity was not a detriment to the reach.

Site Outfall and Drop Structure, taken November 8, 2023

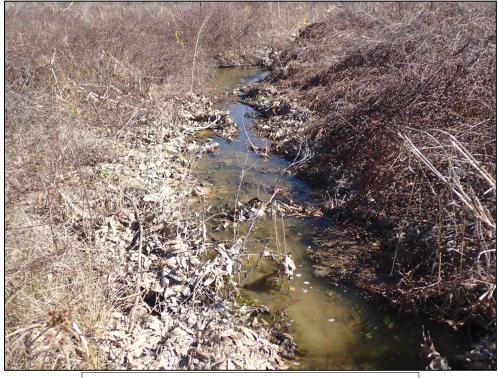
UT 4, taken April 8, 2023

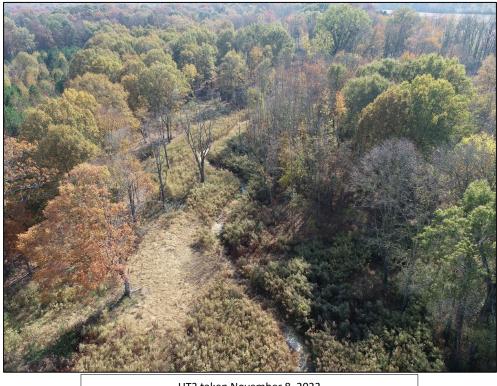
UT3 taken November 8, 2023

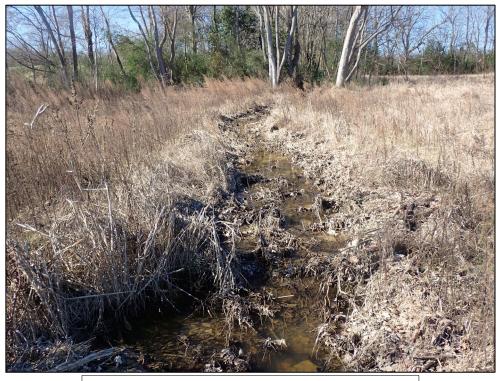
Upper UT 3, taken February 6, 2023

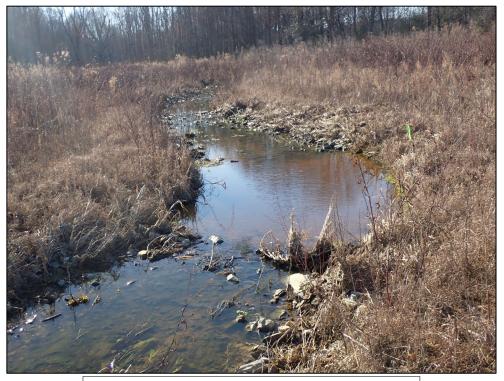
- Bare root planted stem mortality was exceptionally prominent within the former pond bed along Waxhaw Branch. Visible surface cracking was observed during MY1 monitoring, which resulted in the exposure of roots on bare-root trees, leading to their mortality. In many cases, the dibble bar holes themselves were observed to have contributed to surface cracking and air pruning. As such, the 2023 Adaptive Management Plan focuses on planting methods such as live-staking and seeding, that allow trees to establish roots themselves rather than attempting to transplant an existing root structure into potentially inadequate soil conditions. Target planting areas are depicted on Figure 1 (Appendix A), and details regarding the supplemental planting effort are in the 2023 Adaptive Management Plan (Appendix F). Once the planting phase of the Adaptive Management Plan is complete RS will provide an Adaptive Management Plan Implementation Memo.

Waxhaw Branch in Old Pond Bed, taken February 6, 2023

Due to insufficient planted stem survival and a lack of wetland hydrology within the former pond bed along Waxhaw Branch, RS has implemented an Adaptive Management Plan to address the observed surface cracking in former pod sediments left behind after Site construction. The hydrology issues have been addressed by: (1) physically mixing 0.427 acres of existing top soils that were observed to be severely cracked, then reincorporating the soil along with additional large woody debris to help reestablish healthy soil structure; and (2) installing 2 floodplain grade control (VGC) structures to eliminate subsurface groundwater flow through existing surface cracks and to encourage sediment deposition within the cracks instead of on the floodplain itself. The VGC structures were installed in areas where outer bends of Waxhaw Branch come within close proximity of the former pond boundary. These management activities are expected to improve groundwater hydrology in this area during future monitoring years. Soil mixing areas and locations of the VGC structures are depicted on Figure 1 (Appendix A). Details regarding soil and hydrology improvement-related activities are in the 2023 Adaptive Management Plan (Appendix F).

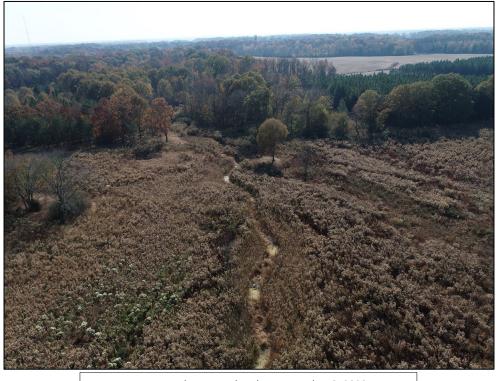
Lower Waxhaw Branch, taken November 8, 2023

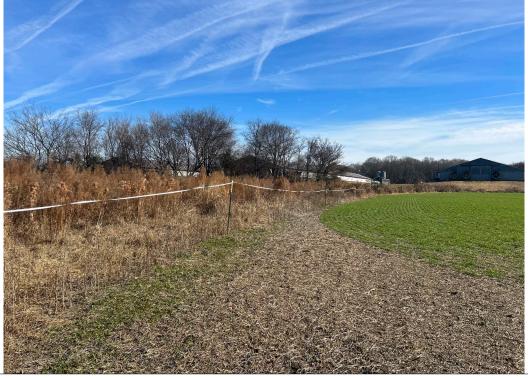
Six small areas (totaling 0.296 acres) of easement encroachment were observed during MY1 (2023) around the boundary of UT-2 and UT3A. RS has communicated with the farmer that easement encroachment is not permissible, and enhanced easement visibility by adding signage and horse tape to prevent further encroachment (Appendix A and G). RS will replant these areas as needed with 3-gallon upland containerized species from the approved Mitigation Plan during the Adaptive Management Plan planting phase.

Horse tape installed to prevent easement encroachment, taken December 21, 2023

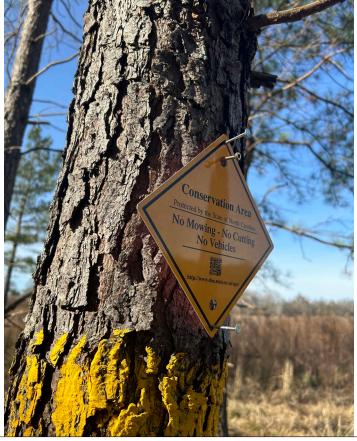
Upgraded fastener and blazing of trees, taken December 21, 2023

- Additional items from the DMS boundary inspection report related to marking/monumentation that was missing, damaged, or not meeting specification were addressed (Appendix A and G).
