YEAR 2 (2016) MONITORING REPORT
ABBEY LAMM
STREAM AND WETLAND MITIGATION SITE
ALAMANCE COUNTY, NORTH CAROLINA
FULL DELIVERY CONTRACT NO. 5790

CAPE FEAR RIVER BASIN
CATALOGING UNIT 03030002

Data Collection – March-October 2016

December 2016

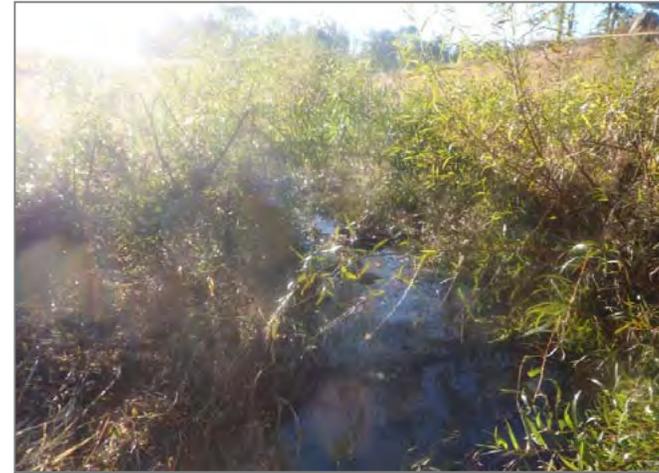
Site	Abbey Lamm
Watershed:	Cape Fear, 0303002
XS ID	Main Channel XS - 1, Pool
Feature	Pool
Date:	4/7/2016
Field Crew:	Perkinson, Keith

SUMMARY DATA	
Bankfull Elevation:	73.1
Bankfull Cross-Sectional Area:	9.7
Bankfull Width:	12.5
Flood Prone Area Elevation:	NA
Flood Prone Width:	NA
Max Depth at Bankfull:	1.6
Mean Depth at Bankfull:	0.8
W / D Ratio:	NA
Entrenchment Ratio:	NA
Bank Height Ratio:	1.0

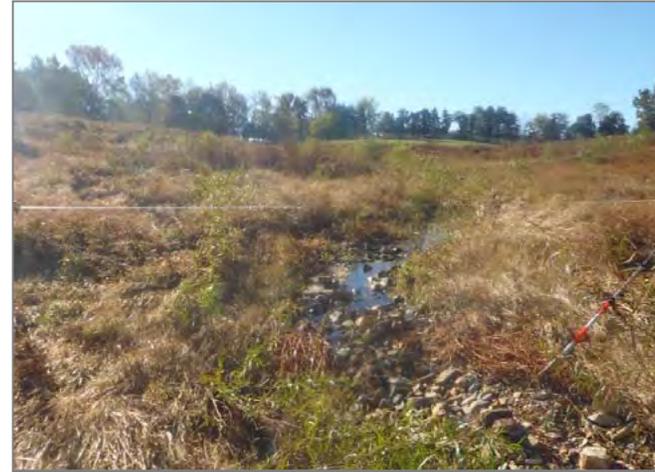
Site	Abbey Lamm
Watershed:	Cape Fear, 0303002
XS ID	Main Channel XS - 5, Pool
Feature	Pool
Date:	4/7/2016
Field Crew:	Perkinson, Keith

SUMMARY DATA	
Bankfull Elevation:	76.6
Bankfull Cross-Sectional Area:	7.7
Bankfull Width:	15.7
Flood Prone Area Elevation:	NA
Flood Prone Width:	NA
Max Depth at Bankfull:	0.8
Mean Depth at Bankfull:	0.5
W / D Ratio:	NA
Entrenchment Ratio:	NA
Bank Height Ratio:	1.0

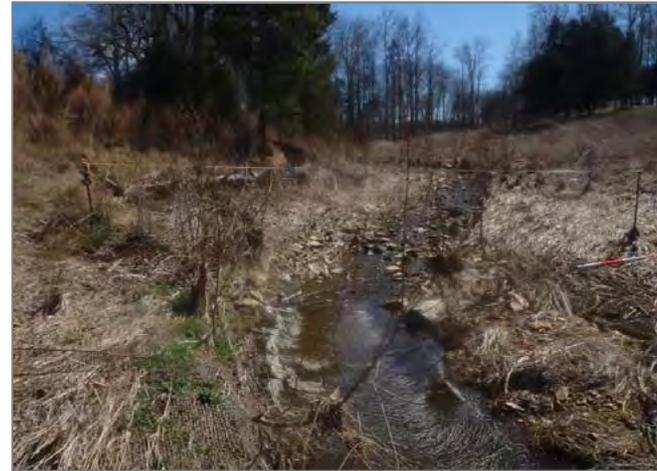
Site	Abbey Lamm
Watershed:	Cape Fear, 0303002
XS ID	Main Channel XS - 11, Pool
Feature	Pool
Date:	4/7/2016
Field Crew:	Perkinson, Keith

SUMMARY DATA	
Bankfull Elevation:	84.9
Bankfull Cross-Sectional Area:	11.2
Bankfull Width:	10.7
Flood Prone Area Elevation:	NA
Flood Prone Width:	NA
Max Depth at Bankfull:	1.6
Mean Depth at Bankfull:	1.0
W / D Ratio:	NA
Entrenchment Ratio:	NA
Bank Height Ratio:	1.0

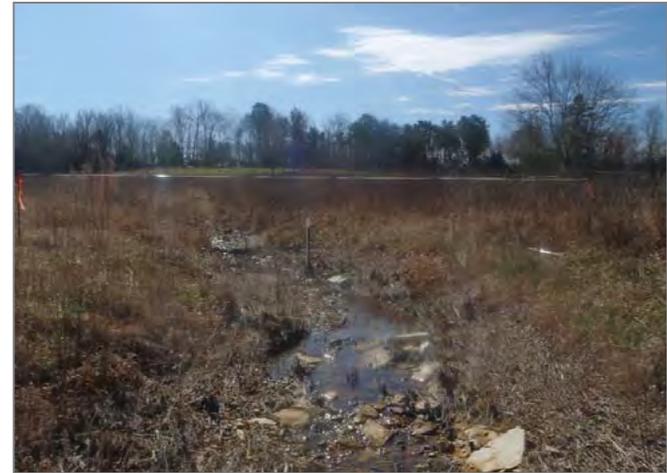
Site	Abbey Lamm
Watershed:	Cape Fear, 0303002
XS ID	UT 1 XS - 1, Pool
Feature	Pool
Date:	4/7/2016
Field Crew:	Perkinson, Jernigan

SUMMARY DATA	
Bankfull Elevation:	124.3
Bankfull Cross-Sectional Area:	4.5
Bankfull Width:	8.0
Flood Prone Area Elevation:	NA
Flood Prone Width:	NA
Max Depth at Bankfull:	1.1
Mean Depth at Bankfull:	0.6
W / D Ratio:	NA
Entrenchment Ratio:	NA
Bank Height Ratio:	1.0

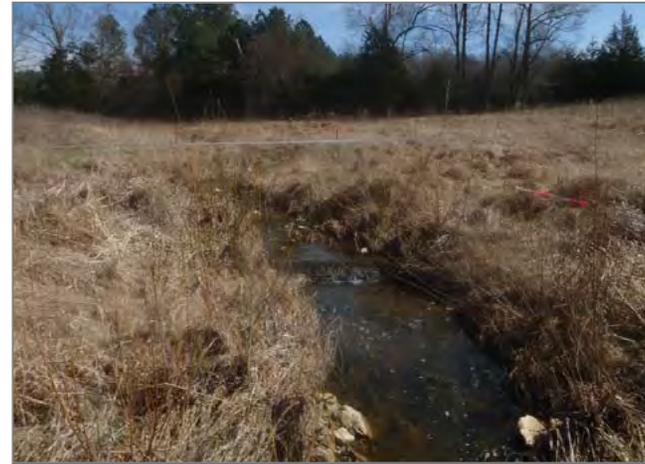
Site	Abbey Lamm
Watershed:	Cape Fear, 0303002
XS ID	UT 2 XS - 3, Pool
Feature	Pool
Date:	4/7/2016
Field Crew:	Perkinson, Jernigan

SUMMARY DATA	
Bankfull Elevation:	128.7
Bankfull Cross-Sectional Area:	5.9
Bankfull Width:	7.2
Flood Prone Area Elevation:	NA
Flood Prone Width:	NA
Max Depth at Bankfull:	1.3
Mean Depth at Bankfull:	0.8
W / D Ratio:	NA
Entrenchment Ratio:	NA
Bank Height Ratio:	1.0

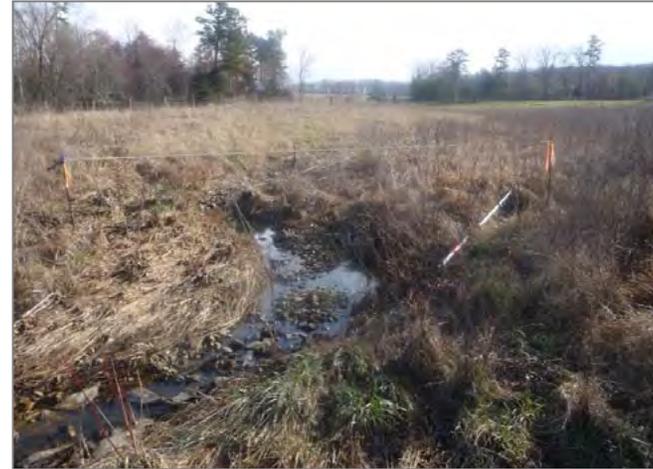
Site	Abbey Lamm
Watershed:	Cape Fear, 0303002
XS ID	UT 3 XS - 2, Pool
Feature	Pool
Date:	4/7/2016
Field Crew:	Perkinson, Jernigan

SUMMARY DATA	
Bankfull Elevation:	76.3
Bankfull Cross-Sectional Area:	5.5
Bankfull Width:	10.7
Flood Prone Area Elevation:	NA
Flood Prone Width:	NA
Max Depth at Bankfull:	1.1
Mean Depth at Bankfull:	0.5
W / D Ratio:	NA
Entrenchment Ratio:	NA
Bank Height Ratio:	1.0

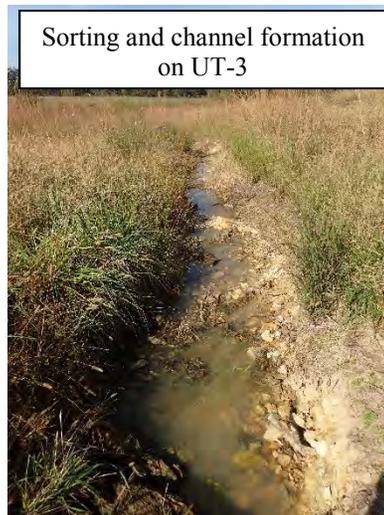
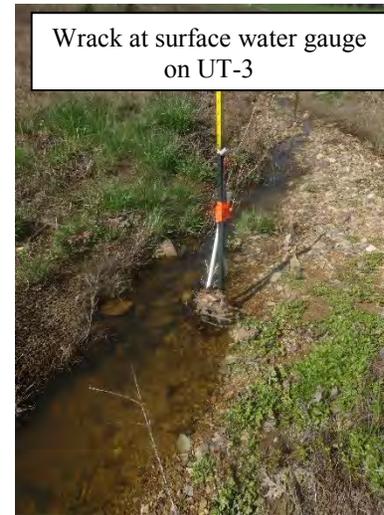
UT3 Channel Evidence	Year 1 (2015)	Year 2 (2016)
Max consecutive days channel flow	51	100
Presence of litter and debris (wracking)	Yes	Yes
Leaf litter disturbed or washed away	Yes	Yes
Matted, bent, or absence of vegetation (herbaceous or otherwise)	Yes	Yes
Sediment deposition and/or scour indicating sediment transport	Yes	Yes
Water staining due to continual presence of water	Yes	Yes
Formation of channel bed and banks	Yes	Yes
Sediment sorting within the primary path of flow	Yes	Yes
Sediment shelving or a natural line impressed on the banks	Yes	Yes
Change in plant community (absence or destruction of terrestrial vegetation and/or transition to species adapted for flow or inundation for a long duration, including hydrophytes)	Yes	Yes
Development of channel pattern (meander bends and/or channel braiding) at natural topographic breaks, woody debris piles, or plant root systems	Yes	Yes
Exposure of woody plant roots within the primary path of flow	No	No

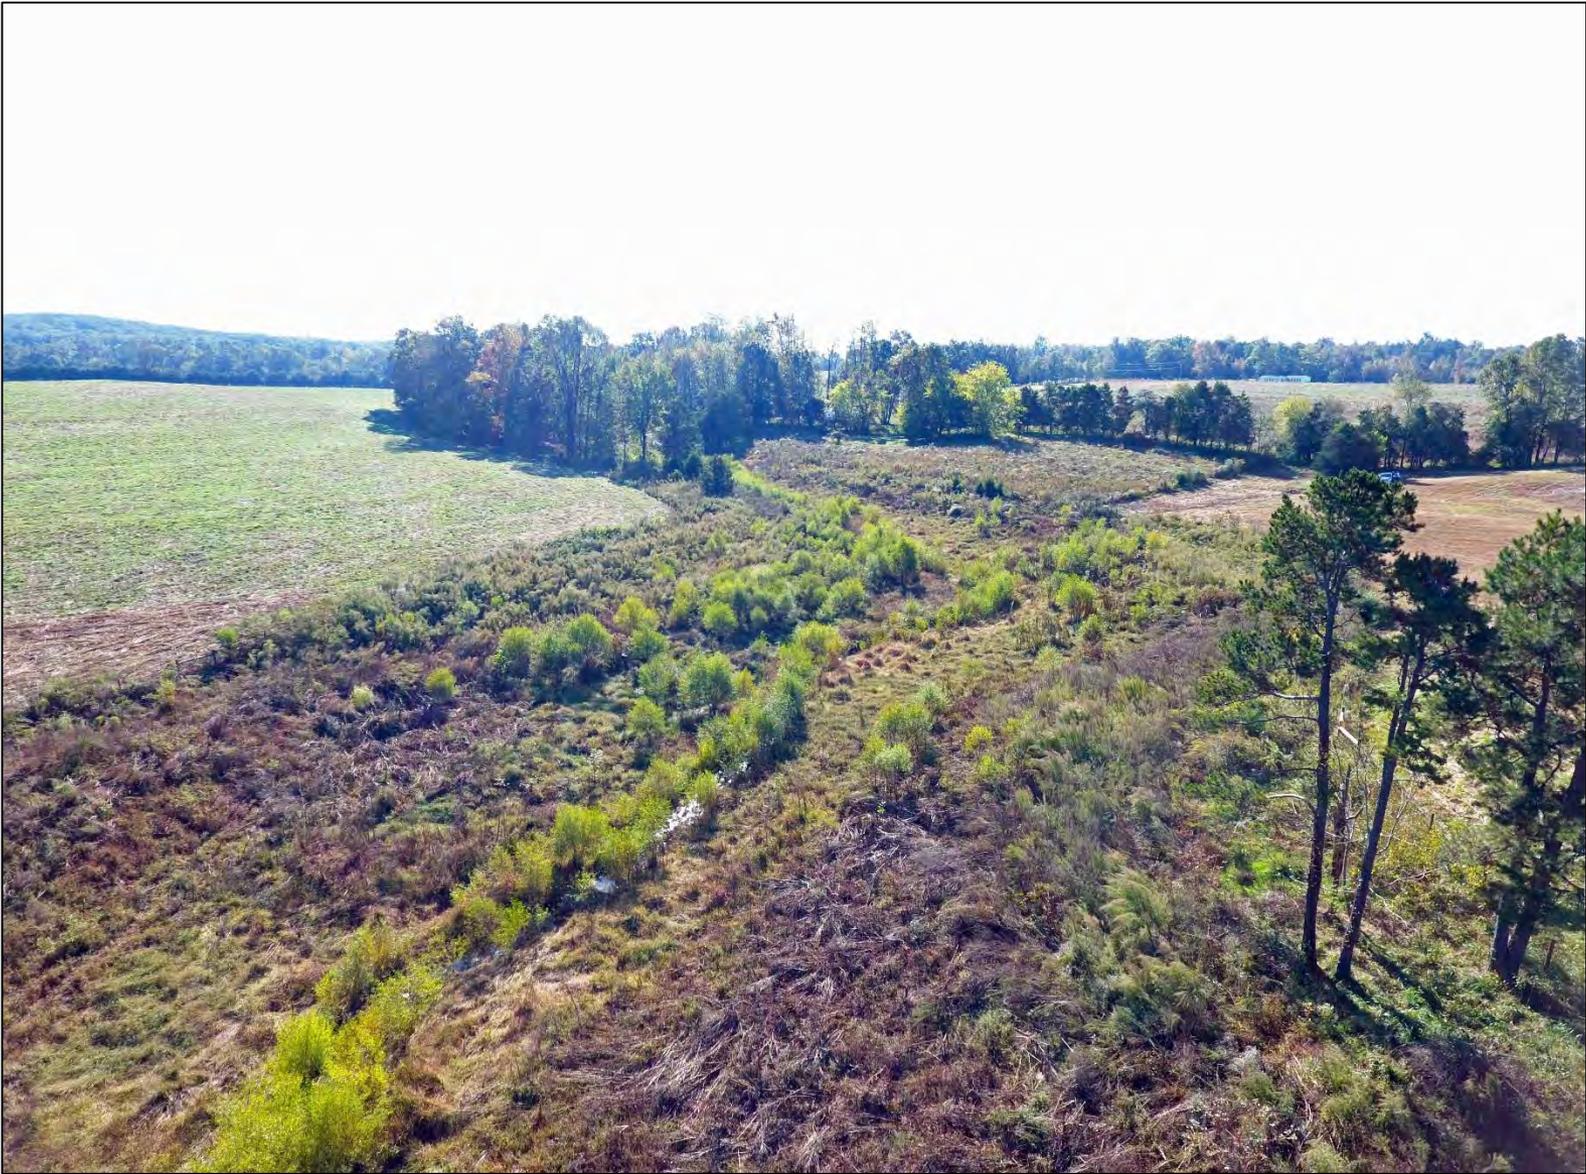
Photo 1: Downstream end of the Main Stem looking upstream into the old pond bed

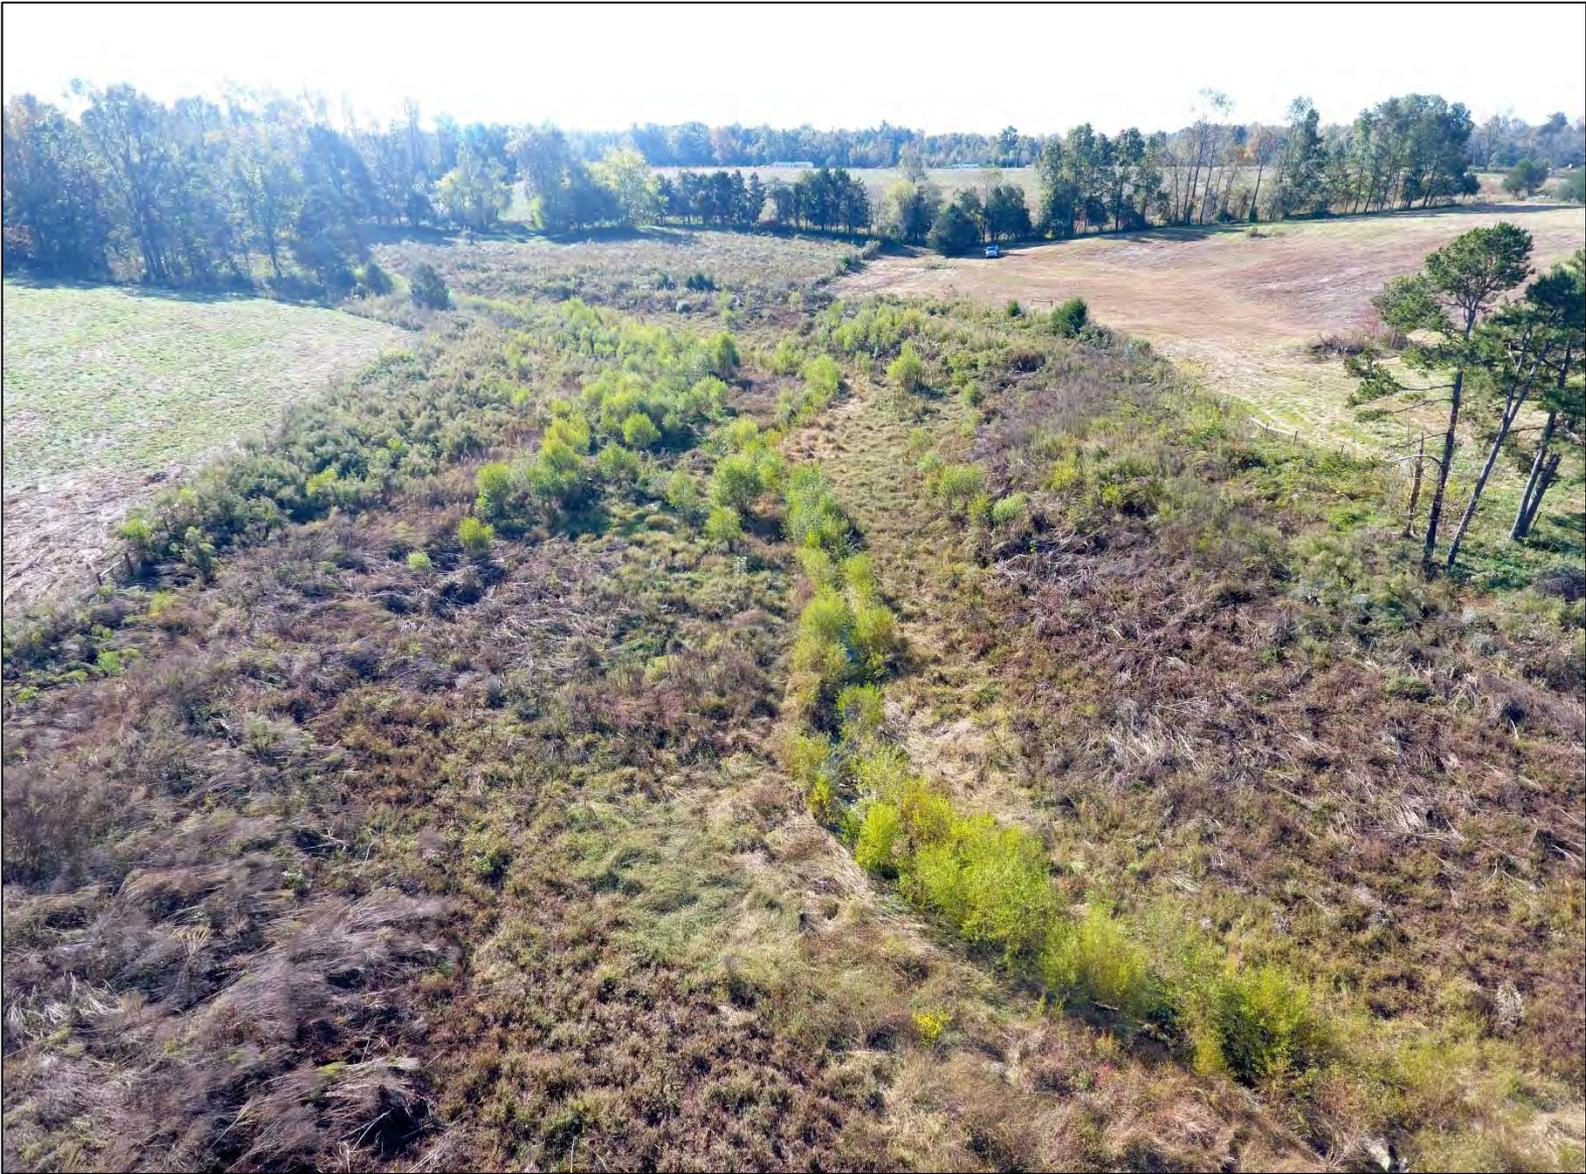
Photo 2: Downstream end of the Main Stem looking upstream into the old pond bed

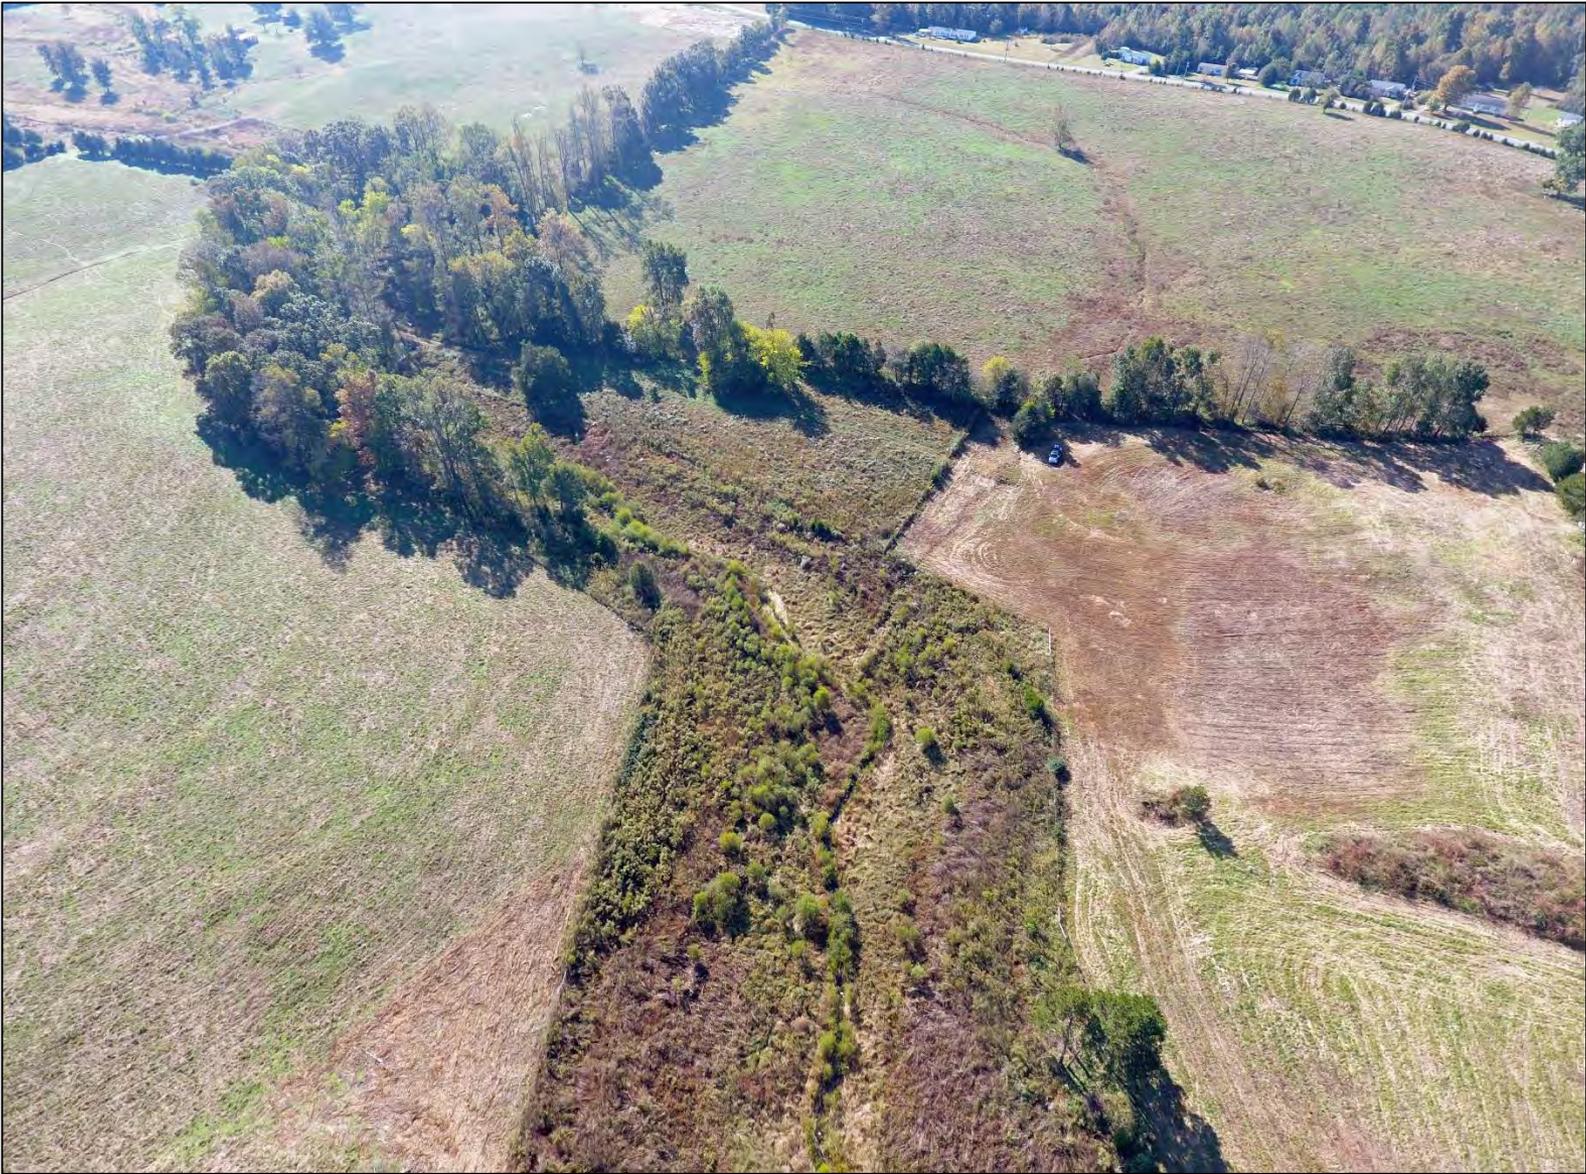
Photo 3: Downstream end of the Main Stem looking upstream into the old pond bed

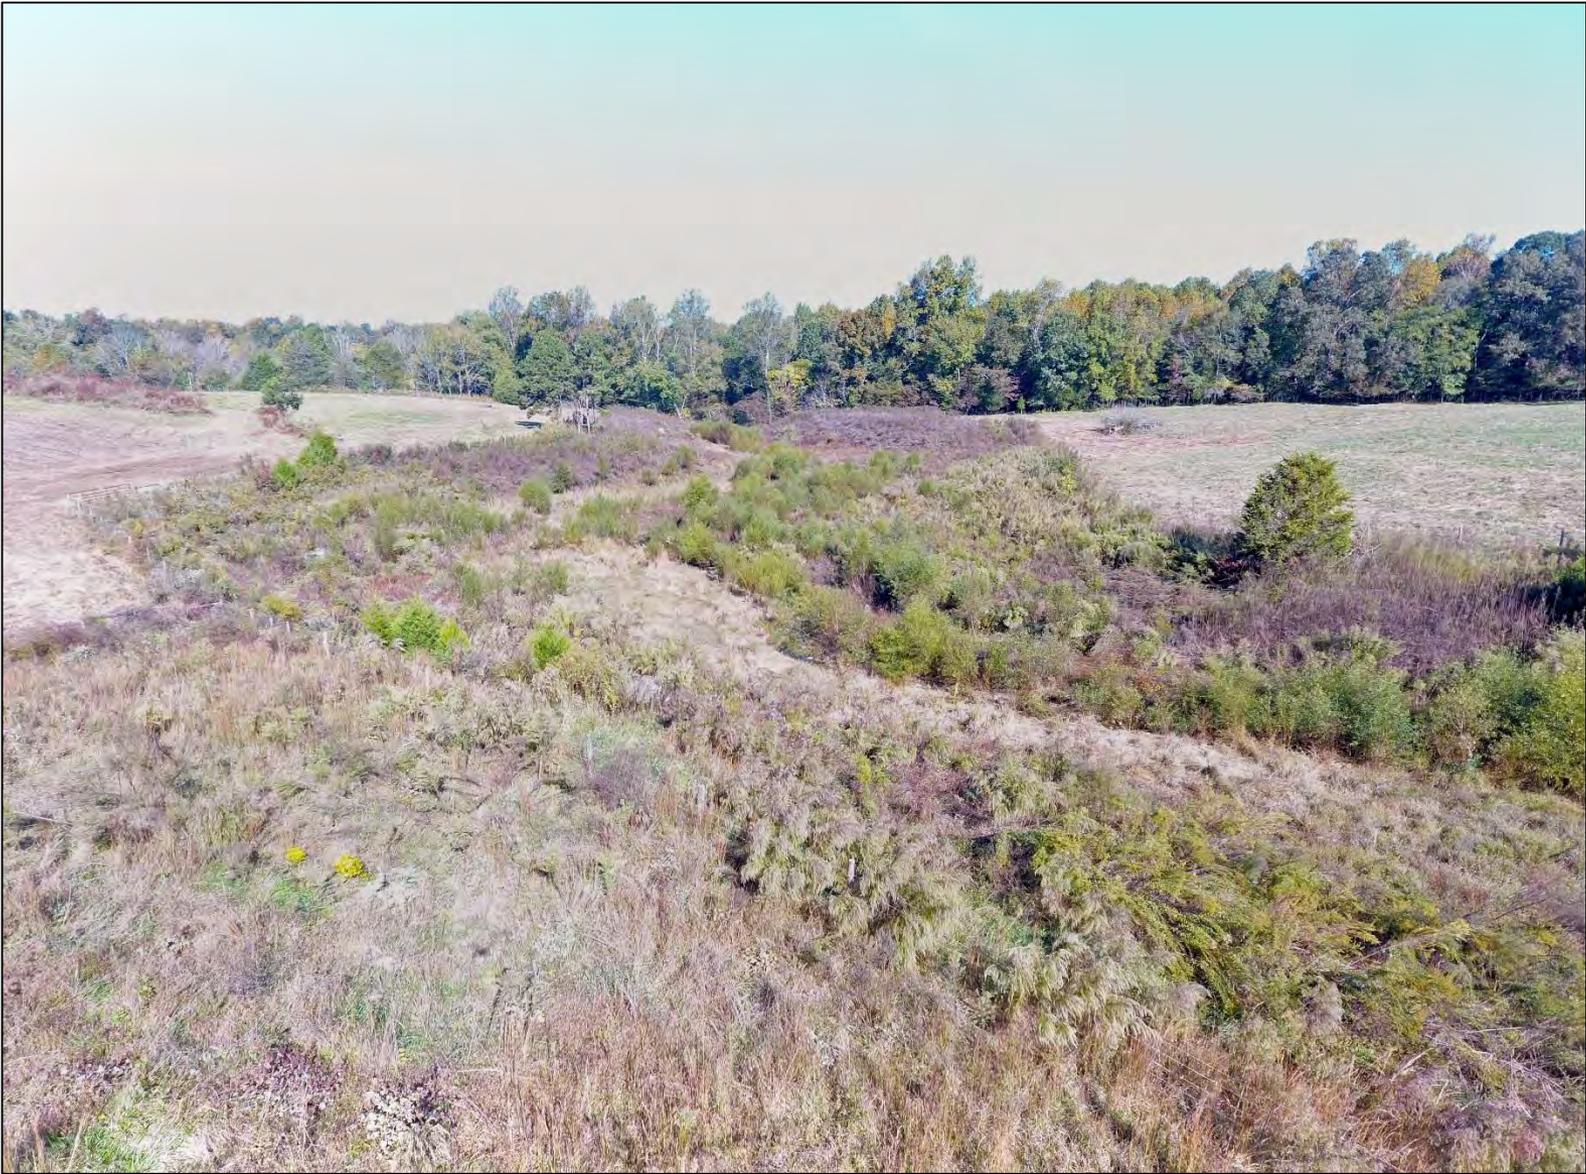
Photo 4: Upstream end of the old pond looking downstream

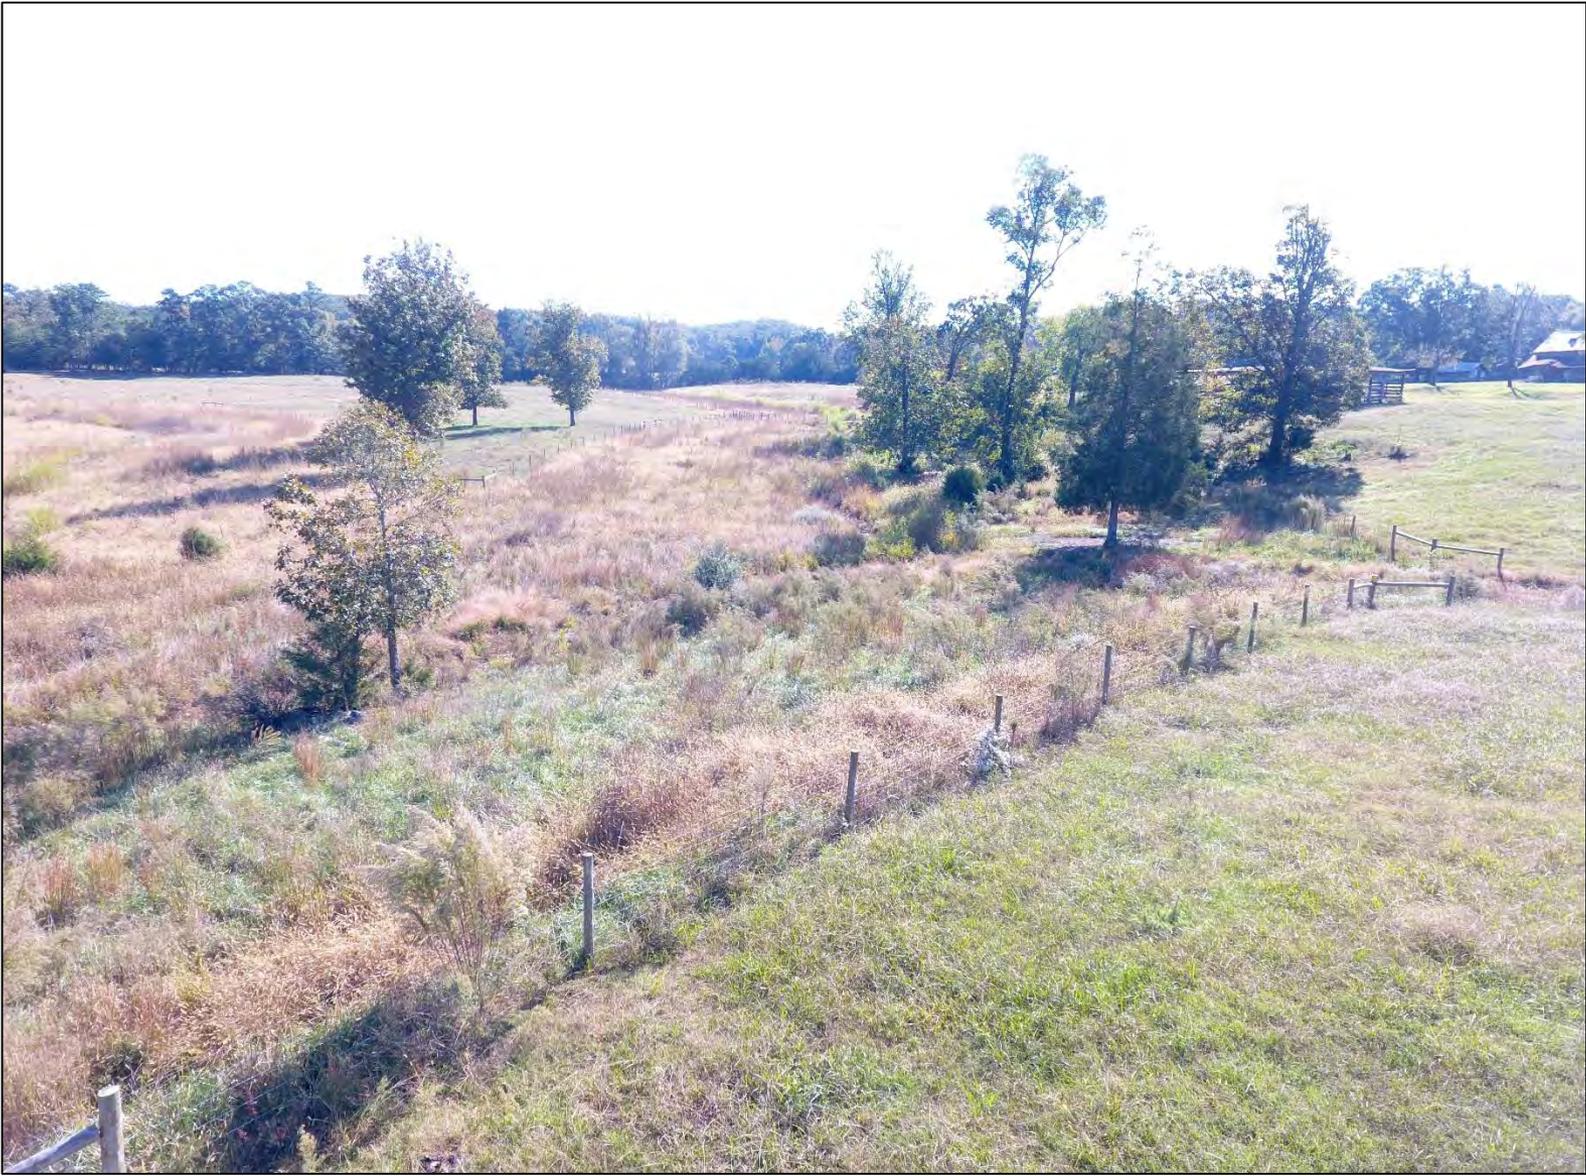
Photo 5: middle crossing looking upstream at the Main Stem and UT-3 on the left

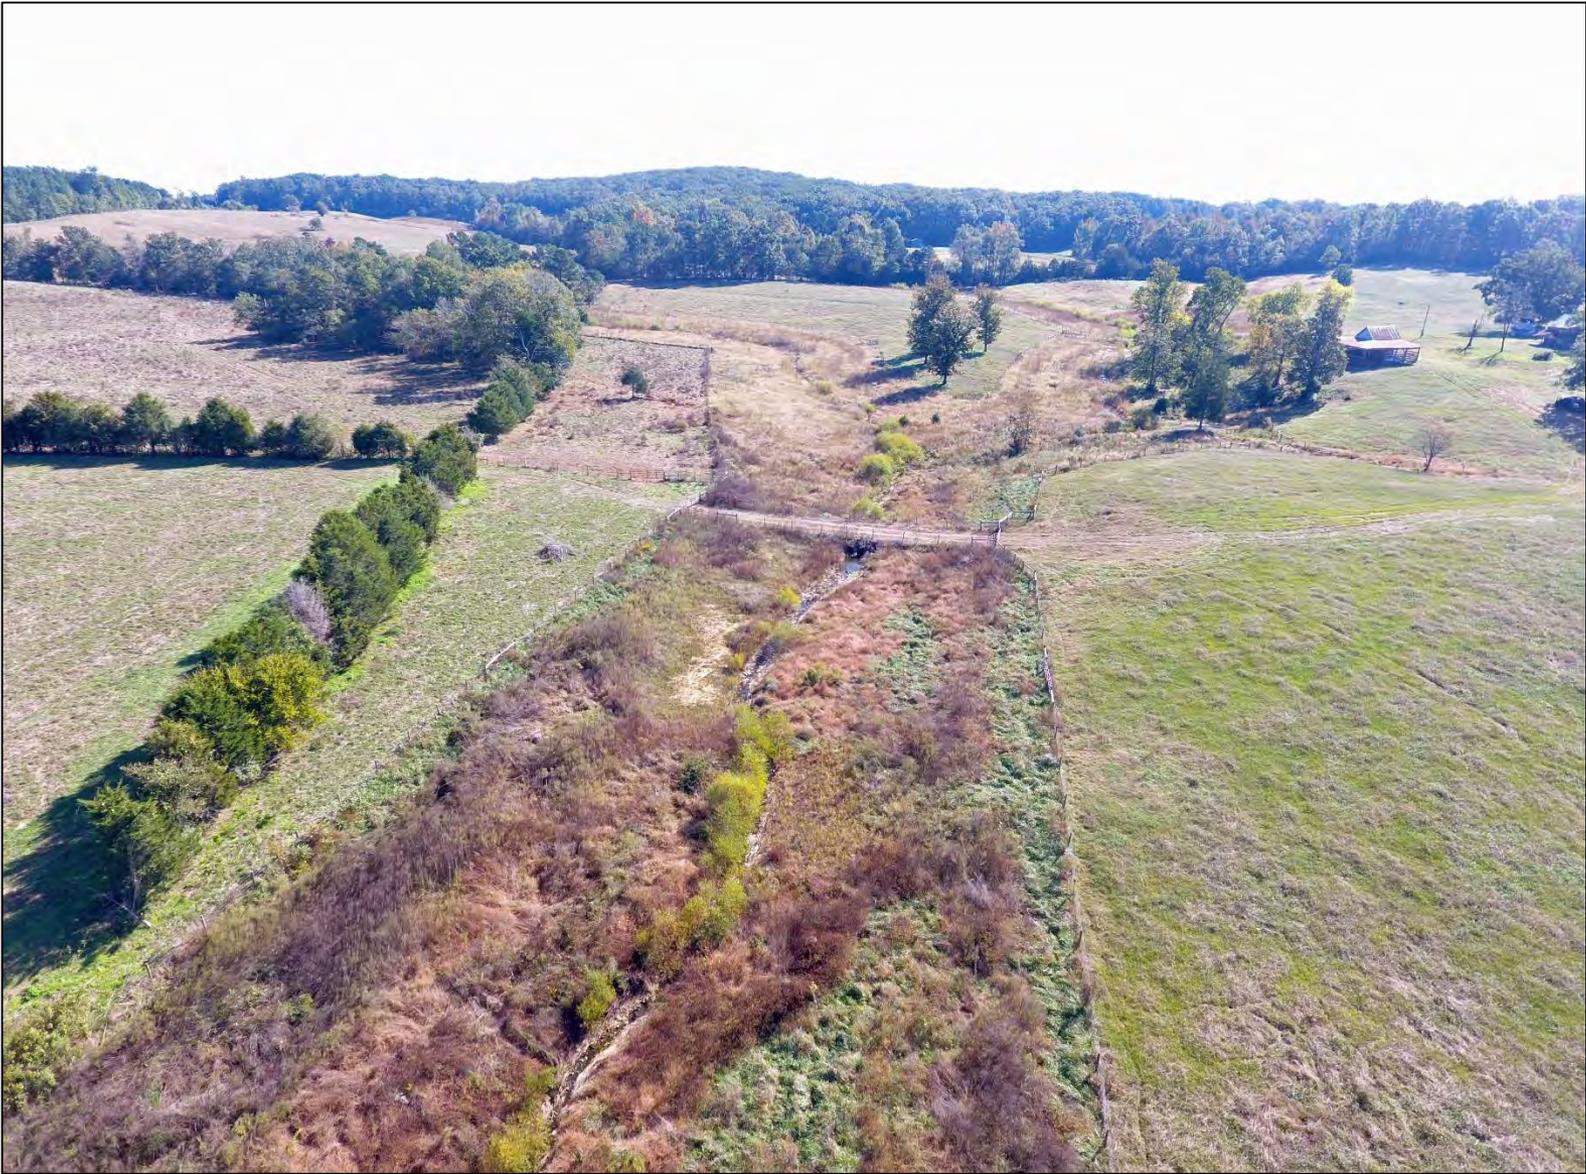
Photo 6: middle crossing looking upstream at the Main Stem and UT-3 on the left

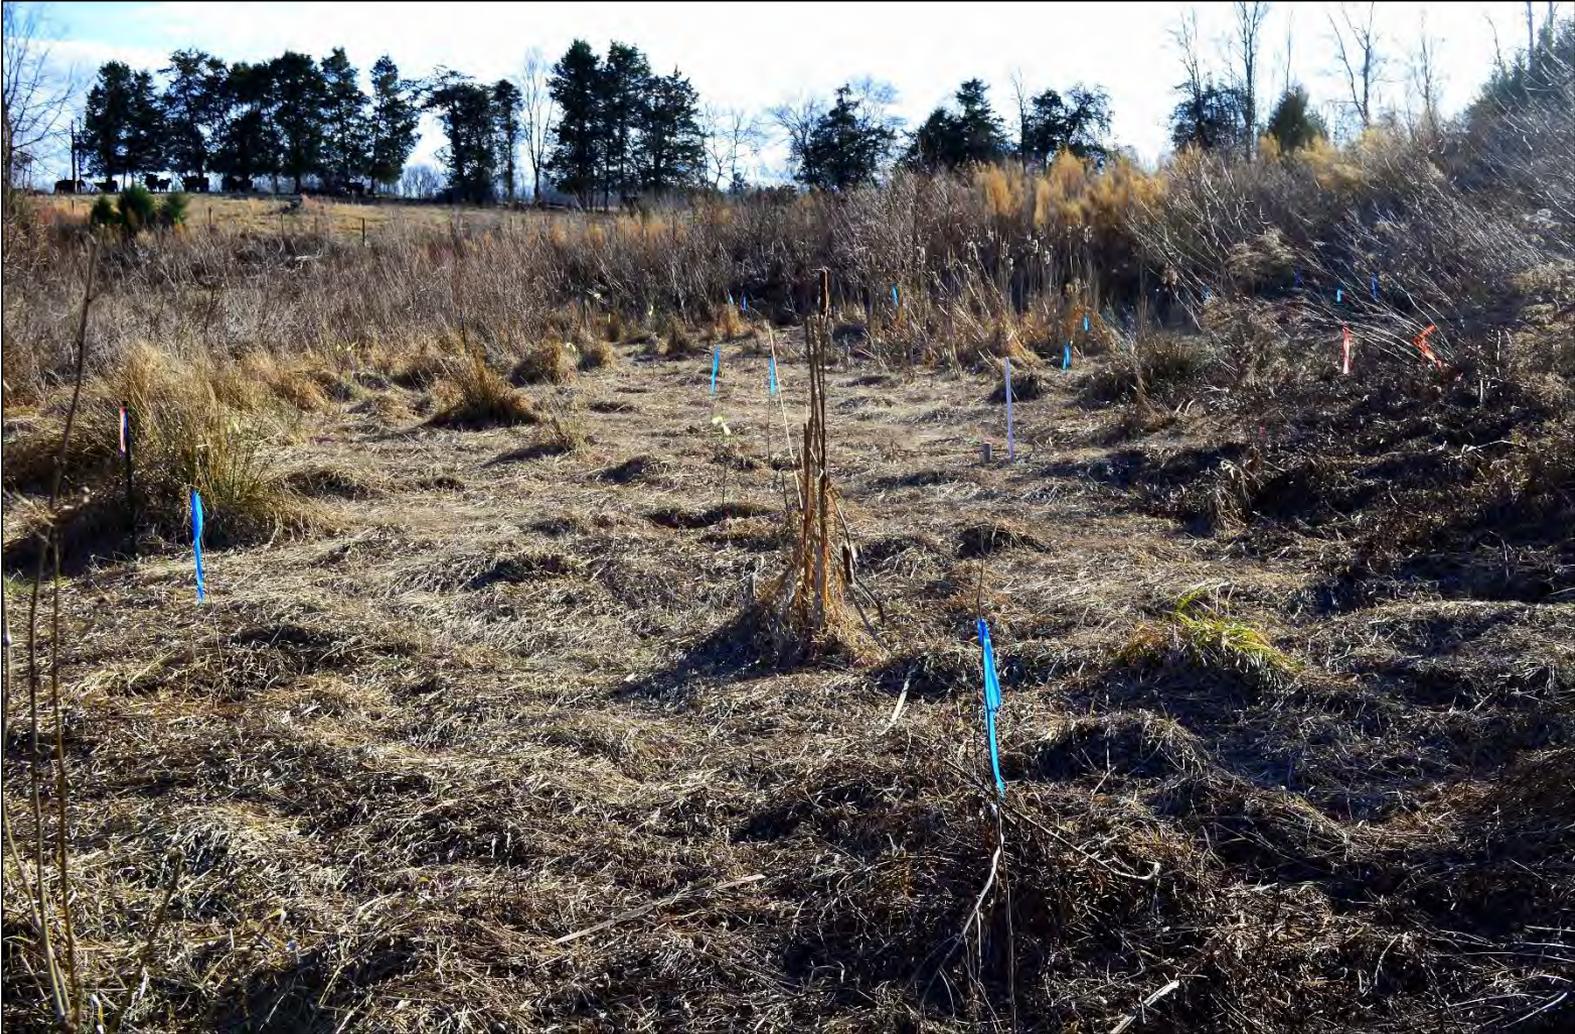
Photo 1: Looking S. along Replant Area -1

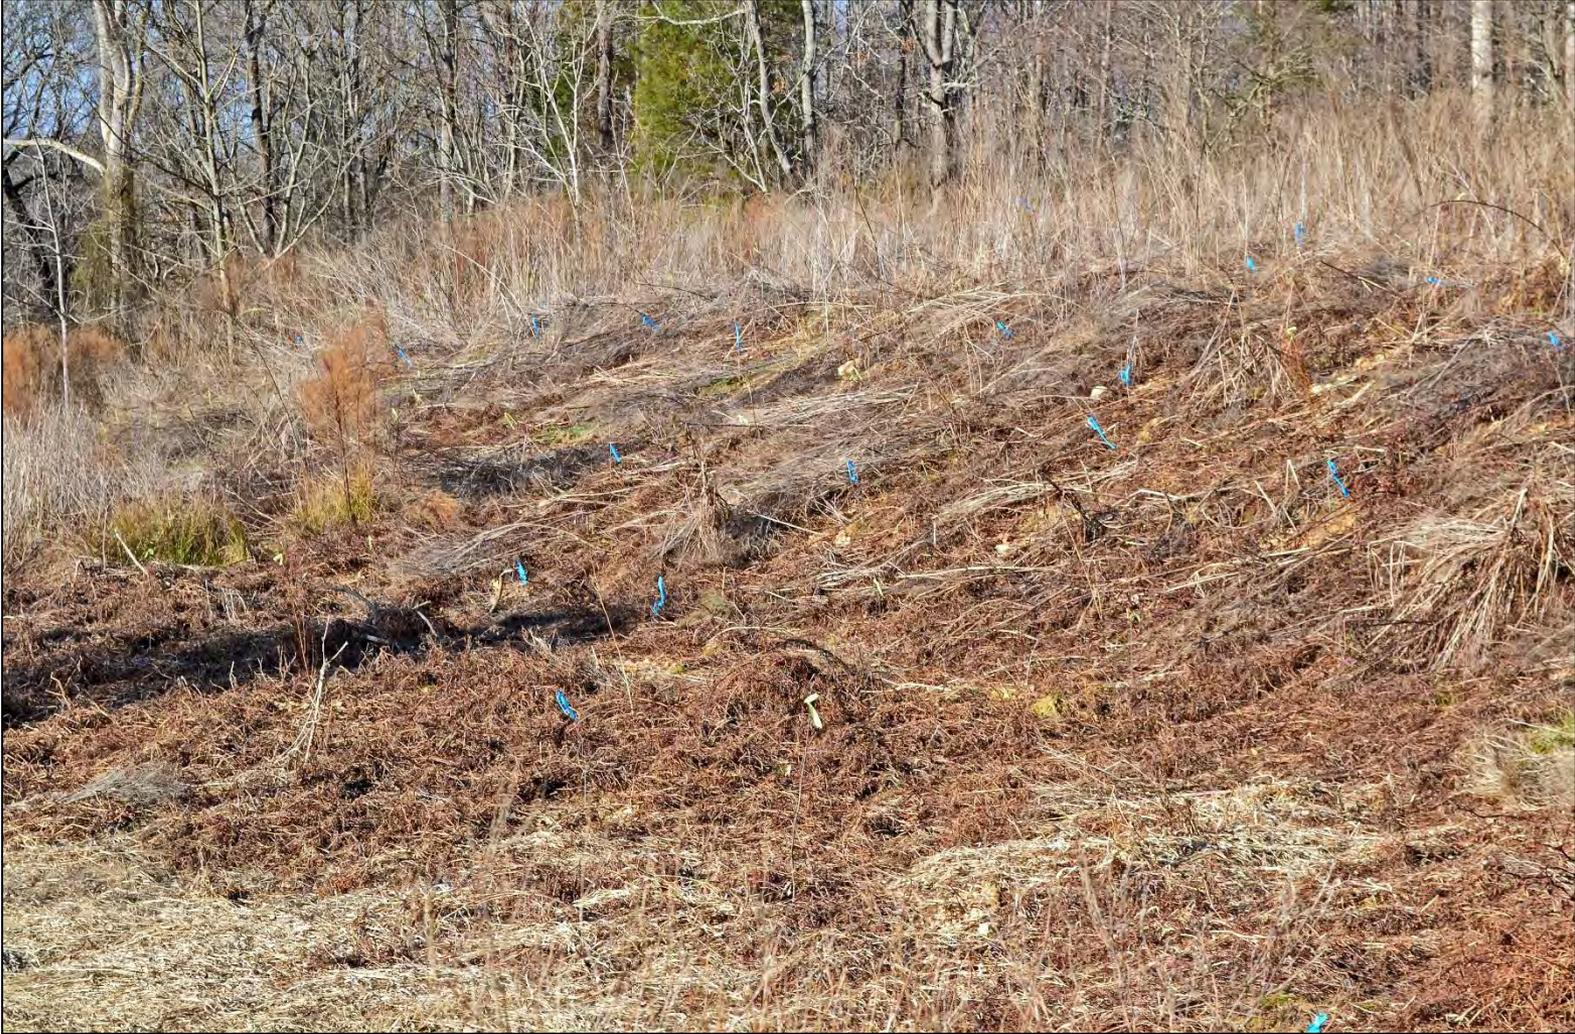
Photo 2: Looking N. in Replant Area 2, just N. of veg. plot 14

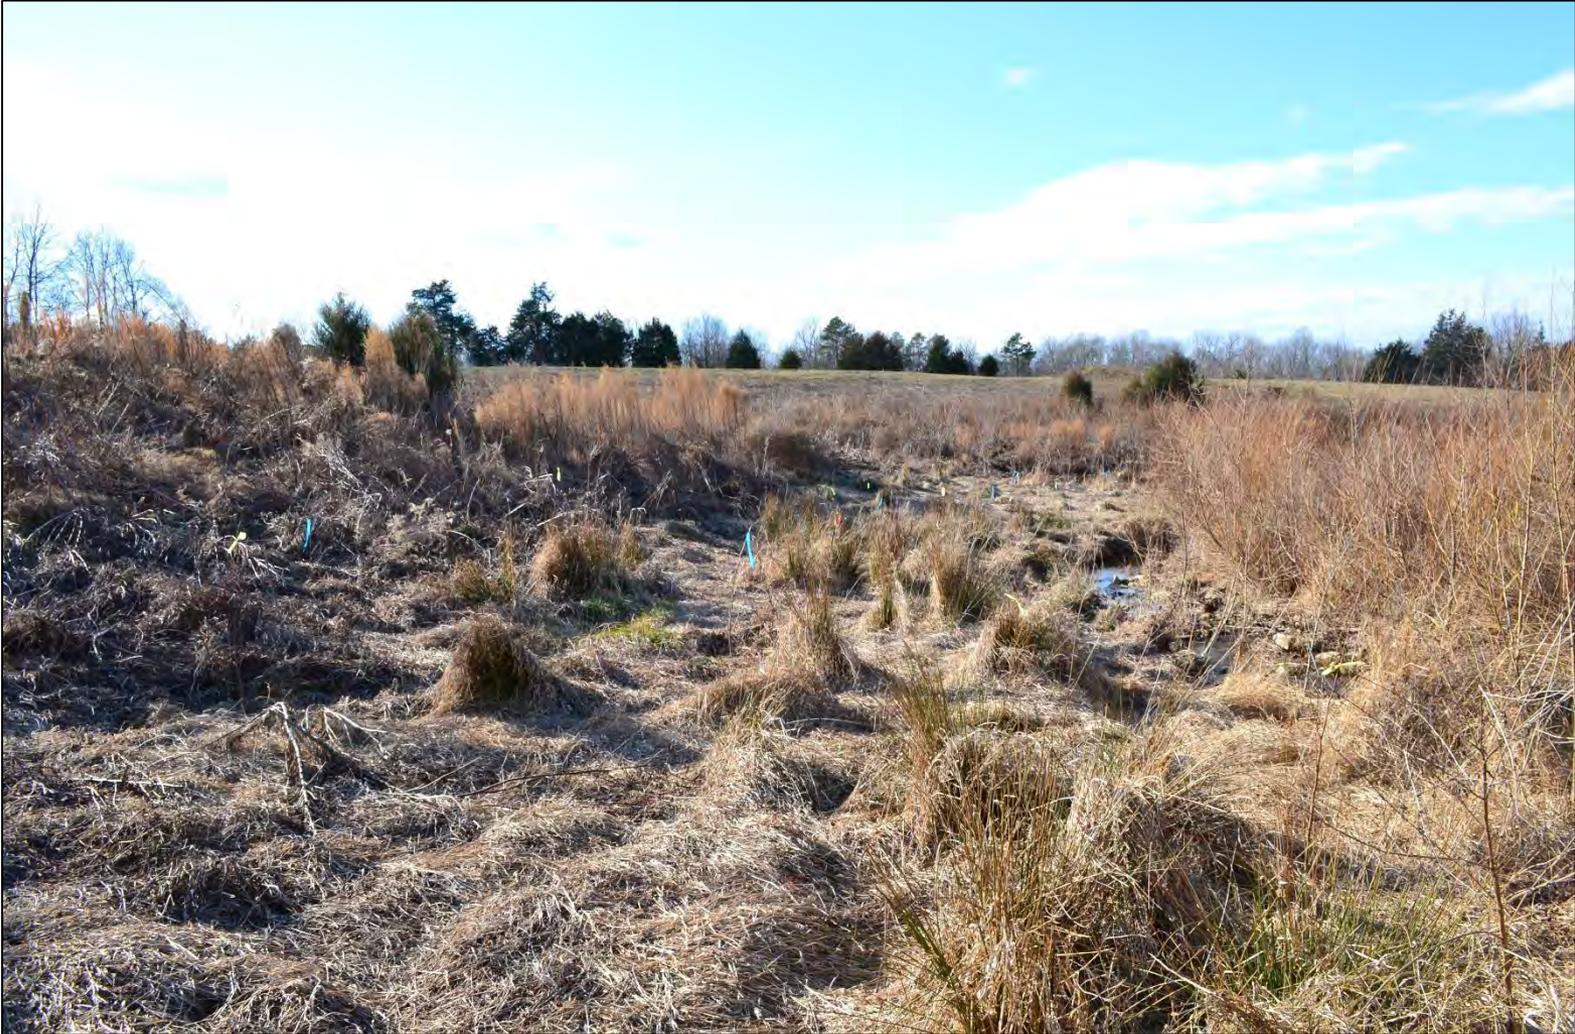
Photo 3: Looking W. in Replant Area 3, near veg. plot 13

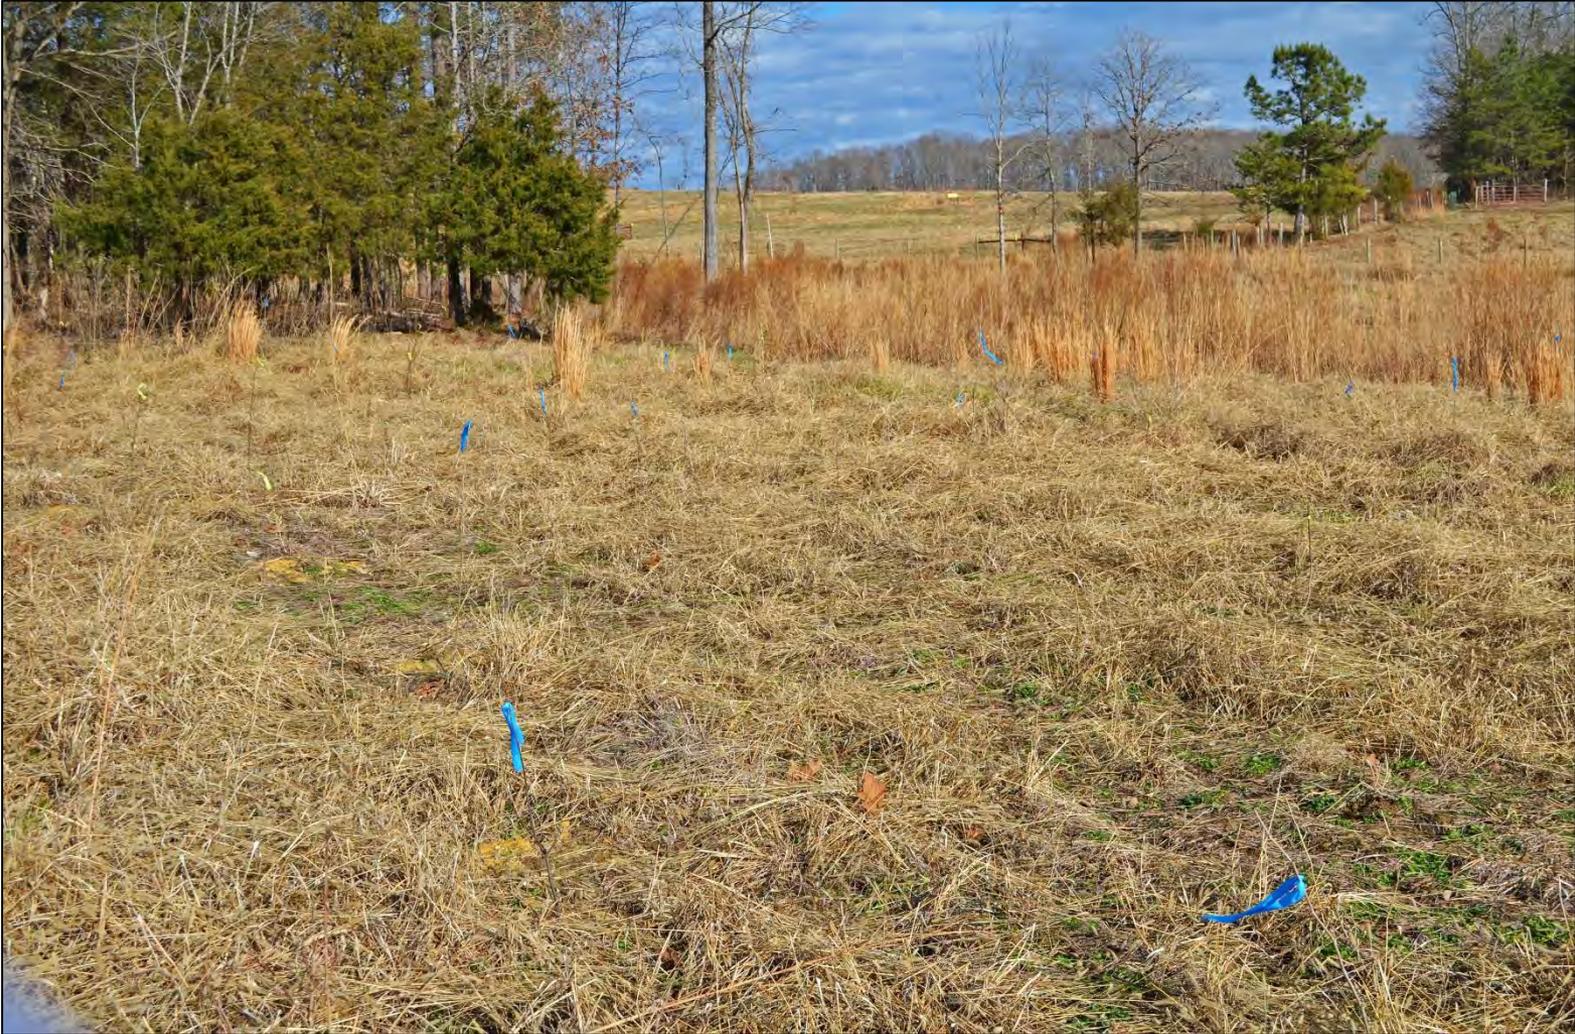
Photo 4: Looking NE. in Replant Area 5, near veg. plot 7

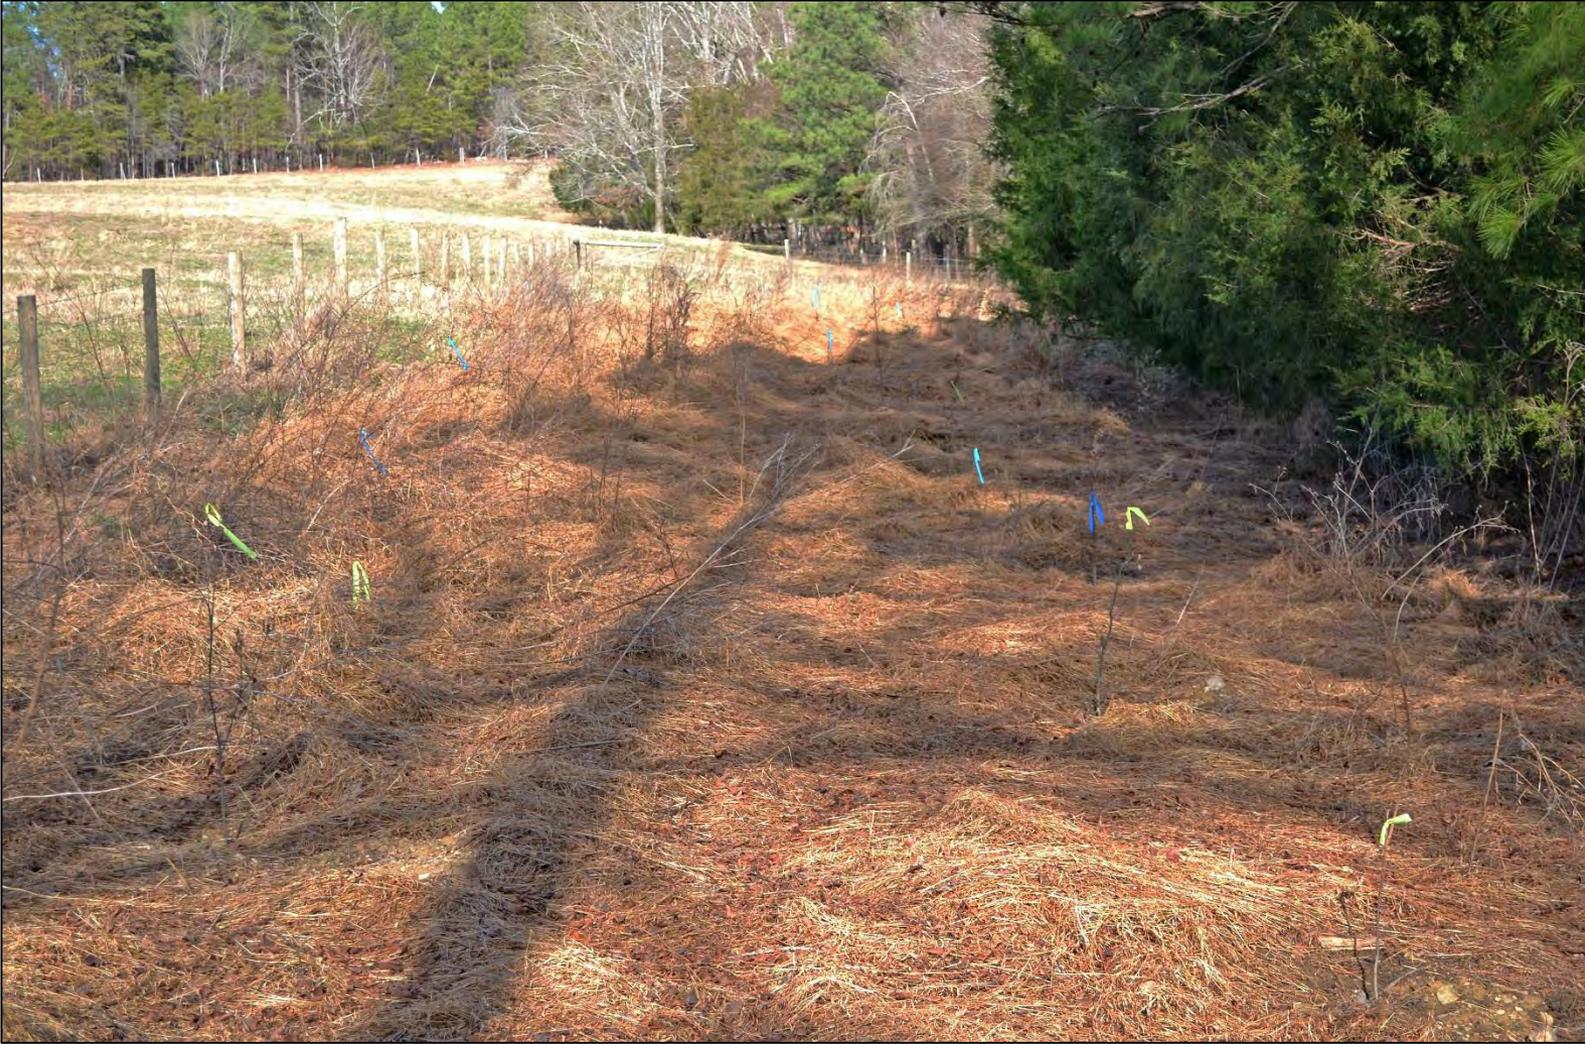
Photo 5: Looking N. in Replant Area 6.
