YEAR 2 (2016) MONITORING REPORT
ABBEY LAMM
STREAM AND WETLAND MITIGATION SITE
ALAMANCE COUNTY, NORTH CAROLINA
FULL DELIVERY CONTRACT NO. 5790

CAPE FEAR RIVER BASIN
CATALOGING UNIT 03030002

Data Collection – March-October 2016

December 2016

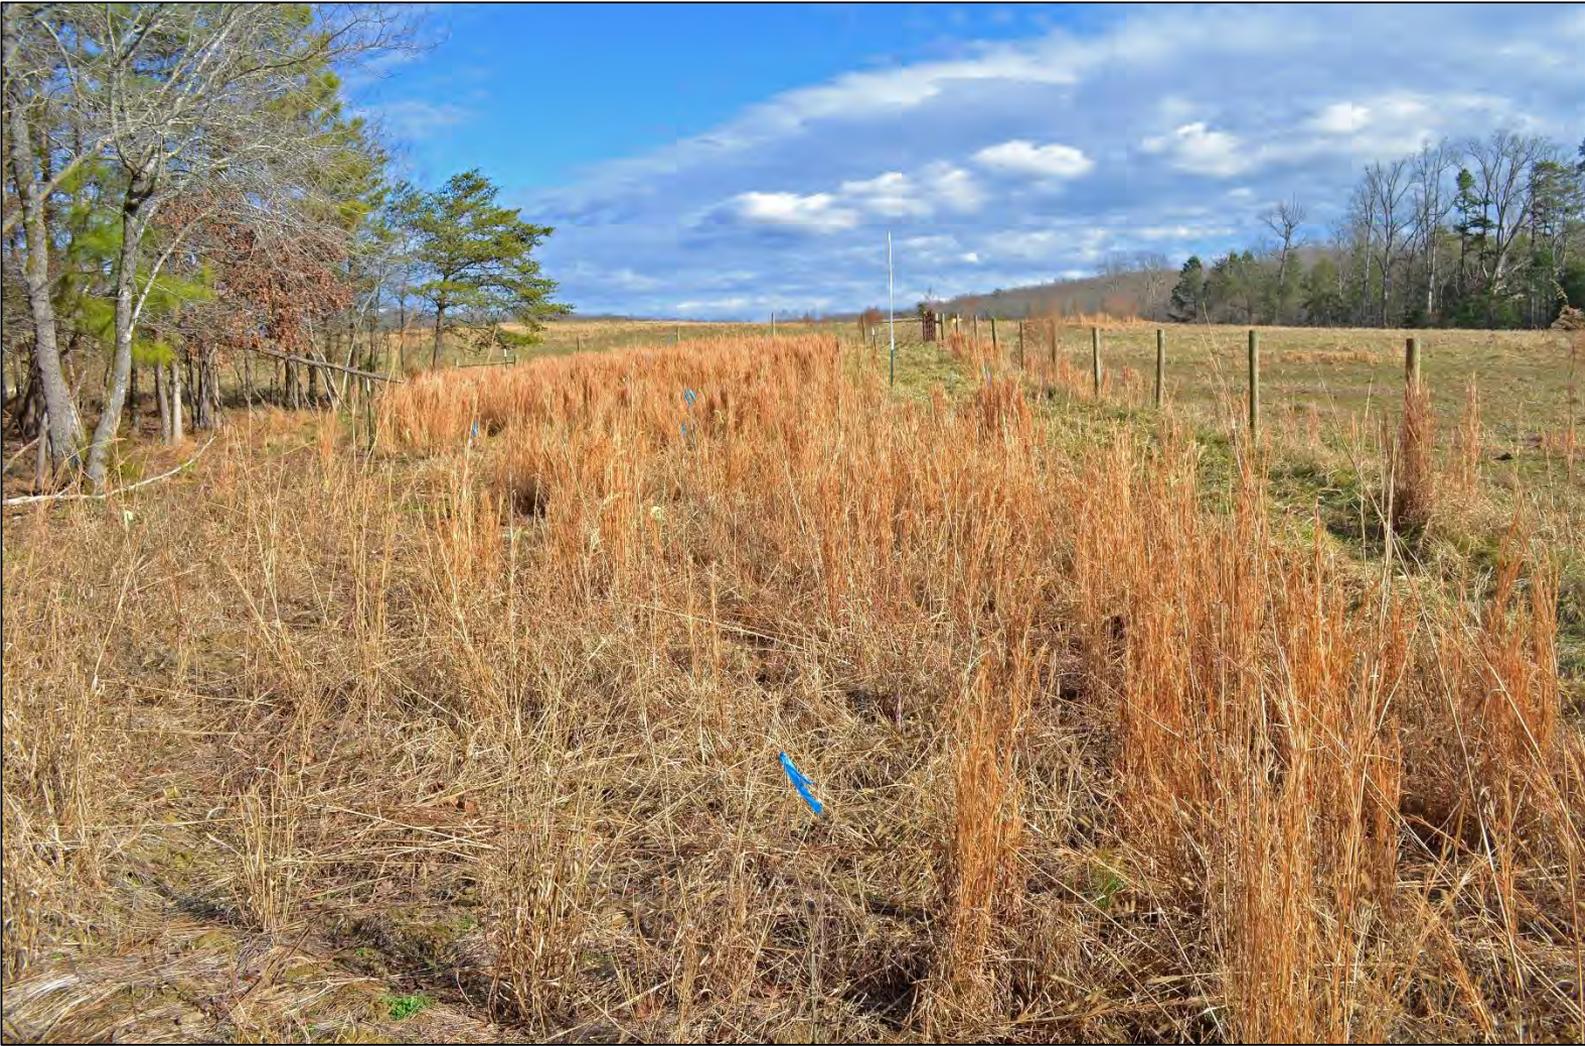
Photo 6: Looking N. in Replant Area 6, towards veg. plot 9.

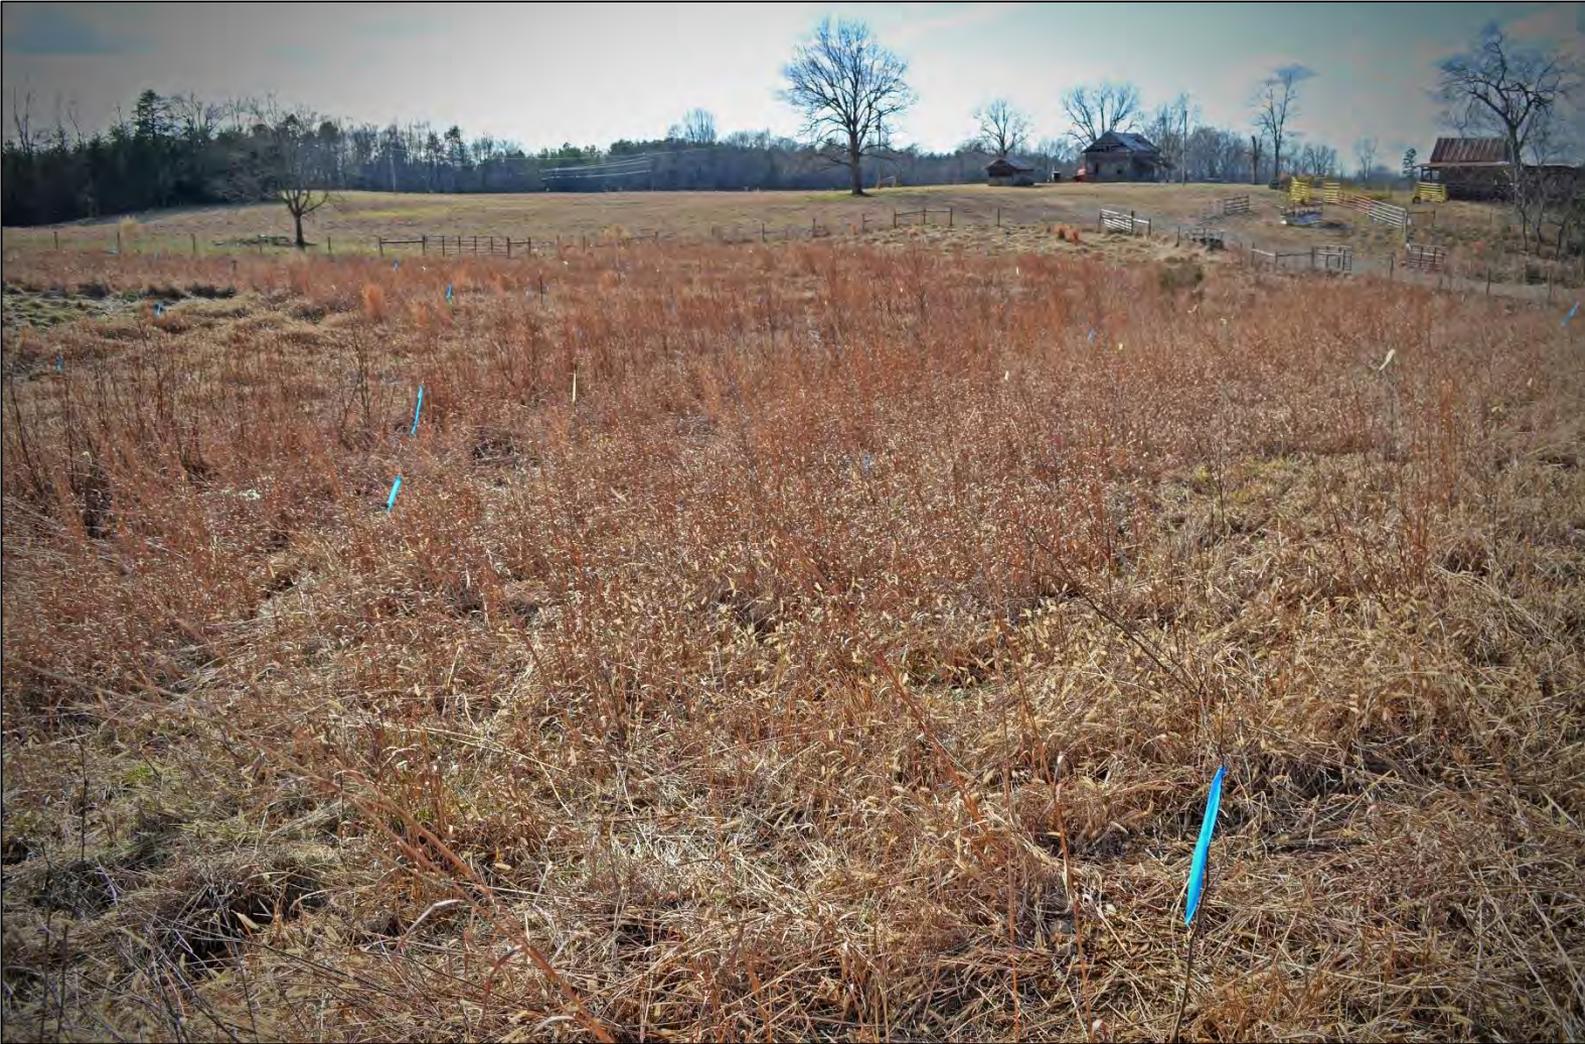
Photo 7: Looking SW. in Replant Area 8.

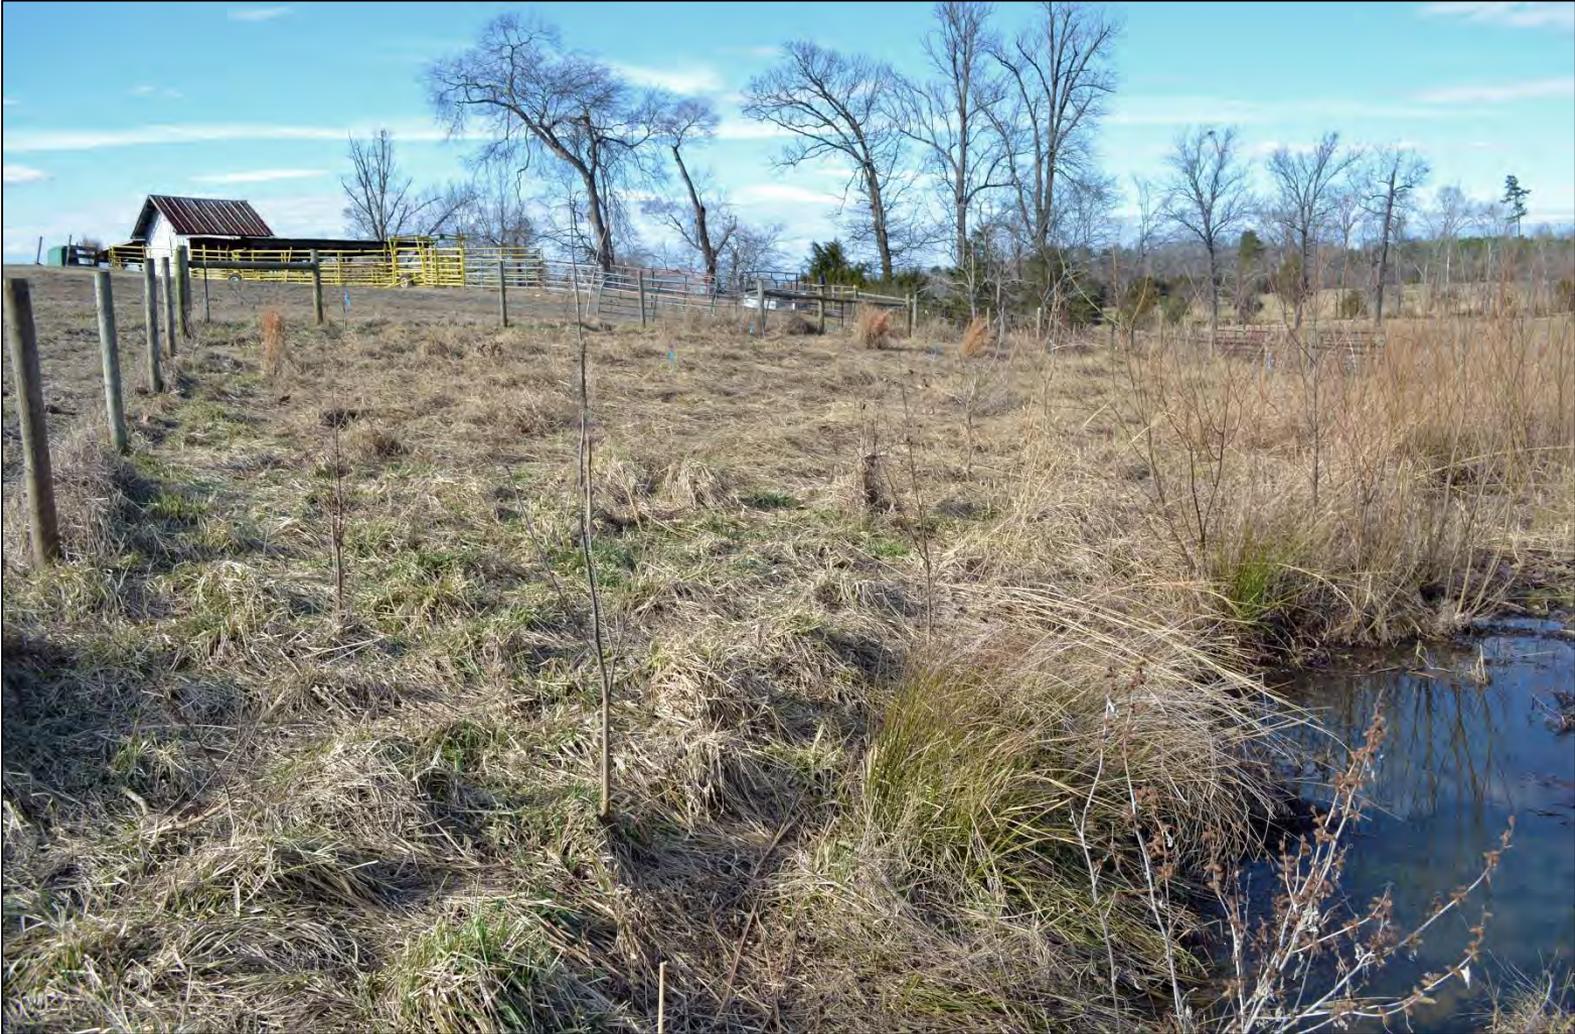
Photo 8: Looking NW. in Replant Area 10.
