# ***YEAR 3 MONITORING REPORT***

## **ADKIN BRANCH STREAM RESTORATION PROJECT PHASE 1 – WASHINGTON AVE. TO LINCOLN ST.**

Lenoir County, North Carolina  
EEP IMS No. 7

Construction Completed: April 2011  
Morphology Data Collected: July 2013  
Vegetation Data Collected: July 2013  
Submitted: November 27, 2013

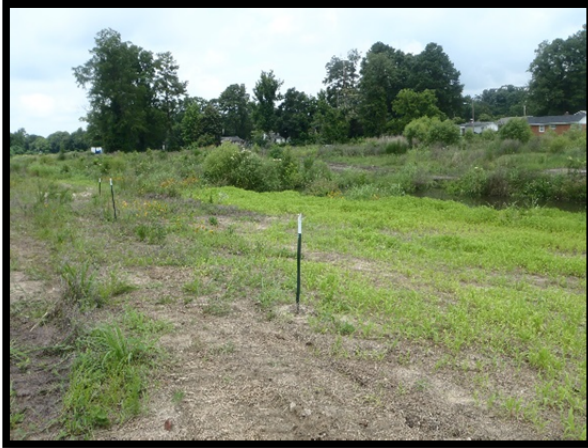
**3.9 Vegetation Plot 9**

Fifteen of the twenty-two individual vegetation plots met success criteria when counting planted stems alone. Plot 9 was not sampled because it was destroyed by construction equipment during stream repair efforts in July 2013. The site is scheduled to receive supplemental planting in areas disturbed by the construction activities of 2013. The areas that are to be replanted include the staging and stockpile locations, haul road and any other area within the easement that were impacted by construction equipment. Three plots (Plots 6, 10, and 11) did not meet success criteria based on planted stems alone; however, when including appropriate naturally recruited stems of hickory (*Carya* sp.) and American elm (*Ulmus americana*), these plots exceeded success criteria. Herbaceous vegetation has continued to fill in stream bench areas that were bare in Year 1 (2011). Planted tree growth within the Site, in general, is poor. These issues encompass the majority of the Site and should be monitored closely in subsequent monitoring years. Several small areas of invasive species occur within the Site including Chinese privet, Johnson grass, lespedeza, and Japanese honeysuckle as depicted on the CCPV (Appendix B).

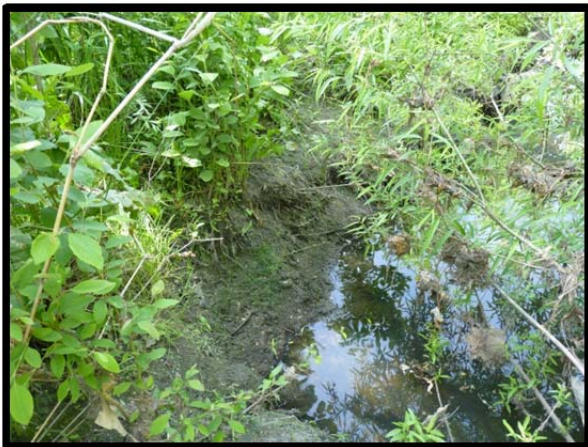
**3.21 Minor erosion near 45+00**

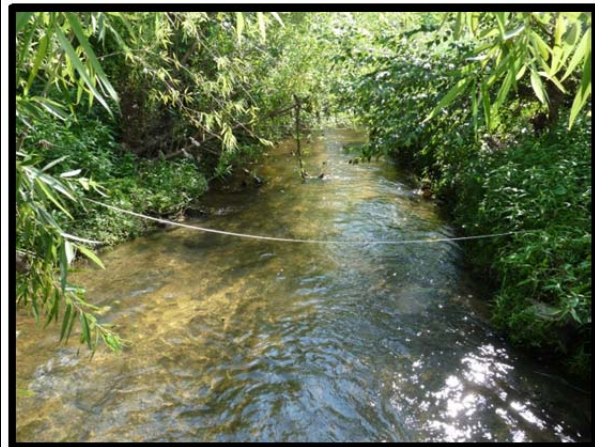
**3.22 Thin grass/bare on right bank of  
cross section 5**

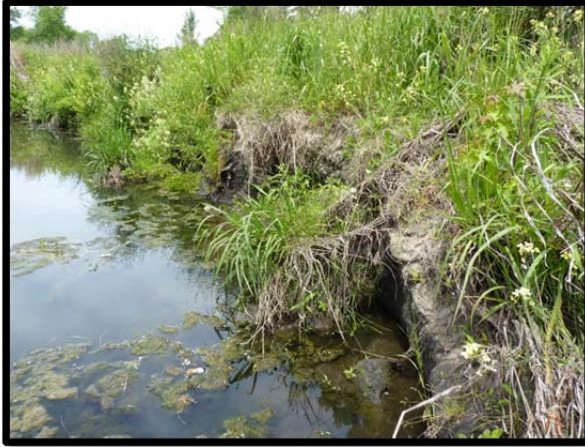
**3.23 Severe erosion near cross section 10**

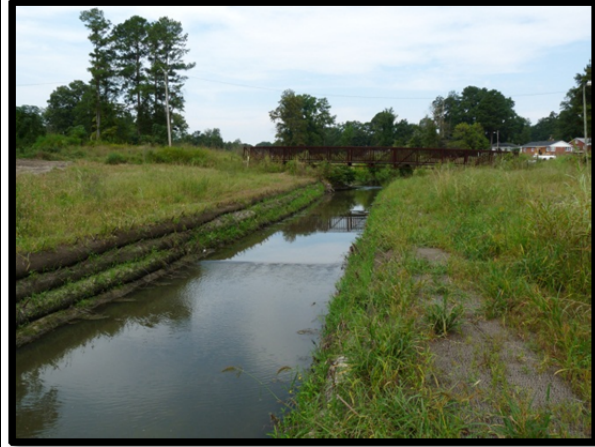
**3.24 Additional soil lifts**

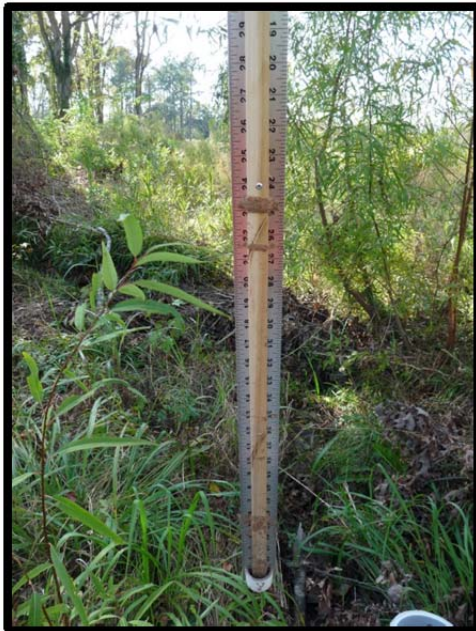
Figures 6.1 & 6.2 October 2011 Crest Gauge Photos

Date	Crest Gauge Info		Gauge Reading (ft)	Gauge Elevation (ft)	Crest Elevation (ft)	Bankfull Elevation (ft)	Height above Bankfull (ft)	Photo
	Site	Sta.						
10/26/2011	3	22+65	1.96	25.51	27.47	26.07	1.40	6.1
10/26/2011	1	54+00	2.8	25.27	28.07	27.03	1.04	6.2
11/8/2012	1	54+00	4.0	25.27	29.27	27.03	2.24	7.1 & 7.2
7/9/2013								8.1 & 8.2
