**FINAL
Beaverdam Mitigation Project
Harnett County, North Carolina**

**Cape Fear River Basin No. 03030004
DENR-EEP Contract No. D06029-B**

Year 3 Monitoring Report

December 2010

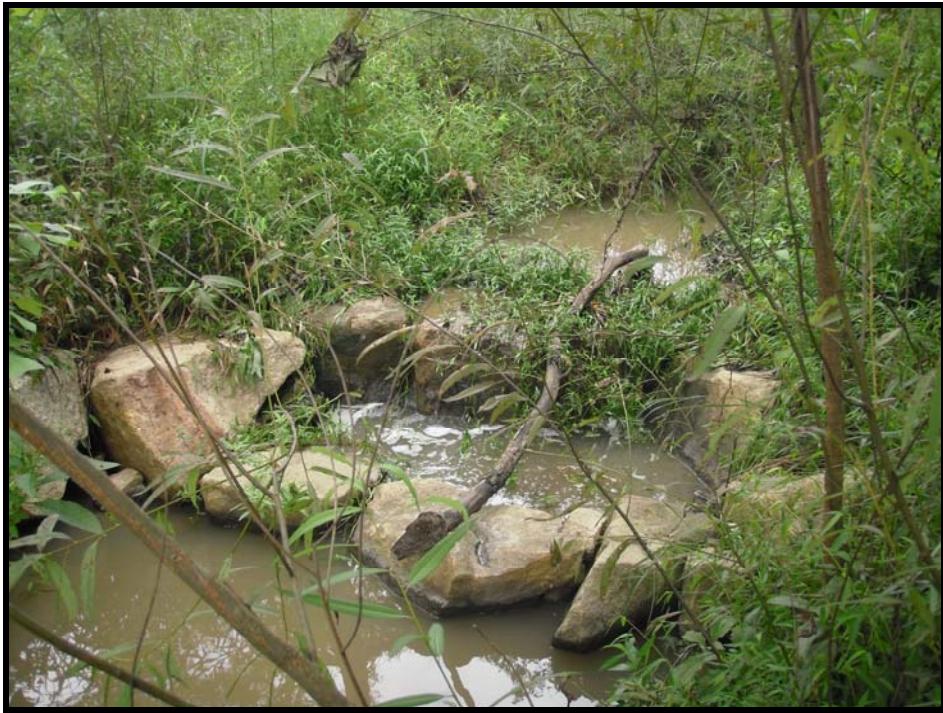
SOA1 – Piping around header rock on Rock A-vane at Sta. 133+30 (UT1-A)

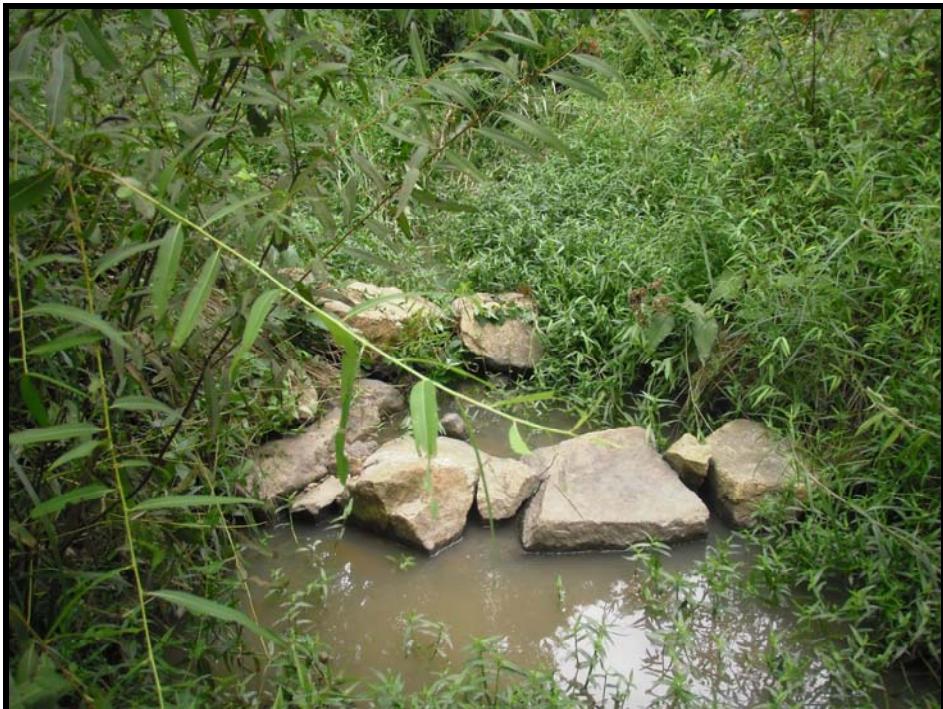
SOA2 – Piping around header rock on Rock A-vane at Sta. 134+50 (UT1-A)

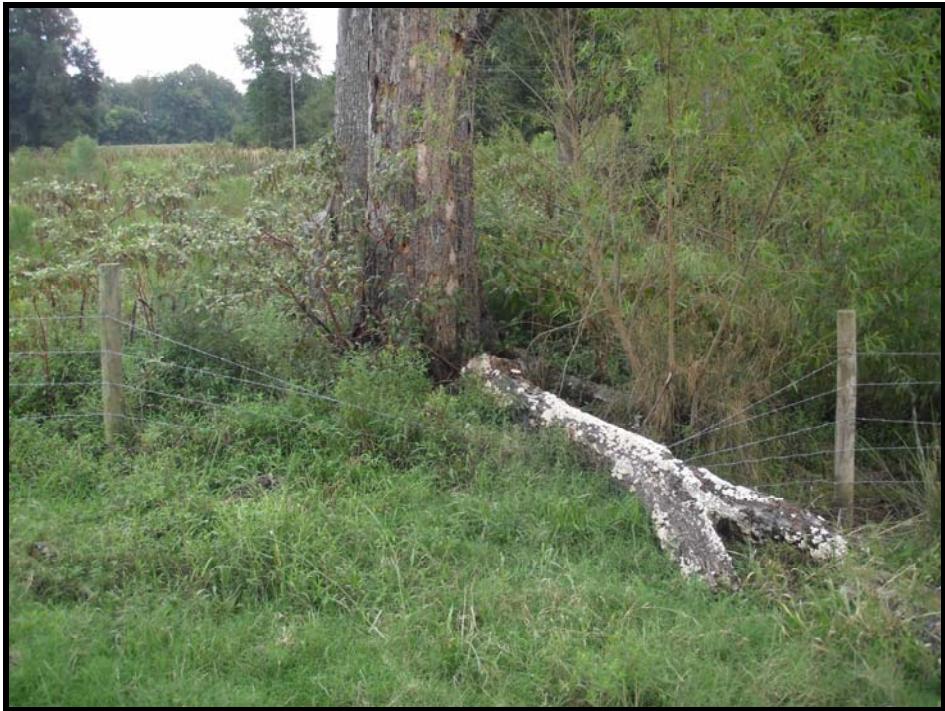
SOA3 – Easement fencing is down at Sta. 118+70 (UT1-B)

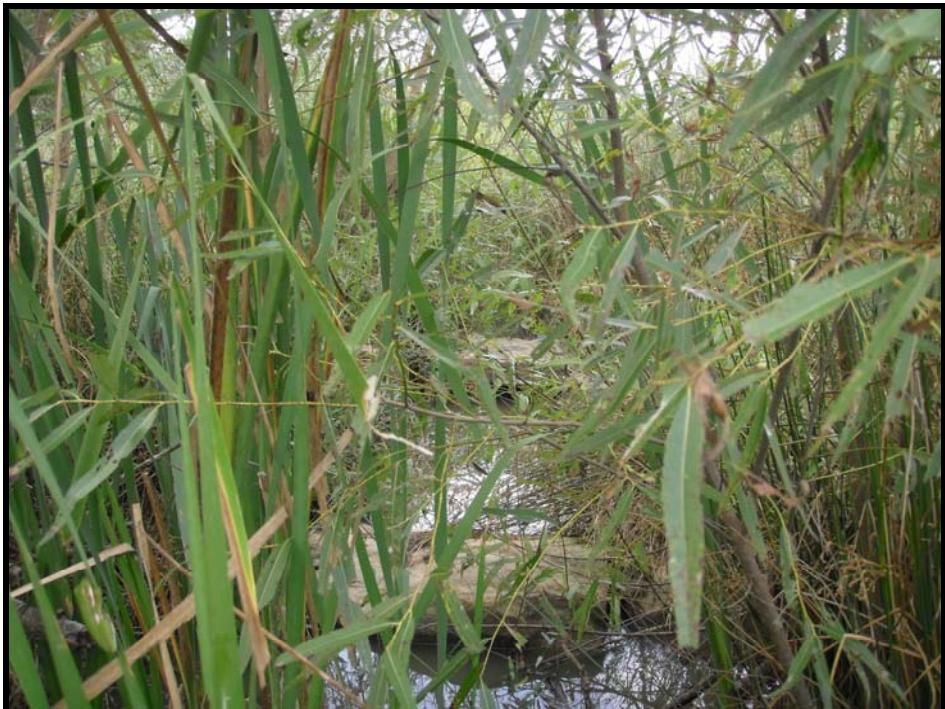
SOA4 – Piping around header rock on rock A-vane at Sta. 119+50 (UT1-B2)

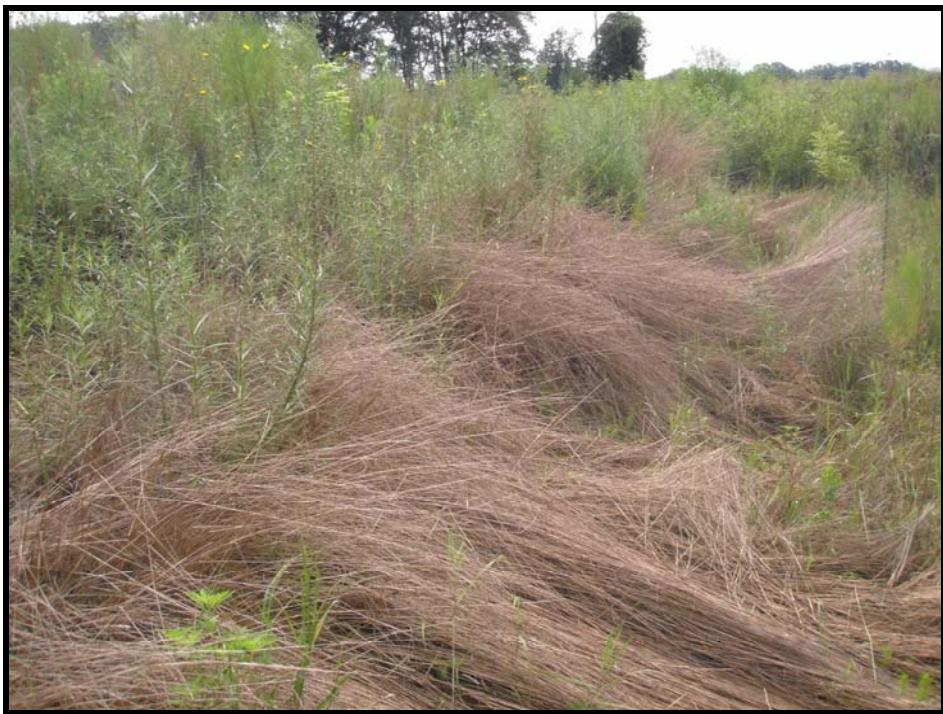
SOA5 – Minor rills and left bank erosion at Sta. 329+50 – 331+00 (UT3)
