**Beaverdam Mitigation Project  
Harnett County, North Carolina**

**Cape Fear River Basin No. 03030004  
DENR-EEP Contract No. D06029-B**

**Year 4 Monitoring Report**

**January 2012**

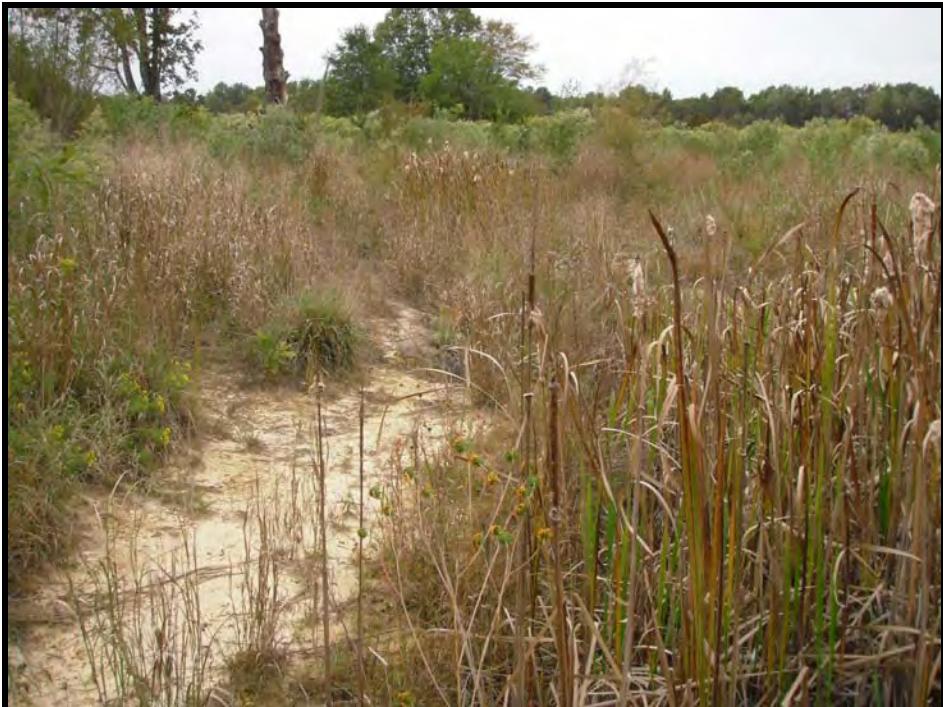
SOA1 – Sparse vegetation on left and right banks at Sta. 153+00 – 153+30 (UT1-A)

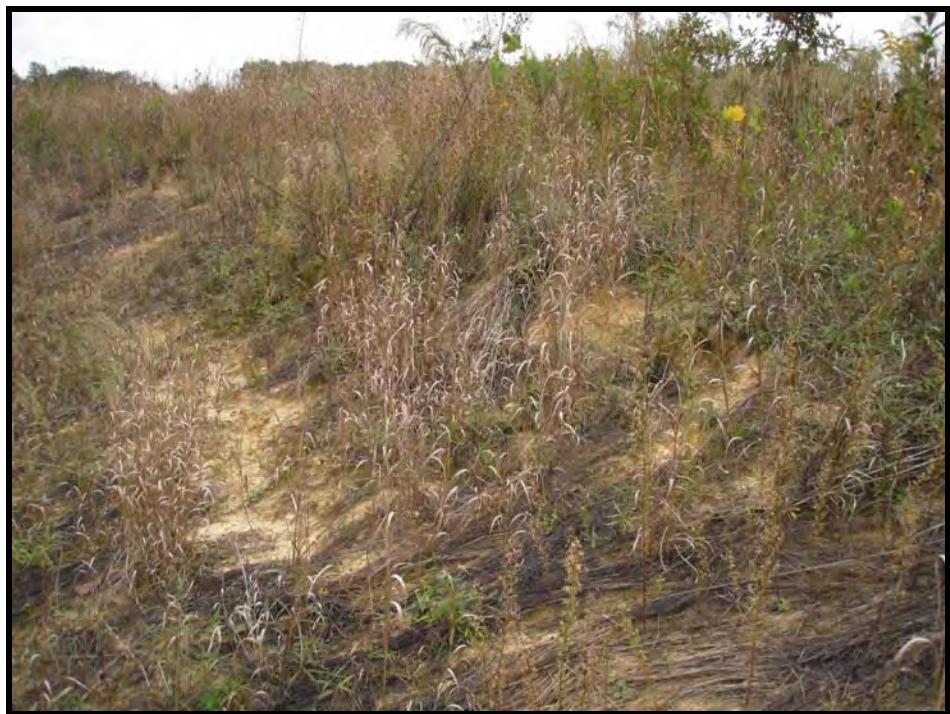
SOA4 – Sparse vegetation on left bank at Sta. 329+50 – 329+80 (UT3)

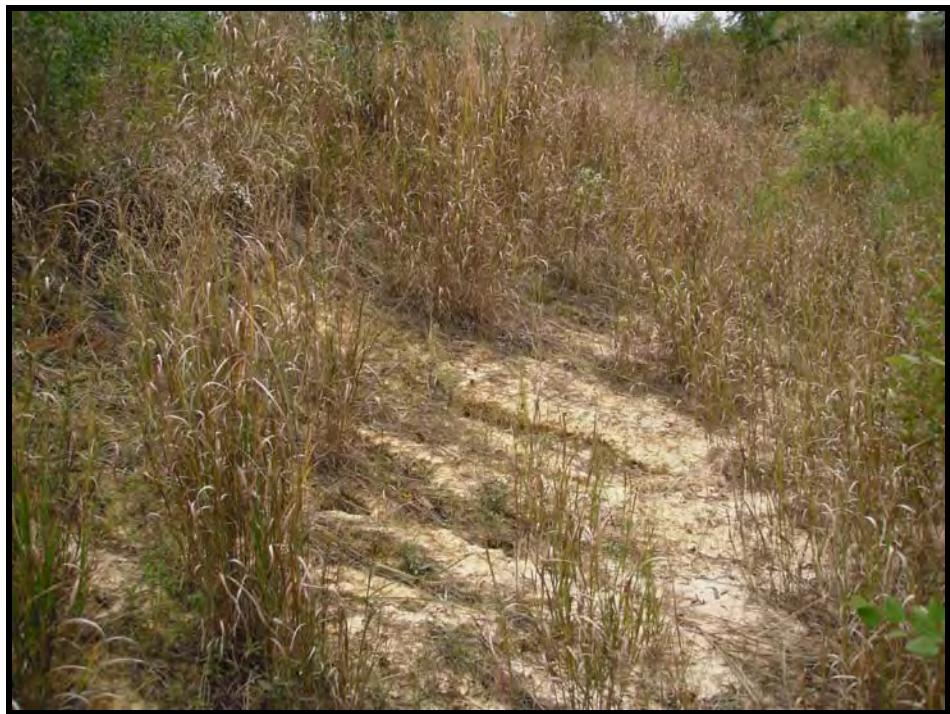
SOA5 – Localized erosion on right bank at Sta. 335+10 – 335+40 (UT3)
