MONITORING YEAR 1 AND 2 REPORT
BOWLIN-PEAK CREEK MITIGATION SITE

Ashe County, North Carolina

EEP Project Number: 92606
Contract Number: D06082; Task Order: 06NW01-1

Period Covered: March 2008 - June 2009

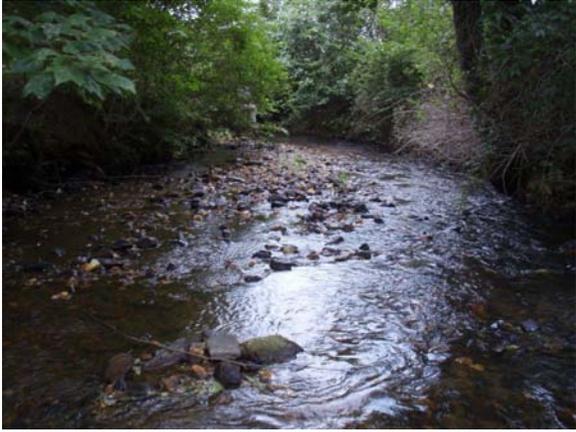
PA3, center/transverse bar: 08 Sep 2008.

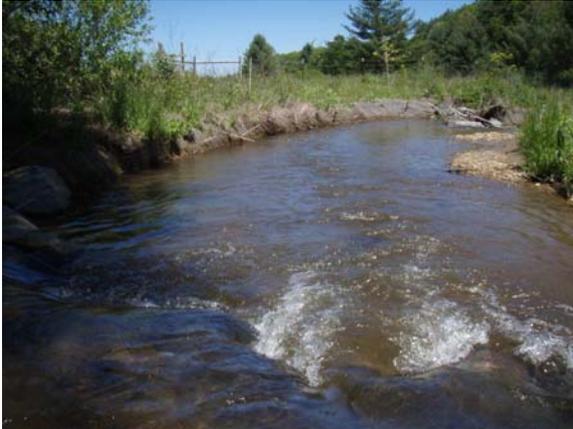
PA1, eroding left bank: 20 May 2009.

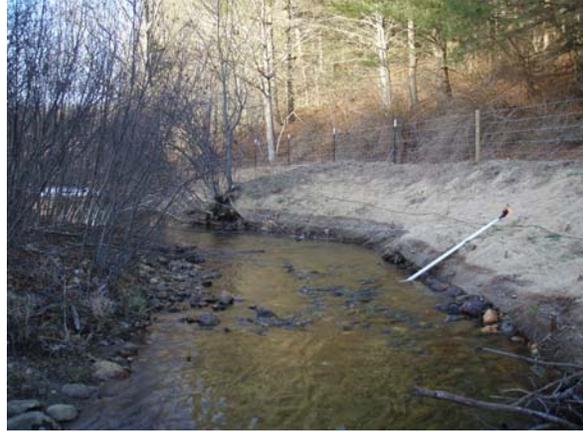
PS-11, bearing 20°: Pre-construction view of cross-section 6 at station 20+90; 19 Mar 07.

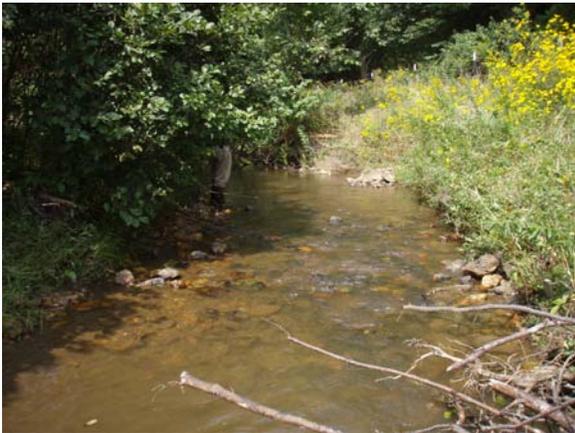
PS-11, bearing 20°: Post-construction view of cross-section 6 at station 20+90; 08 Jan 08.
