**Briles Site**  
**Randolph County, North Carolina**  
*Stream Restoration Plan*

**Contract No. EW-02040S**  
**State Project No. 020591001**

**December 2005**

Prepared by: KCI Associates of North Carolina, P.A.

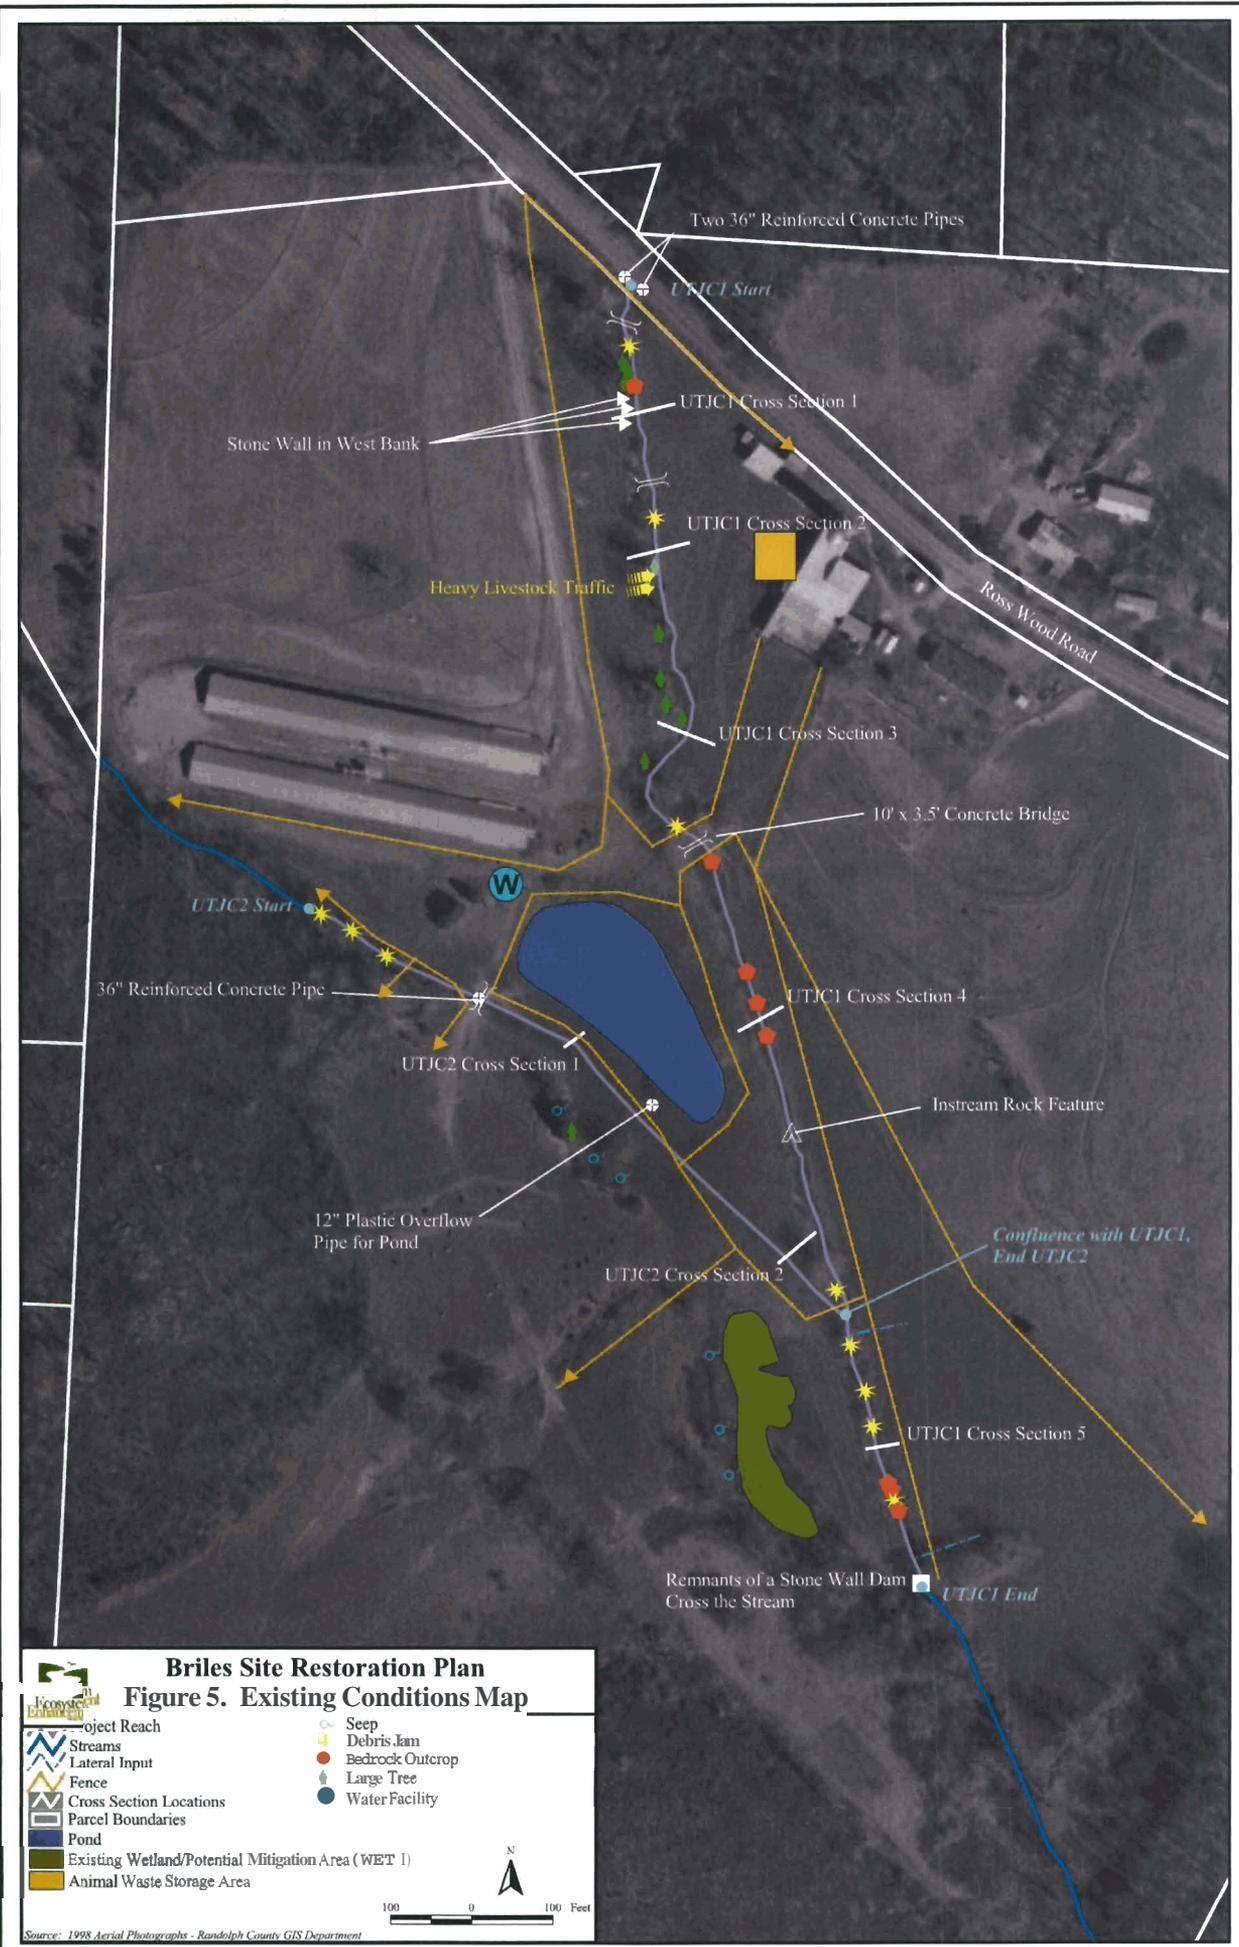
**Briles Site Restoration Plan**  
**Figure 5. Existing Conditions Map**

A site field assessment was conducted in April 2003 to document existing conditions and evaluate the potential for stream and riparian buffer restoration. Observations and collected data are described below, illustrated in Figure 5 Existing Conditions and documented in site photographs (Appendix C). The site was revisited from April to December, 2004 several times to take further measurements, to install a rain gage and stream gages, to sample the stream bed, and several times to collect hydrology data from the instruments.

UTJC1 exhibits characteristics of four separate stages in the CEM. The section of UTJC1 extending 500 feet from the upstream project limits is in Stage IV (degradation and widening). Bed degradation is evident throughout the reach (bank height ratios exceed 1.5). Bank erosion potential (and subsequent widening) is high as a result of stream banks denude of vegetation and rooting strength, in conjunction with pressures from livestock access to the creek. Some large trees stabilize localized sections of stream bank, however a general lack of riparian vegetation exists throughout this reach.

A short meandering section follows for approximately 200 feet, down to a wire fence/concrete bridge. UTJC1 is in Stage VI (quasi-equilibrium) of the CEM. The streambed is stabilized by a small rock dam immediately downstream, which is acting as grade control. Sediment deposition during the recession of high flows is building benches at the **bankfull** elevation. With the addition of a forested riparian buffer, the maintenance of grade control downstream, and the exclusion of livestock, this section of stream should stabilize under current watershed conditions.

UTJC1 transitions to Stage III (degradation) of the CEM below the concrete bridge (extending approximately 680 feet). The stream has cut to bedrock in several locations. The basal **cleanout** along with some rotational failures indicates that a shift to Stage IV (degradation and widening) is likely in these areas. The channel remains in its current modified condition due to extensive bank vegetation, as well as the exclusion of livestock in this reach. A small berm has been constructed adjacent to the **left** (west) stream bank paralleling the stream. This berm confines flows within the incised channel by increasing the elevation to access a larger flood-prone area by nearly a foot.

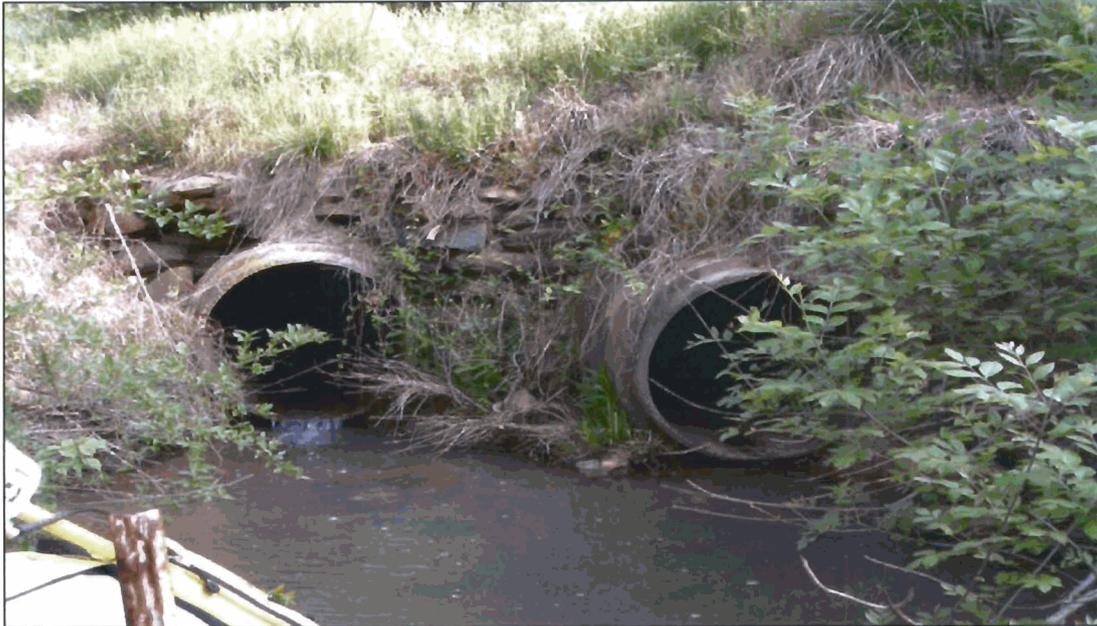
Photograph 1 – Two 36" RCPs mark the upstream extent of the project reach (Station 10+00, looking upstream).

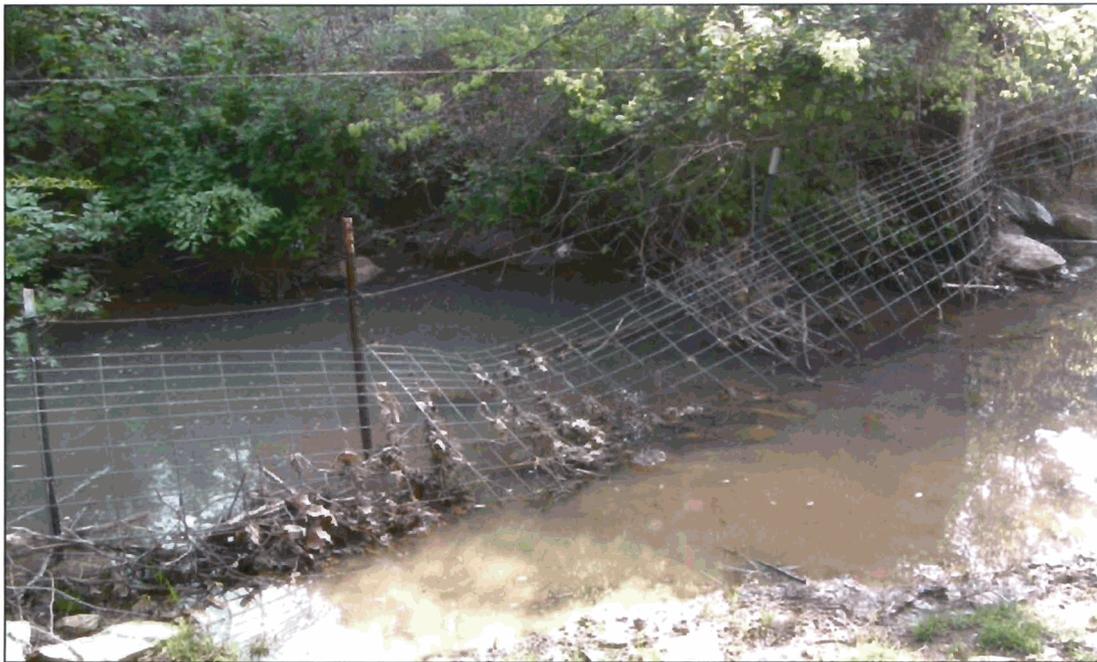
Photograph 2 – A fence line and wire cross the stream at Station 10+24.

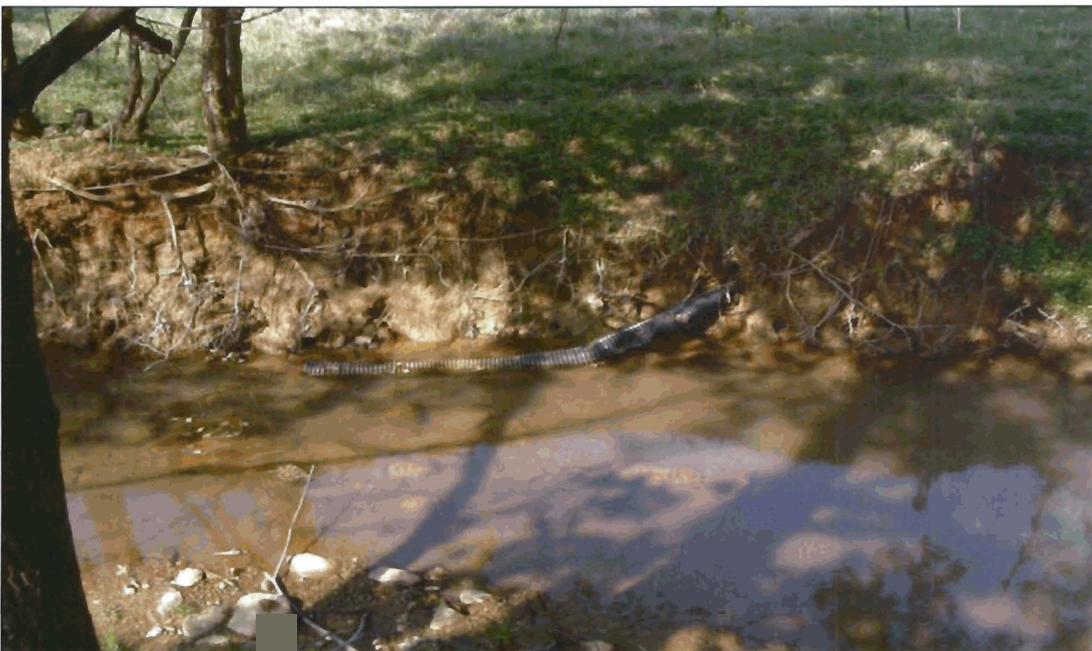
**Photograph 4 – Three-inch (3") drain enters the stream from the west bank at Station 10+80.**

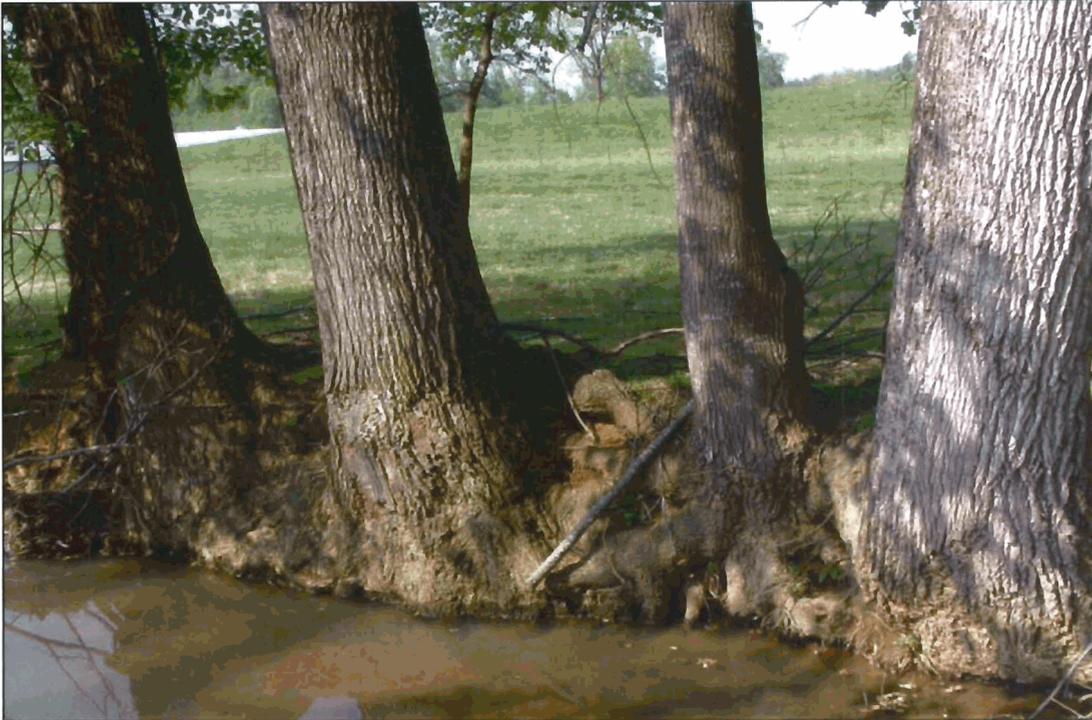
**Photograph 5 – View of four large trees that stabilize the right bank from Station 11+27 to Station 11+47.**

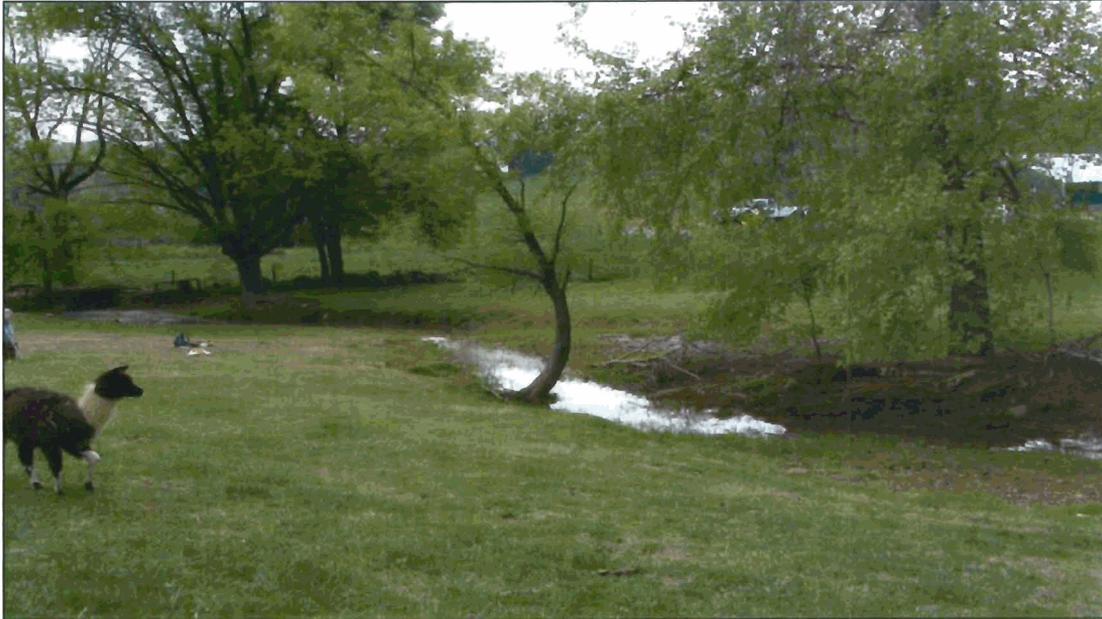
Photograph 13 – View of a meandering pattern for approximately three (3) meander wavelengths from Station 14+58 to Station 16+51. Cross-section 3 at Station 15+96 appears in the center of this photograph.

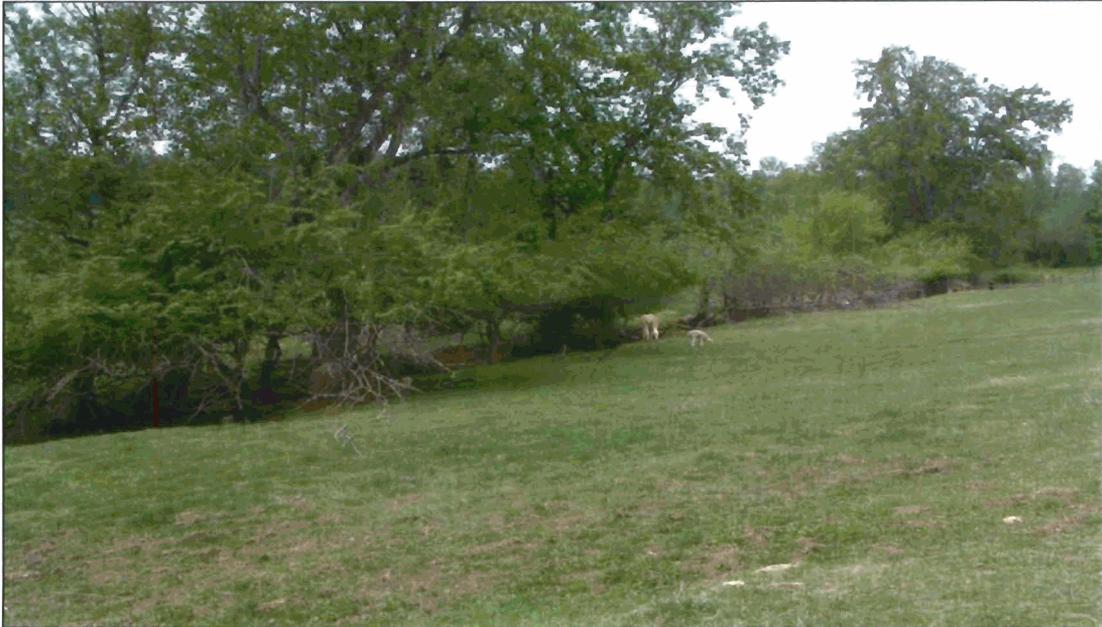
Photograph 14 – View looking northwest at a potential riparian buffer area adjacent to the east side of UTJC1.

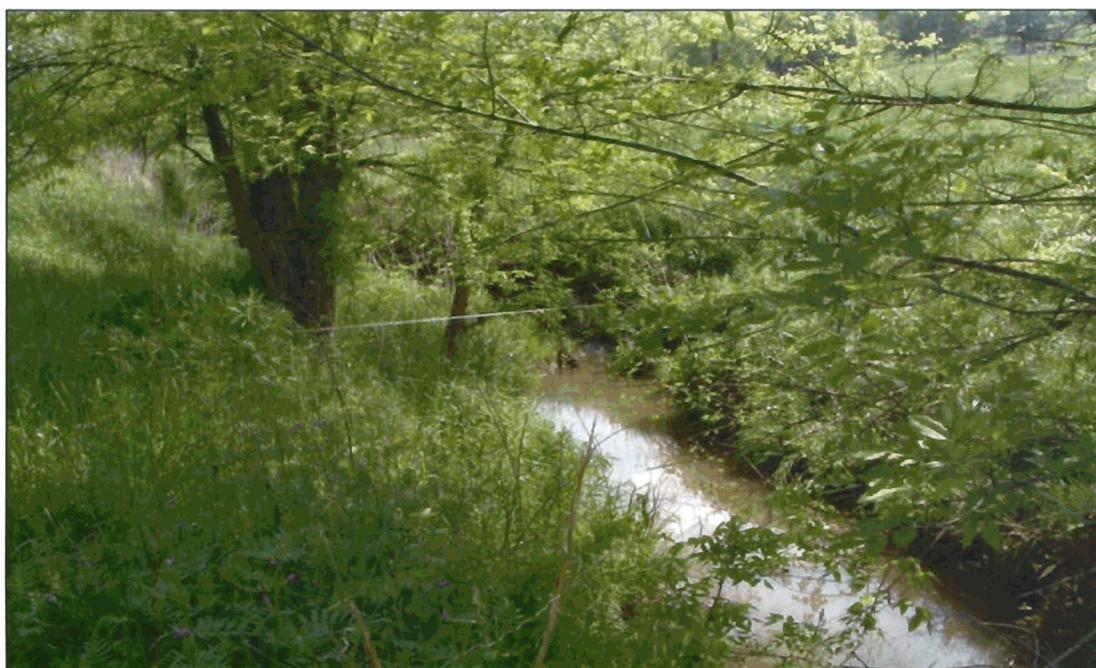
**Photograph 16** – Elevated view of Cross-section 4 at Station 19+90.

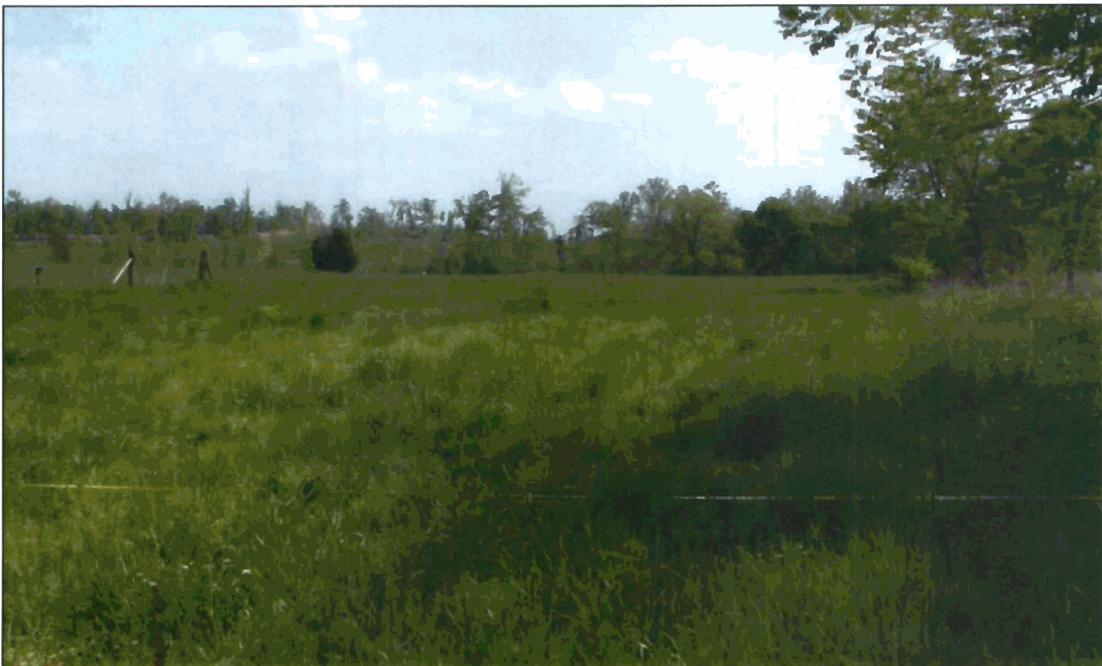
Photograph 18 – Potential restoration/riparian buffer area, adjacent to the east bank of UTJC1 near Station 19+90.

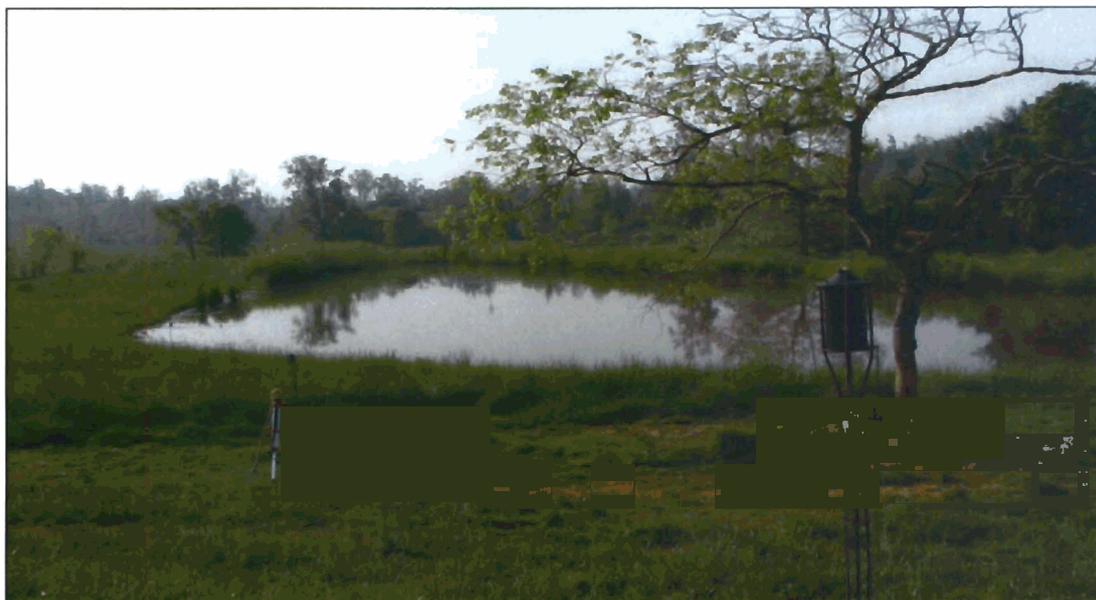
Photograph 20 – This farm pond (constructed in 1998) is situated between UTJC1 and UTJC2. This photograph was taken looking southeast.

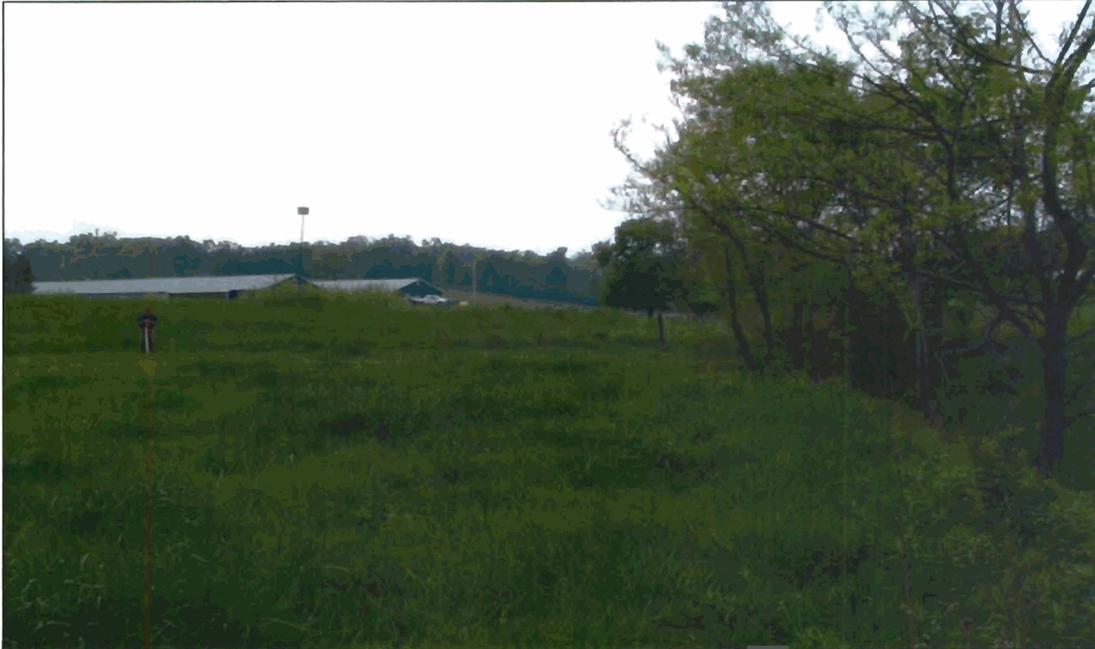
Photograph 21 – View looking to the northwest at the pond elevated between the unnamed tributaries to Jackson Creek. Note the height of the berm along the south side of the pond.

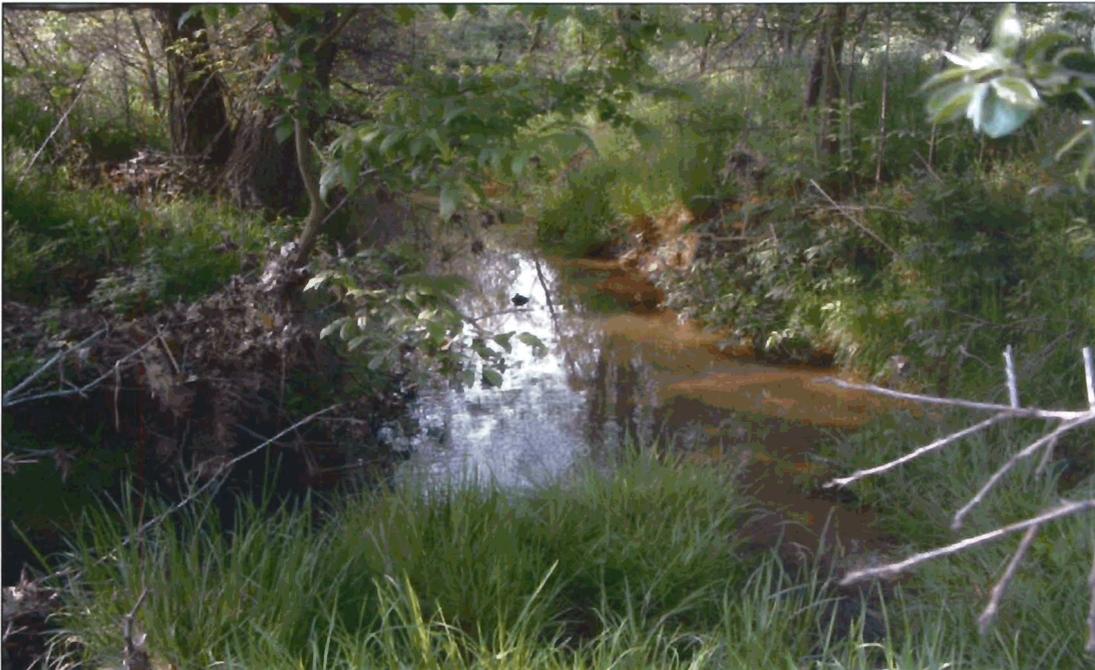
Photograph 22 – Downstream view at the confluence of UTJC2 with UTJC1 (Station 23+72).

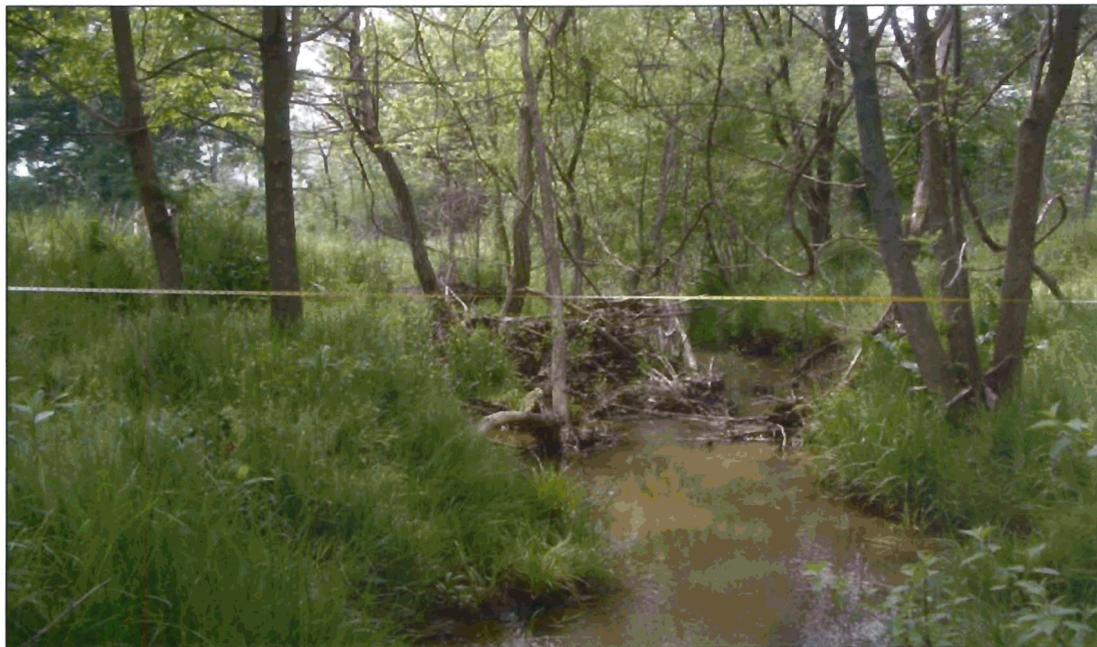
Photograph 24 – Downstream view of Cross-section 5 located at Station 25+40.

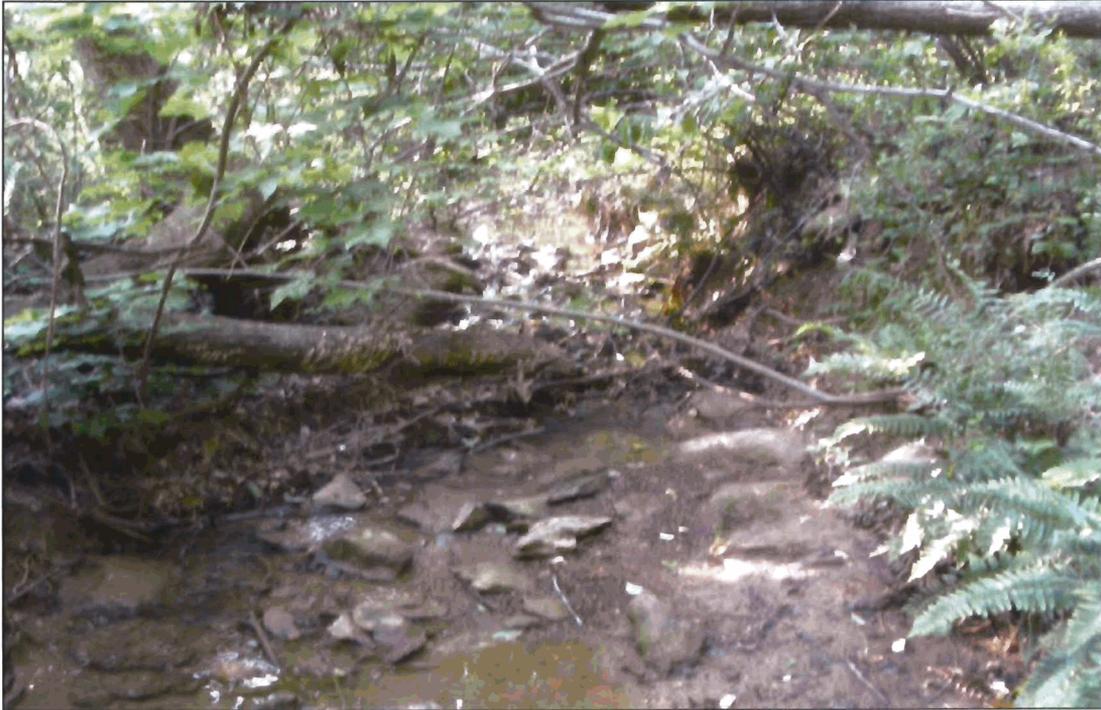
Photograph 1 – This photograph represents the beginning of the project reach on UTJC2 (Station 50+46).

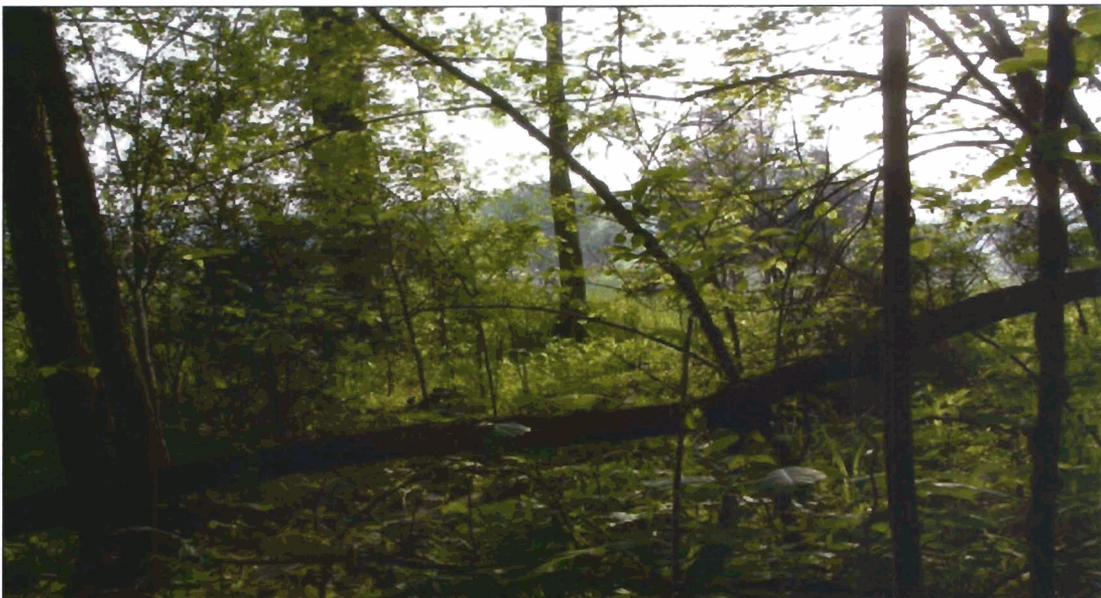
Photograph 2 – View to the southeast through a 25-foot riparian buffer adjacent to the left bank at Station 50+46.

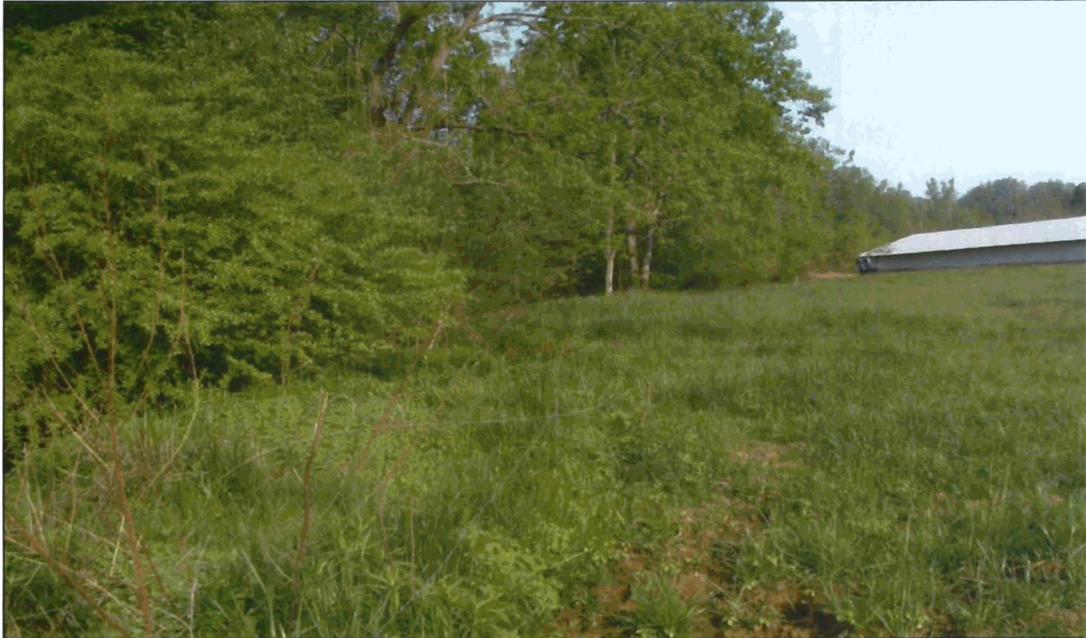
Photograph 5 – Potential riparian buffer area adjacent to the east bank of UTJC2.

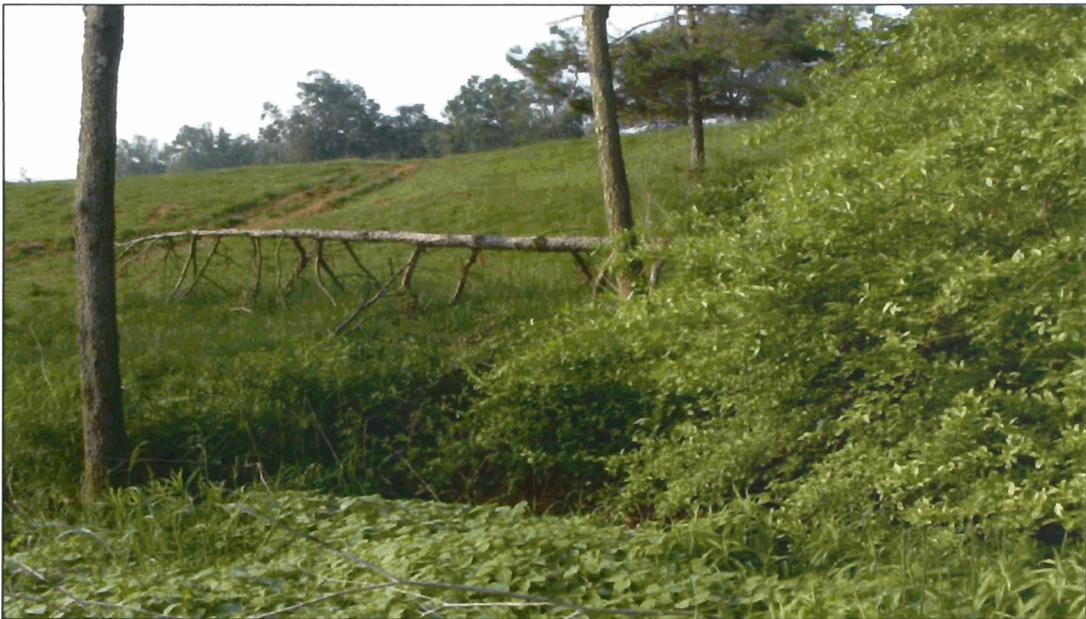
Photograph 6 – View of the valley side wall adjacent to the right bank of UTJC2. Note the end of the riparian vegetation.

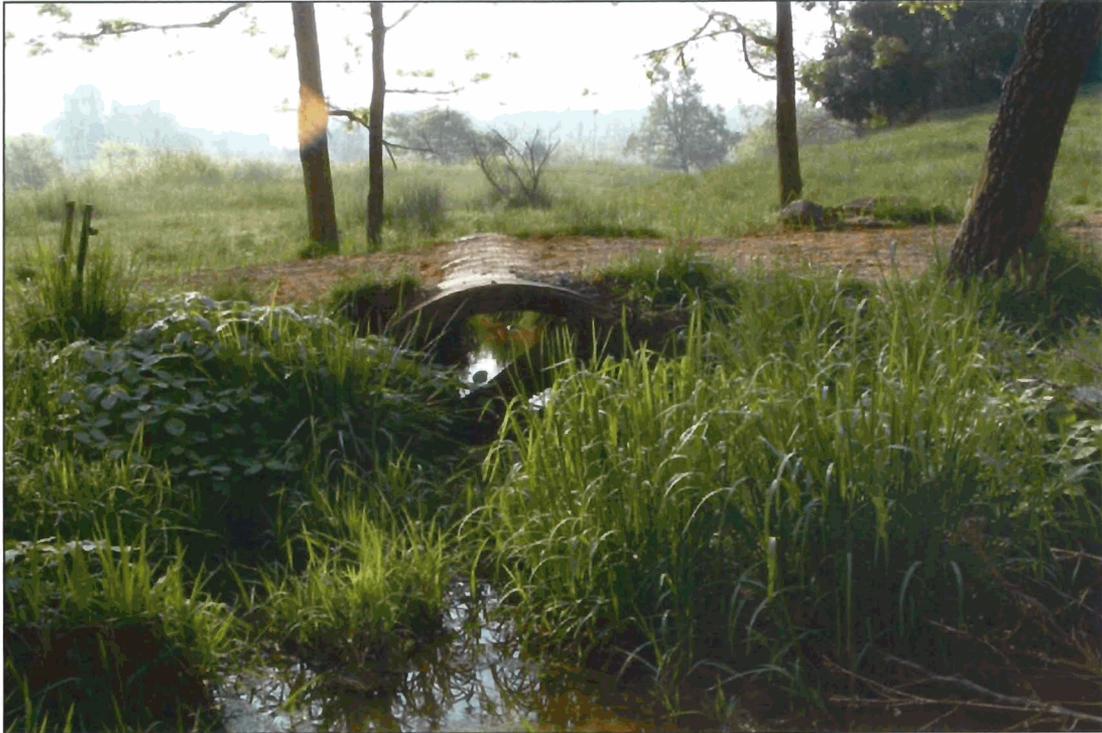
Photograph 7 – Thirty-six inch (36") RCP serves as the primary stream crossing on UTJC2. The structure is located from Station 52+17 to 52+31.

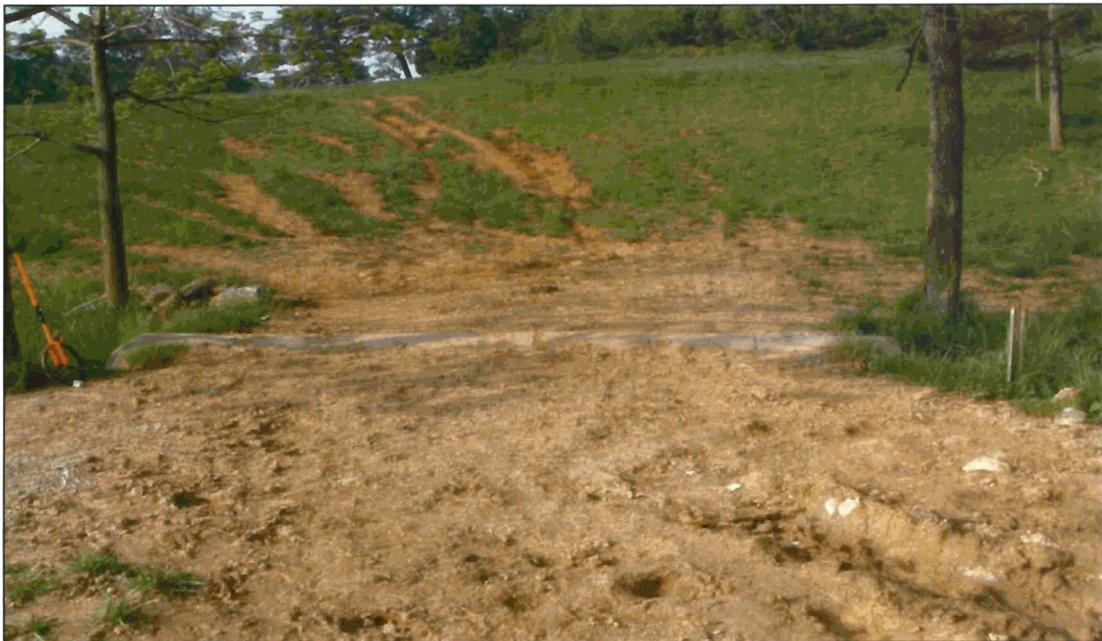
Photograph 8 – View of the same crossing, looking southwest. It is utilized by livestock and for farm machinery.

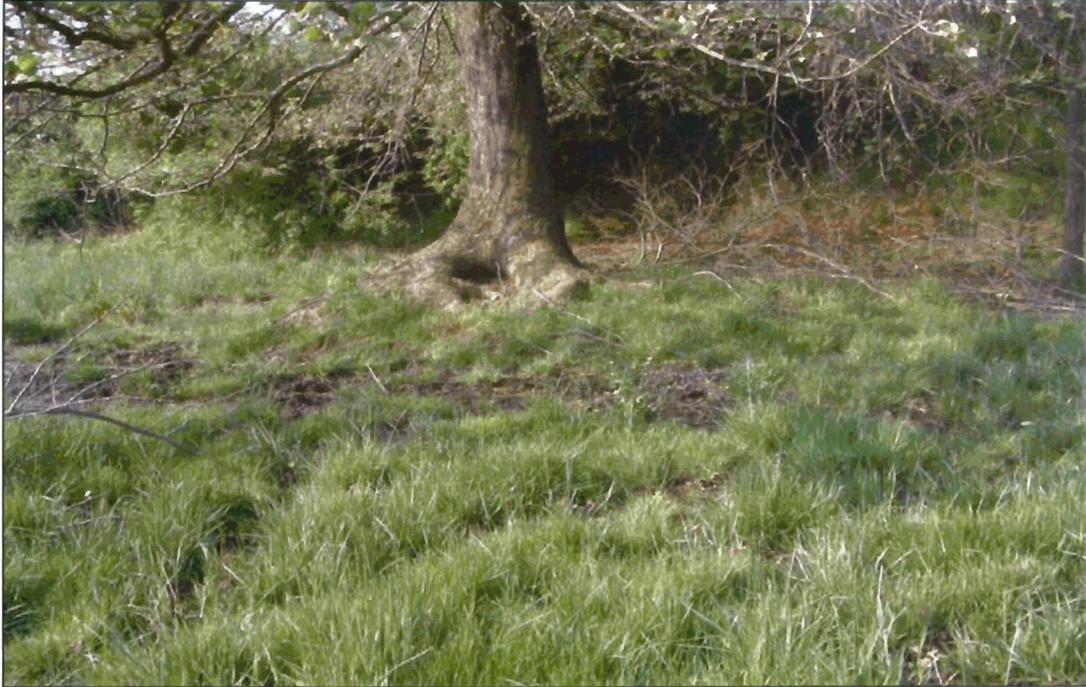
**Photograph 11 – An extended wet area exists adjacent to the right bank from Station 54+75 to 55+80. Multiple seeps from the valley slope interface with the floodplain to provide surface hydrology to this area.**

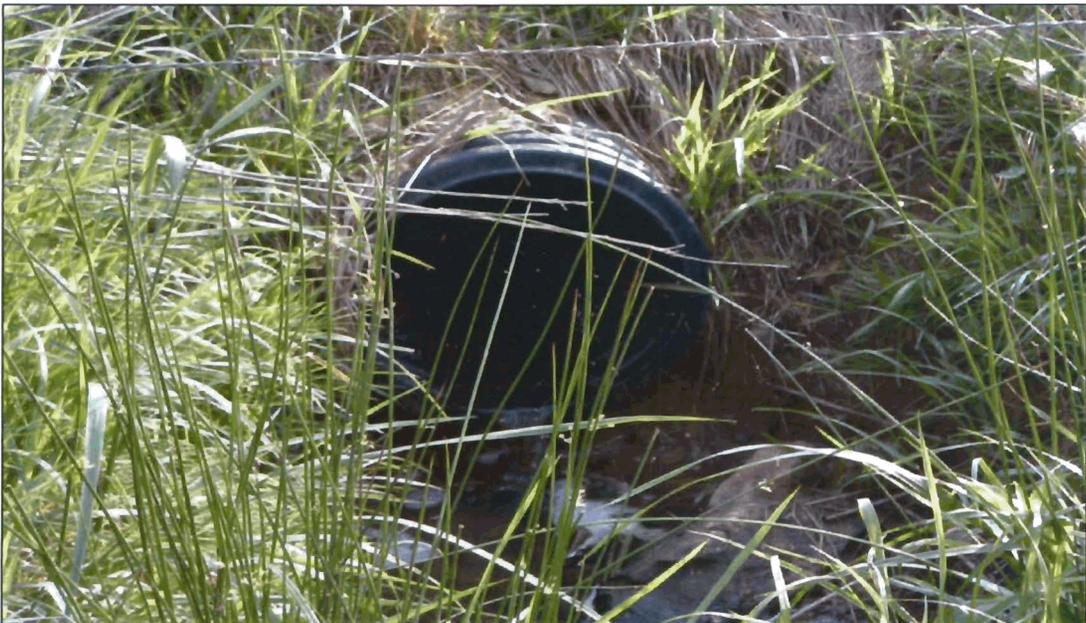
**Photograph 12 – A 12” plastic pipe that serves as the overflow drain from the pond enters the left bank of UTJC2 at Station 54+93.**

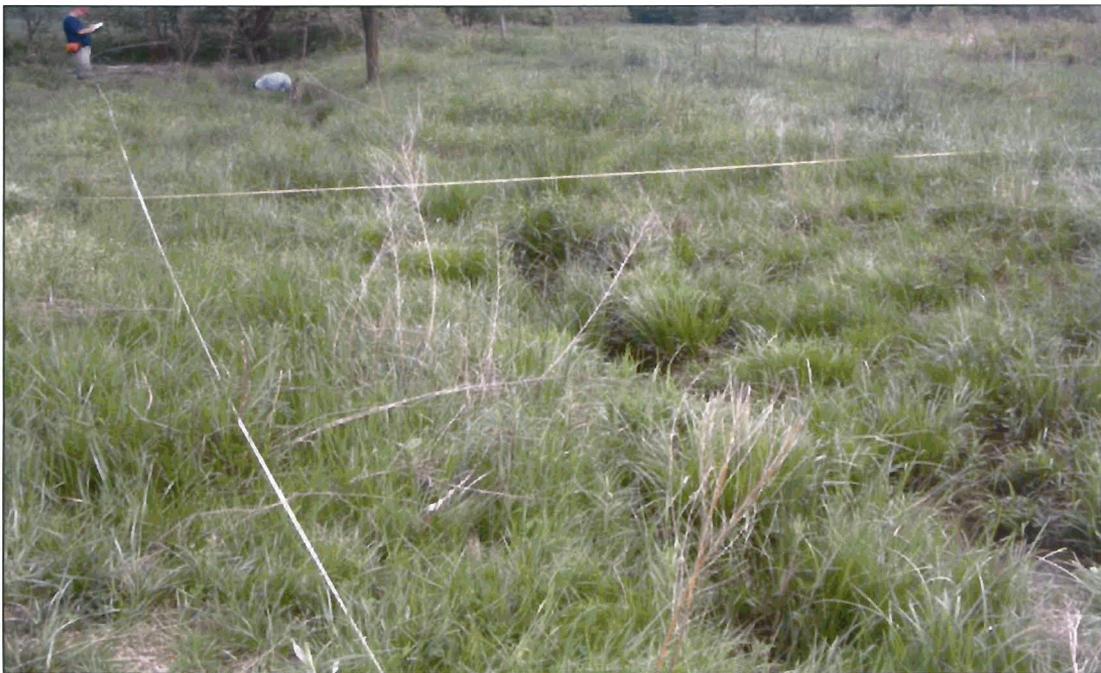
Photograph 14 – Elevated view of Cross-section 2 at Station 57+33.

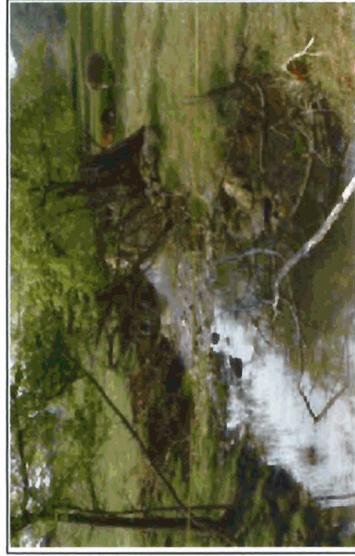
**Yadkin River Basin, UTI X-Sec 1, Station 11+92**

**Stream Type:** G4c

SUMMARY DATA	
Bankfull Elevation:	93.8
Bankfull Cross-Sectional Area:	15.1
Bankfull Width:	11.3
Flood Prone Area Elevation:	95.5
Flood Prone Width:	19.9
Max Depth at Bankfull:	1.7
Mean Depth at Bankfull:	1.3
W / D Ratio:	8.4
Entrenchment Ratio:	1.8
Bank Height Ratio:	1.9
Slope (ft/ft):	0.006
Discharge (cfs):	54

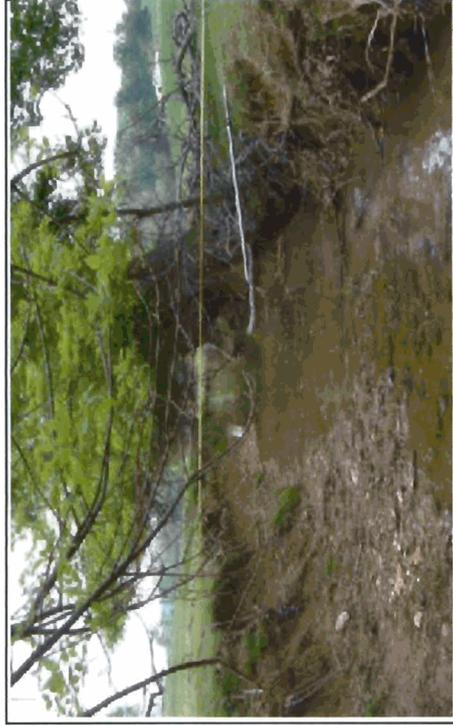
**Yadkin River Basin, UTI X-Sec 2, Station 13+41**

**Stream Type:** E4 to G4c

SUMMARY DATA	
<b>Bankfull Elevation:</b>	94.6
<b>Bankfull Cross-Sectional Area:</b>	18.0
<b>Bankfull Width:</b>	12.0
<b>Flood Prone Area Elevation:</b>	96.6
<b>Flood Prone Width:</b>	56.7
<b>Max Depth at Bankfull:</b>	1.9
<b>Mean Depth at Bankfull:</b>	1.5
<b>W / D Ratio:</b>	8.0
<b>Entrenchment Ratio:</b>	4.7
<b>Bank Height Ratio:</b>	1.9
<b>Slope (ft/ft):</b>	0.004
<b>Discharge (cfs)</b>	54

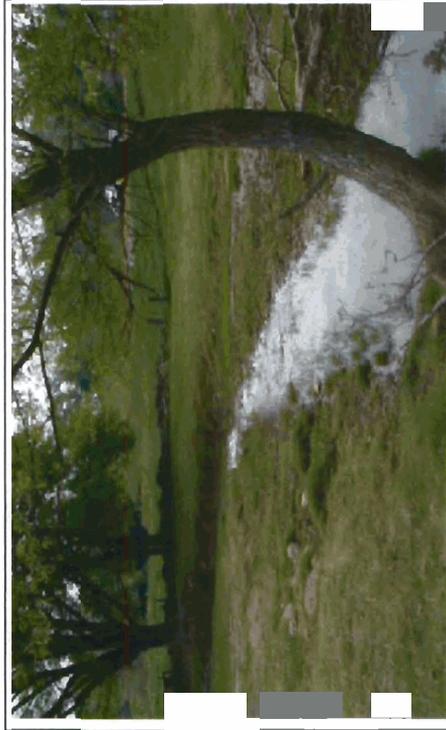
Yadkin River Basin, UTI X-Sec 3, Station 15+96

Stream Type: C4/5

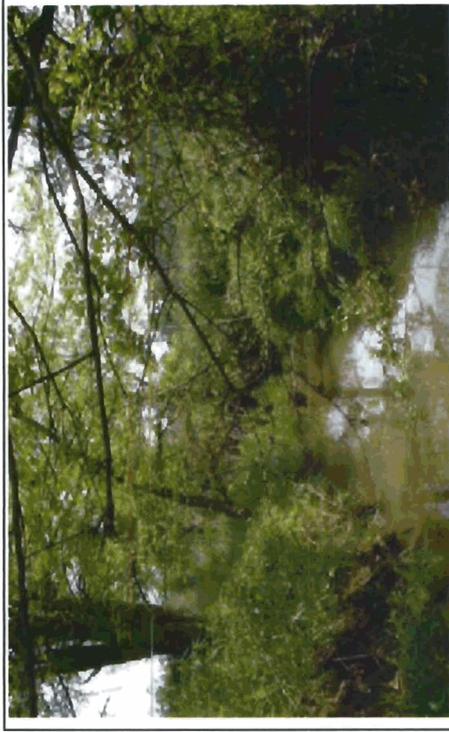
**Yadkin River Basin, UTI X-Sec 4, Station 19+90**

**Stream Type:** E4

SUMMARY DATA	
<b>Bankfull Elevation:</b>	97.6
<b>Bankfull Cross-Sectional Area:</b>	18.8
<b>Bankfull Width:</b>	8.5
<b>Flood Prone Area Elevation:</b>	100.4
<b>Flood Prone Width:</b>	32.0
<b>Max Depth at Bankfull:</b>	2.8
<b>Mean Depth at Bankfull:</b>	2.2
<b>W / D Ratio:</b>	3.8
<b>Entrenchment Ratio:</b>	3.8
<b>Bank Height Ratio:</b>	1.8
<b>Slope (ft/ft):</b>	0.007
<b>Discharge (cfs)</b>	63

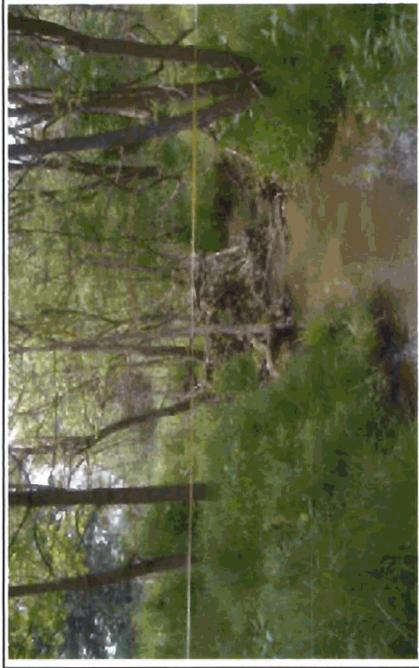
**Yadkin River Basin, UT1 X-Sec 5, Station 25+40**

Stream Type: B5c

SUMMARY DATA	
<b>Bankfull Elevation:</b>	97.8
<b>Bankfull Cross-Sectional Area:</b>	18.8
<b>Bankfull Width:</b>	22.9
<b>Flood Prone Area Elevation:</b>	100.0
<b>Flood Prone Width:</b>	37.3
<b>Max Depth at Bankfull:</b>	2.2
<b>Mean Depth at Bankfull:</b>	0.8
<b>W / D Ratio:</b>	27.9
<b>Entrenchment Ratio:</b>	1.6
<b>Bank Height Ratio:</b>	2.0
<b>Slope (ft/ft):</b>	0.004
<b>Discharge (cfs)</b>	39
