# Brown Creek Tributaries Restoration Project Final Year 5 Monitoring Report

Anson County, North Carolina

DMS Project ID No. 95351, DEQ Contract No. 004641

Report Prepared and Submitted by Michael Baker Engineering, Inc.

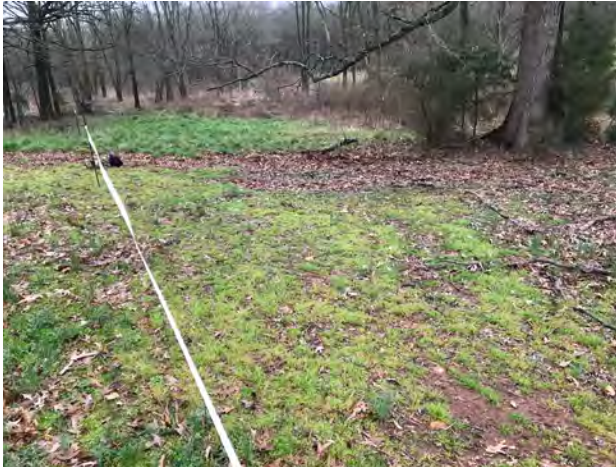
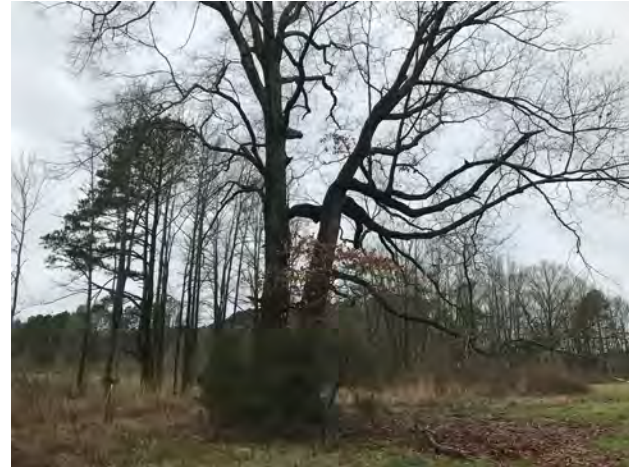
-A small amount of scalloping of the easement is occurring in the planted field to the north of UT4 Reach 1B at approximate Station 11+20. The green cover crop planted between T-Posts and within the easement is visible in the attached photograph. Please take measures to prevent the encroachment and correct any vegetative concerns due to the activity.

**Response:** Baker inspected this area in the field after receiving these comments from DMS. It does appear that approximately 700 ft<sup>2</sup> of area within the easement has been planted with cover crop. Two additional T-posts were installed along the easement boundary with horsetape connecting them to more clearly mark the easement boundary. The landowner will also be made aware of the issue. Riparian seed mix was placed out to reestablish more appropriate herbaceous vegetation. The area is almost entirely located under the canopy of two very large oak trees, which appear to have suppressed or stunted tree growth underneath them in all directions. See photos below:

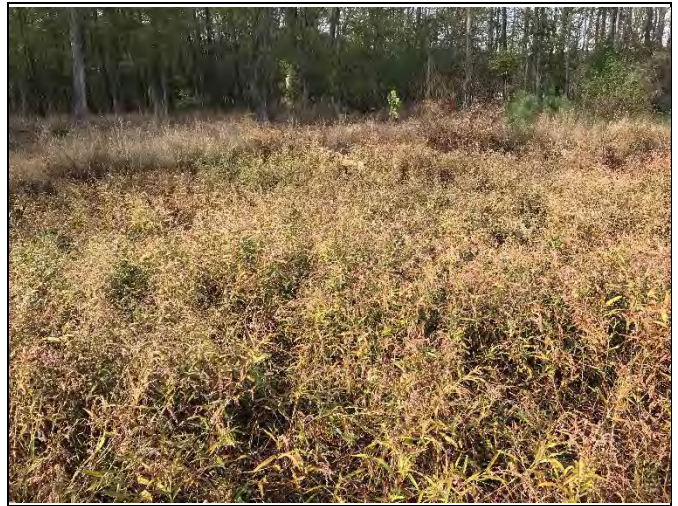
PP-10: HC Reach 1, vernal pool at Station 26+25

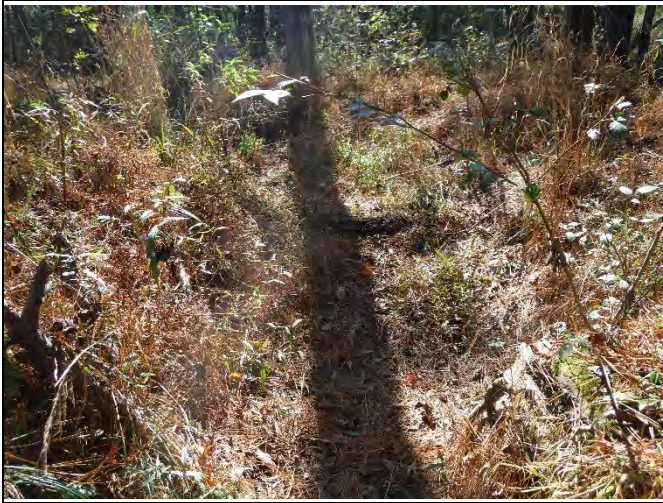
PP-1: Reach UT4-R4a – View upstream, Station 11+50

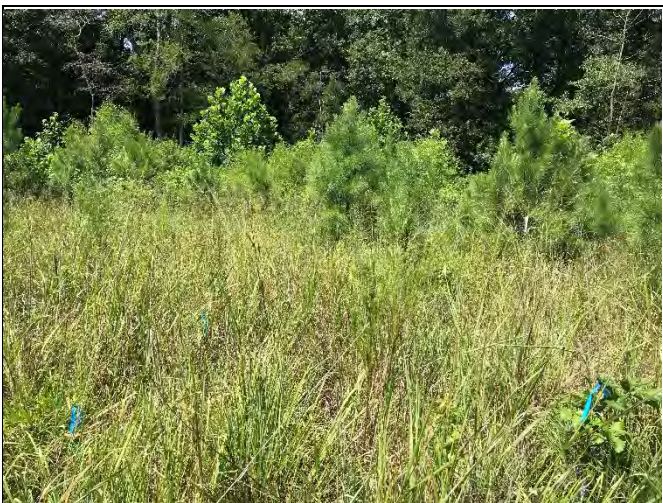
Vegetation Plot 5– HC-R1  
(pines to be thinned)

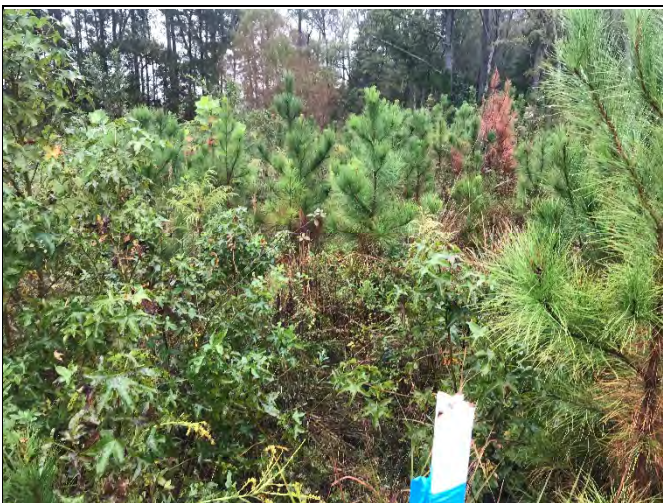
Vegetation Plot 11 – UT4-R2  
(pines/sweetgum to be thinned)

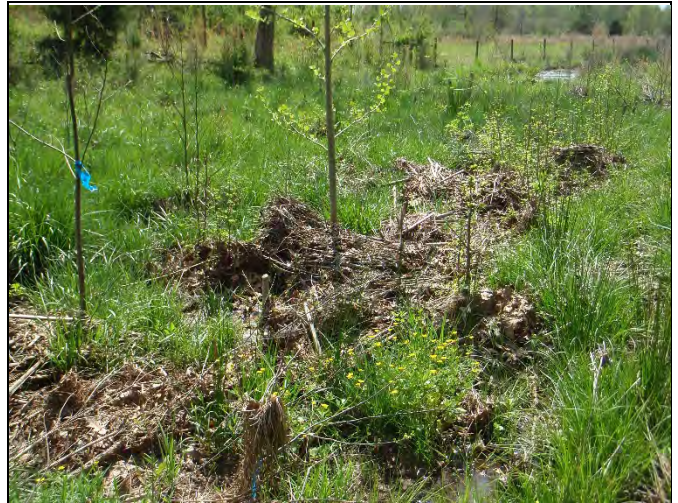
Reach UT4-R2: Evidence of overbank event  
(photo from 4/11/19)

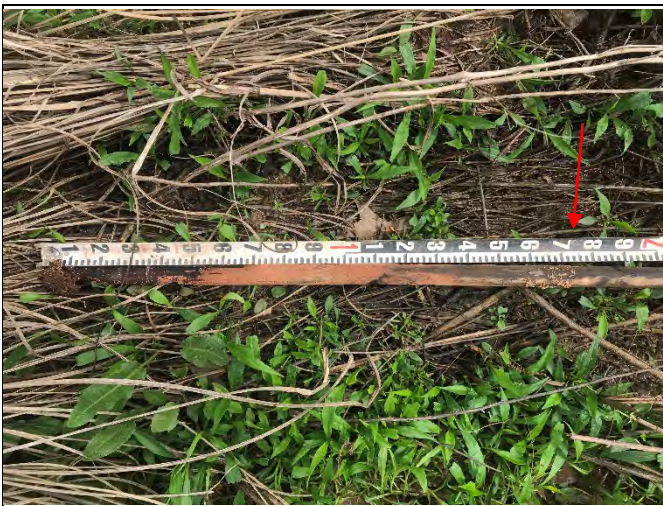
Crest Gauge Reach HC-R1: Overbank event of 1.72'  
(photo from 4/12/19)

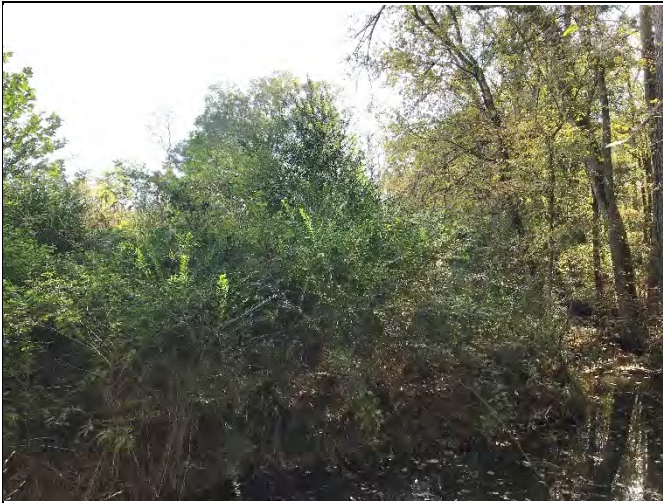
Privet (*Ligustrum sinense*) on upper Reach HC-R1  
(photo from 11/7/19)

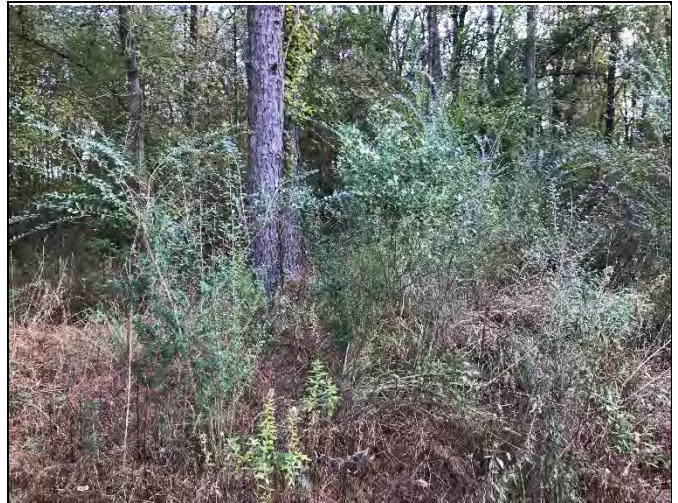
Privet (*Ligustrum sinense*) on Reach HC-R1  
(photo from 11/7/19)

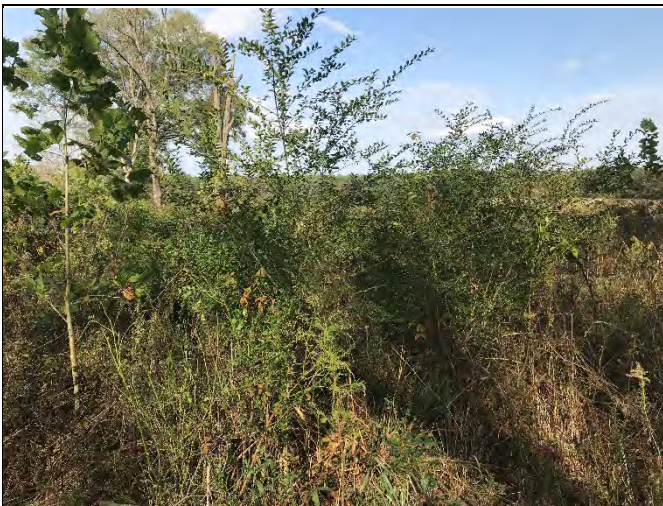
Privet (*Ligustrum sinense*) on Reach HC-R3  
(photo from 11/7/19)

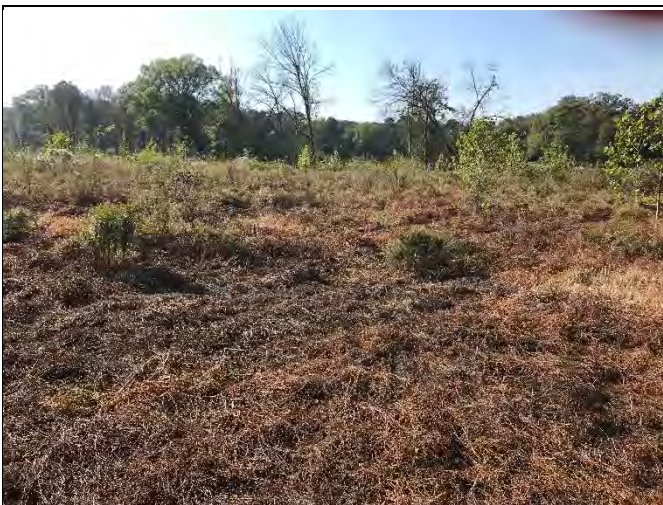
Low stem density on HC-R2 (photo from 11/7/19)

<b>Table 6b. Vegetation Problem Areas (VPAs)</b>			
<b>Brown Creek Tributaries Restoration Project: DMS Project ID No. 95351</b>			
<b>Feature Issue</b>	<b>Station Number</b>	<b>Area</b>	<b>Suspected Cause</b>
Low stem density	UT4-R2, Left bank, Station 32+00 to 35+00	~0.18 acres	None readily identifiable <sup>1</sup>
	HC-R2, Right bank, Station 33+50 to 35+00	~0.19 acres	Extreme wet conditions <sup>2</sup>
Privet ( <i>Ligustrum sinense</i> )	UT4: R4b Right bank, Station X+Y to X+Y, and R5b Right bank, Station X+Y to S+Y	Combined ~0.80 acres	Scattered resprouts
	HC: R1 Left bank, Stations 10+00 to 11+00 and 15+00 to 21+00, and R3 Left bank, Station 11+00 to 13+50		
Notes:			
<p>1 This area of observed low stem density is located in a relatively higher and drier location on the floodplain than the more successful adjacent areas and the soil is particularly dense here (though no benching or cutting down of soil was conducted here during construction), though this is just speculation and the exact reason for the observed mortality is not readily identifiable. The area appears to meet MY5 success criteria, though just barely, so additional supplemental planted will be put out in the winter of 2019-2020 to ensure this area meets vegetative success at MY7.</p>

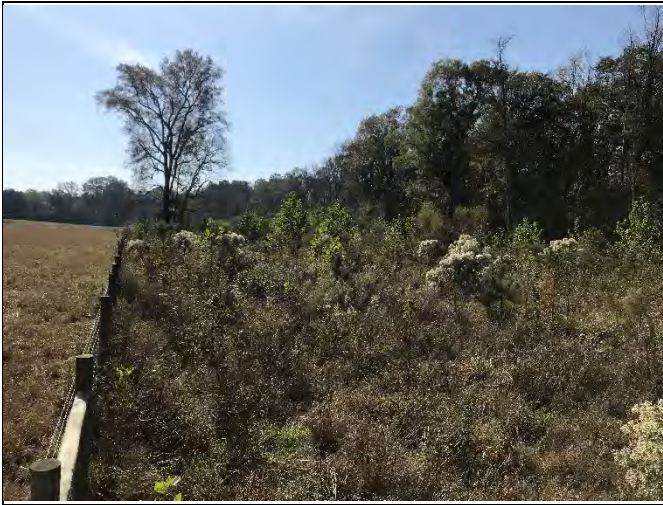
Previously reported low-vigor area on upper HC-R1  
(photo from 11/7/19)

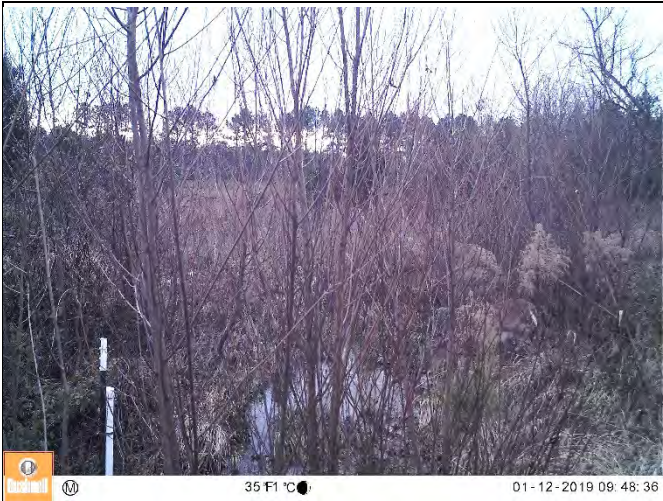
Flow camera showing flow in riffle on Reach UT4-R4b  
(photo from 1/12/19)

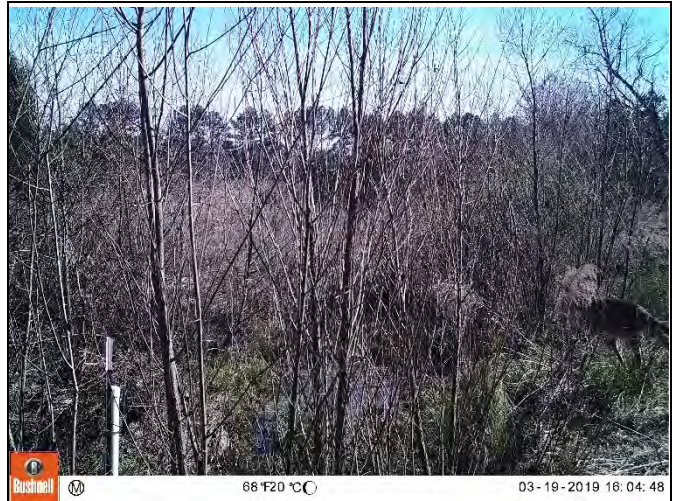
Flow Camera showing flow in riffle on Reach UT4-R4b  
(photo from 3/19/19)

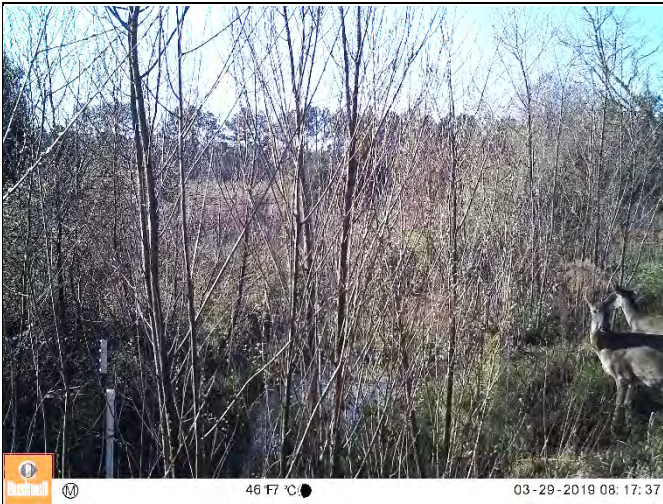
Flow camera showing flow in riffle on Reach UT4-R4b  
(photo from 3/29/19)

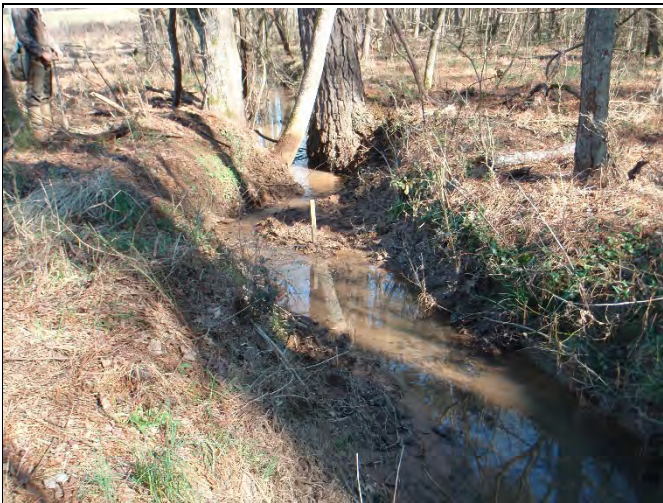
Photo showing flow on middle Reach HC-R3  
(photo from 4/12/19)

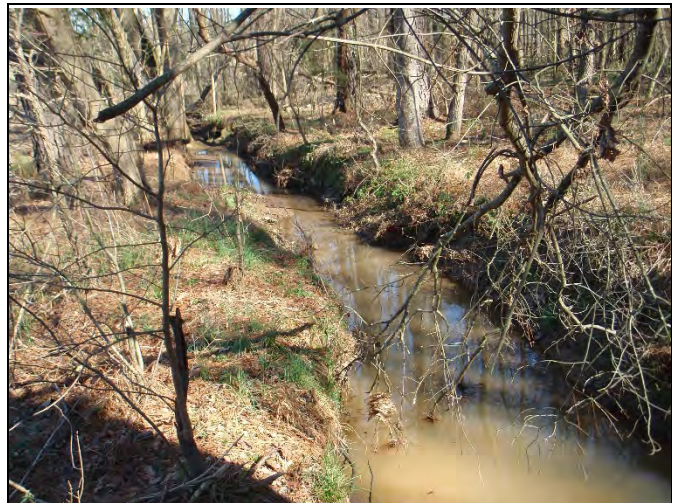
Photo showing flow on middle Reach HC-R3  
(photo from 4/12/19)

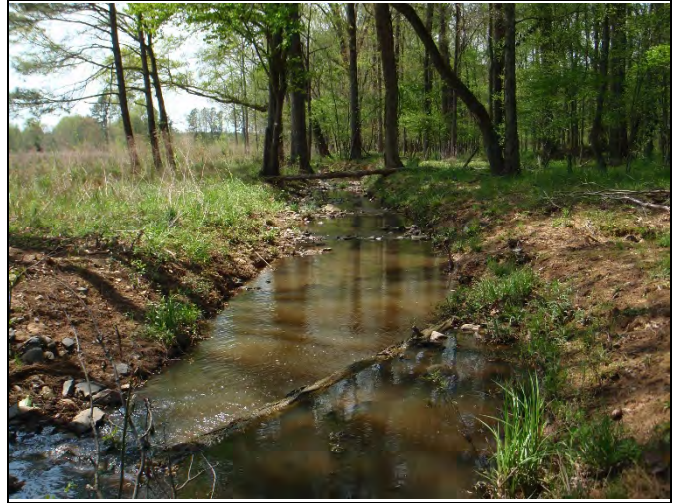
Photo showing flow on upper Reach UT4-R2  
(photo from 4/11/19)
