# Brown Creek Tributaries Restoration Project Final Year 6 Monitoring Report

Anson County, North Carolina

DMS Project ID No. 95351

Monitoring Year: 6 of 7

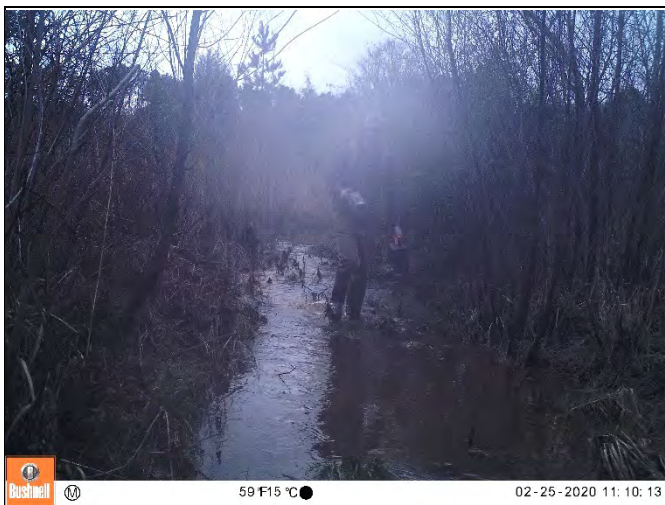
Flow camera was replaced in April 2020 with a newer model

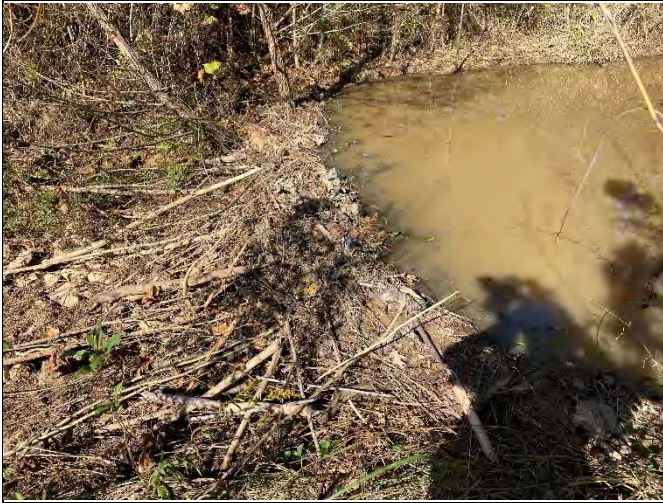
Second beaver dam on lower UT4-R2

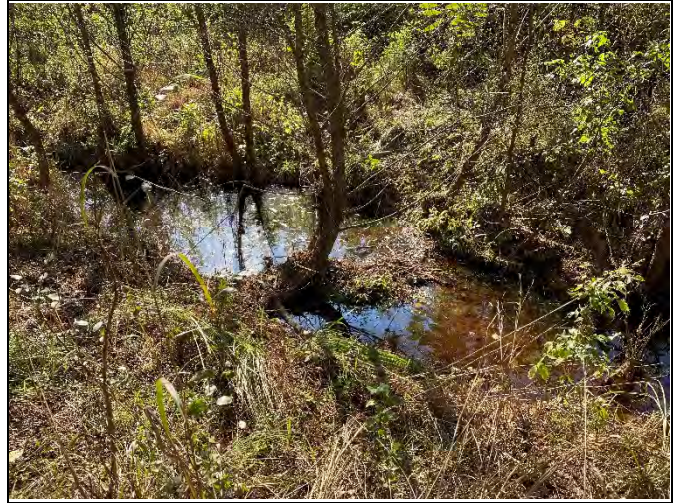
Beaver dam on UT4-R5b

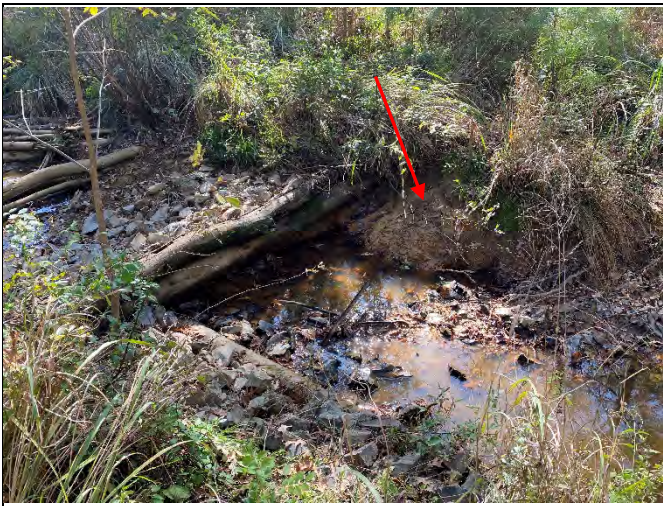
SPA #1: UT4-R2

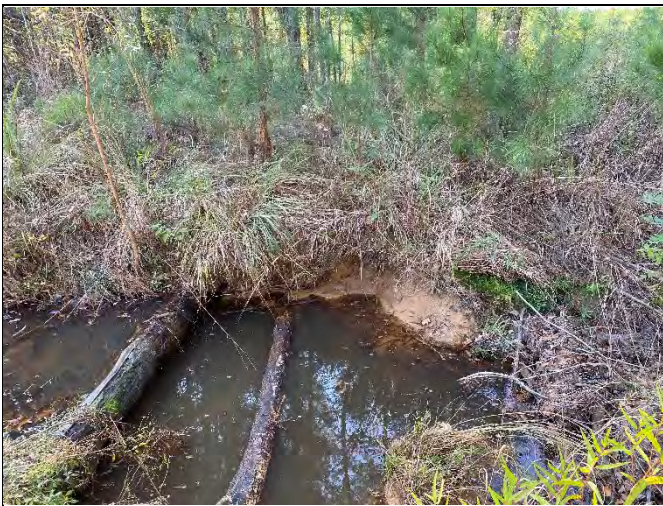
SPA #2: UT4-R2

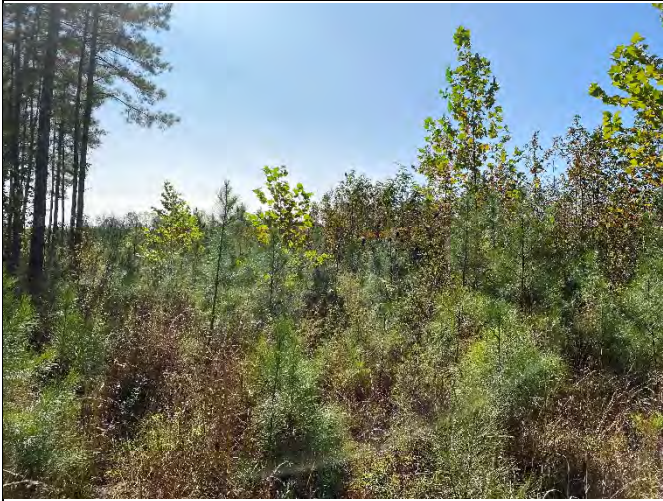
Pine trees on UT4-R3

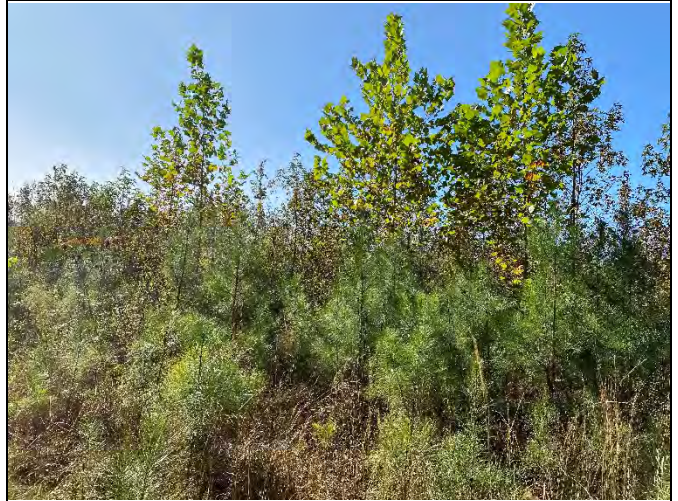
Pine trees on UT4-R3

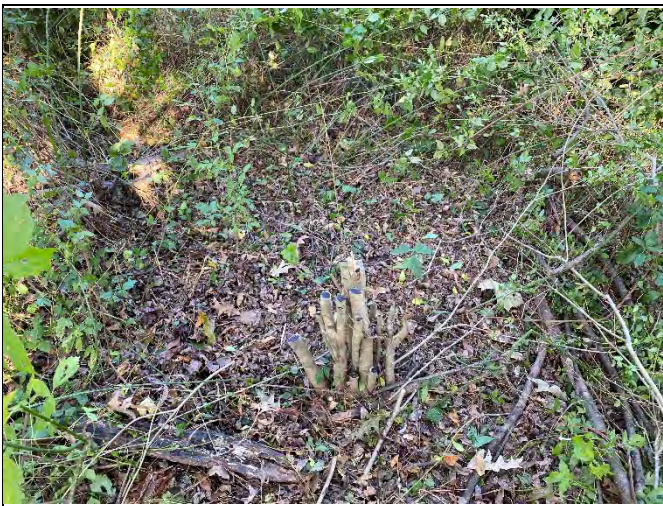
UT4-R5b: Cut/sprayed privet

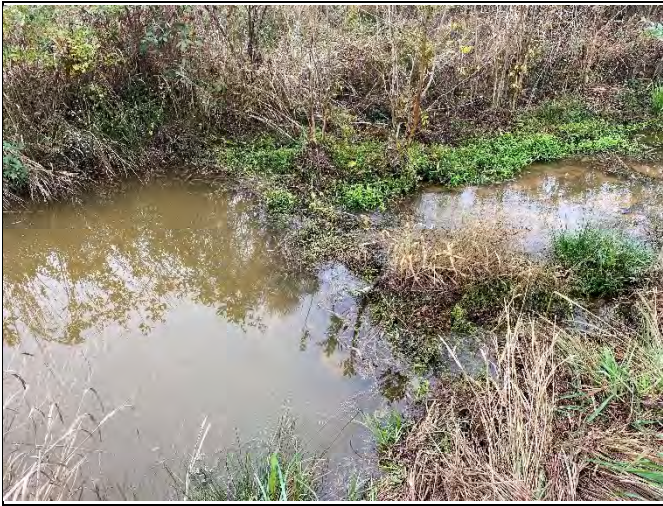
Beaver dam on HC-R2

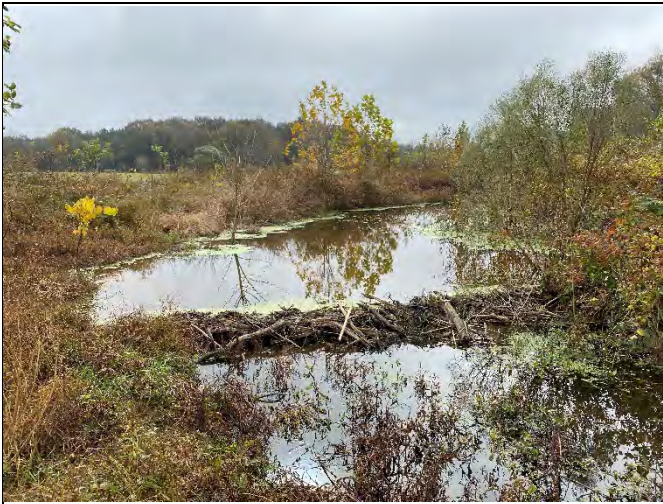
Beaver dam on HC-R2
