# **MONITORING YEAR 1 ANNUAL REPORT**

## **CANDY CREEK MITIGATION SITE**

DMS Project Number 96315

Data Collection Period: October 2017

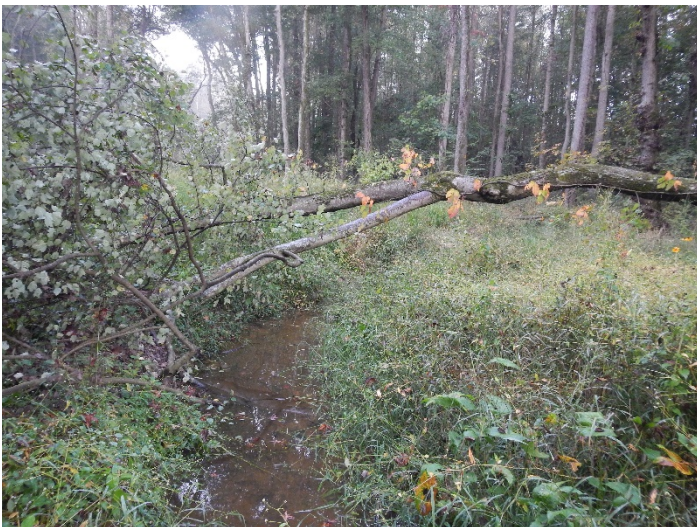
**Photo Point 78 – looking upstream (10/10/2017) \***

\*Photo Point 78 - Tree has been removed from channel
