# MONITORING YEAR 7 ANNUAL/CLOSEOUT REPORT

## CANDY CREEK MITIGATION SITE

Guilford County, NC  
NCDEQ Contract 5794  
NCDMS Project Number 96315  
USACE Action ID Number 2015-01209  
DWR Project Number 14-0334  
RFP Number 16-005568

Data Collection Period: February - October 2023  
Draft Submission Date: November 2023  
Final Submission Date: January 2024

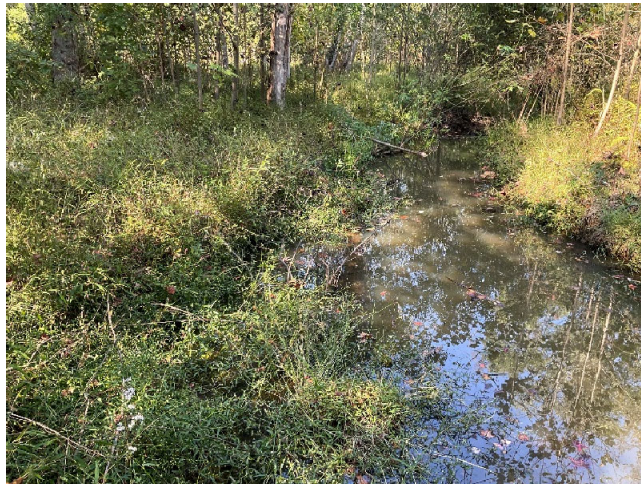
Candy Creek Reach 1 – Erosion, LB (Sta. 122+50)  
(10/17/2023)

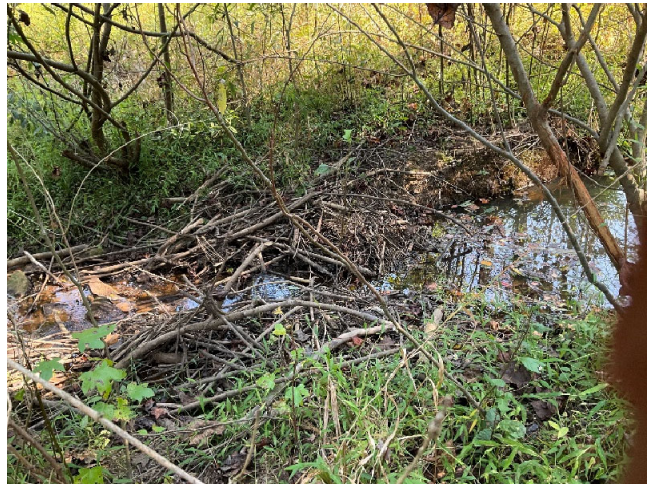
Candy Creek Reach 1 – Breached beaver dam (Sta. 122+50)  
(10/17/2023)

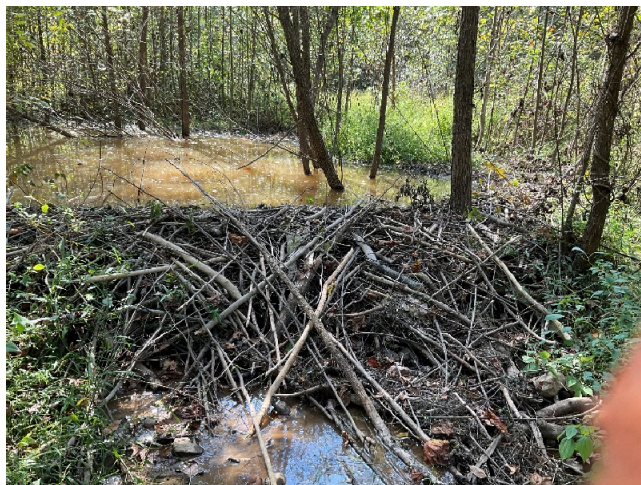
Candy Creek Reach 2 – Beaver dam; breached in late  
October (Sta. 128+00) (10/17/2023)

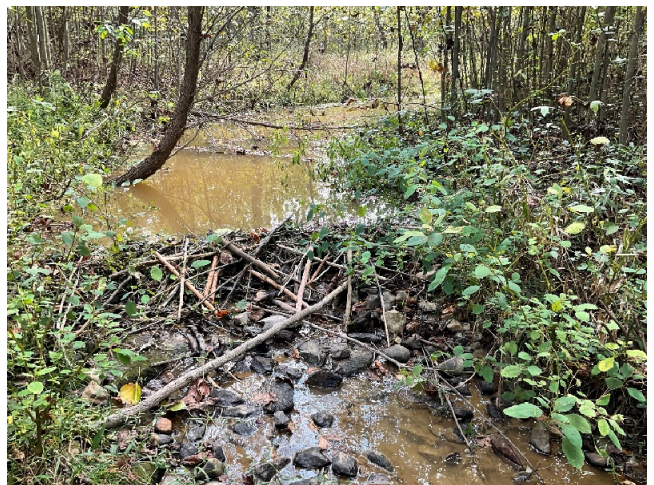
Candy Creek Reach 2 – Beaver dam; breached in late October  
(Sta. 130+00) (10/17/2023)

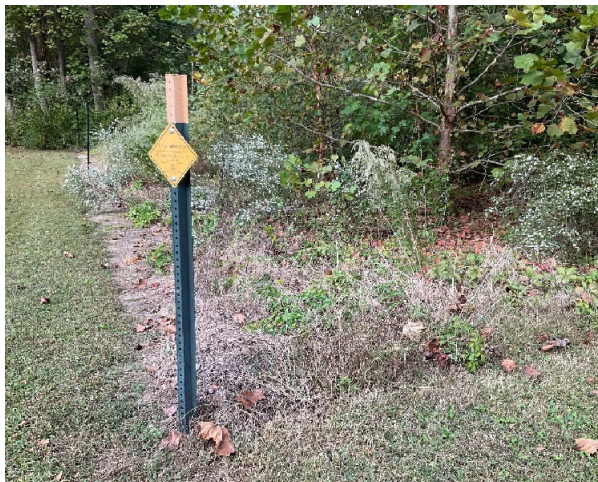
Candy Creek Reach 3 – Resolved mowing encroachment and a new signpost (Sta. 149+02) (10/17/2023)

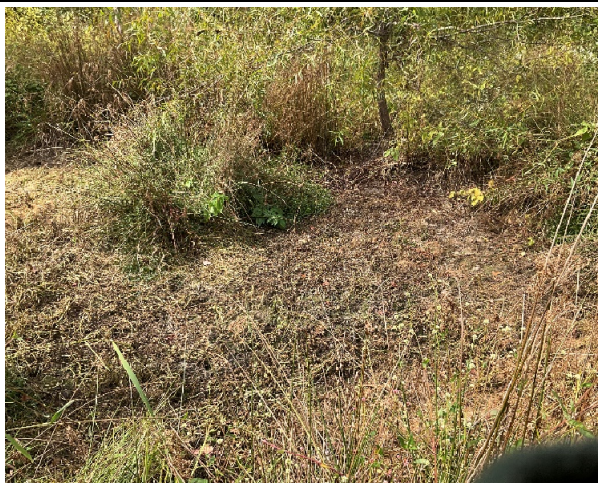
Candy Creek Reach 4 – Treated primrose (*Ludwigia peploides*) (Sta. 188+00) (10/17/2023)

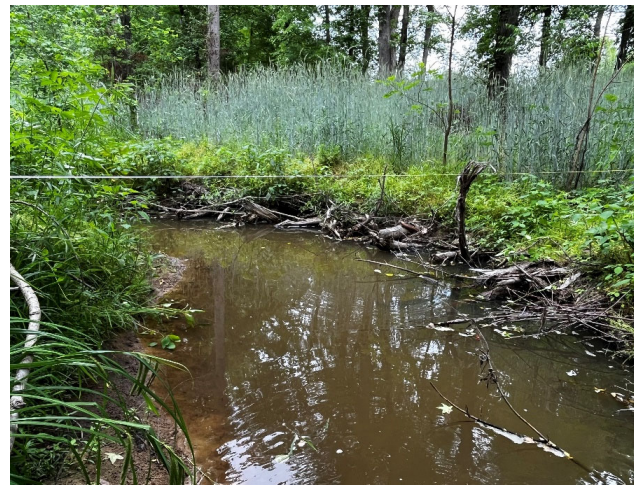
### Cross-Section 16 - Candy Creek Reach 3

\*Right bank rebuilt in September 2022.
