South Fork Hoppers Creek - Melton Farm Stream Restoration Project Year 5 Monitoring Report

McDowell County, North Carolina

NCDMS Project Number – 92251

<u>Site Assessment Report – Monitoring Year 5</u>

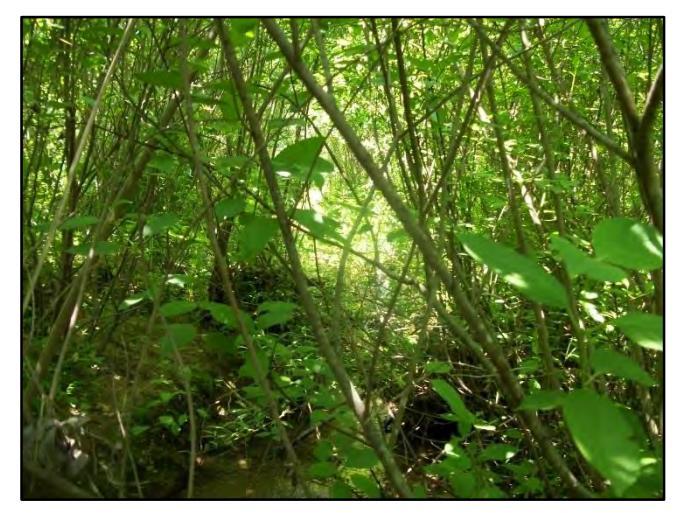
PID 1– Constructed riffle (5/25/16)

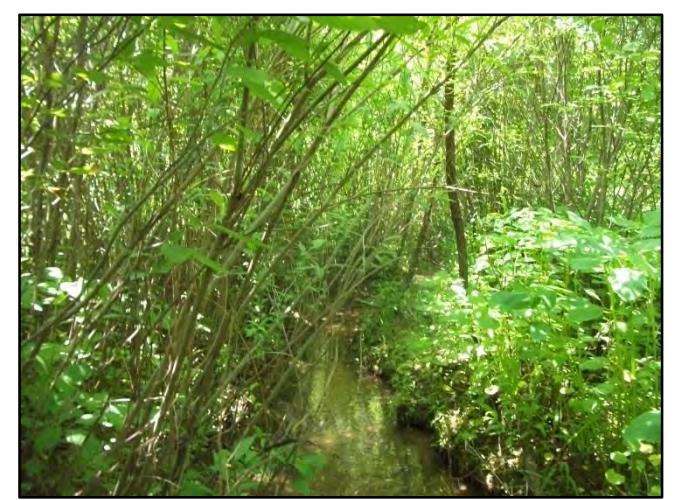
PID 3 – Log vane in constructed pool (5/25/16)

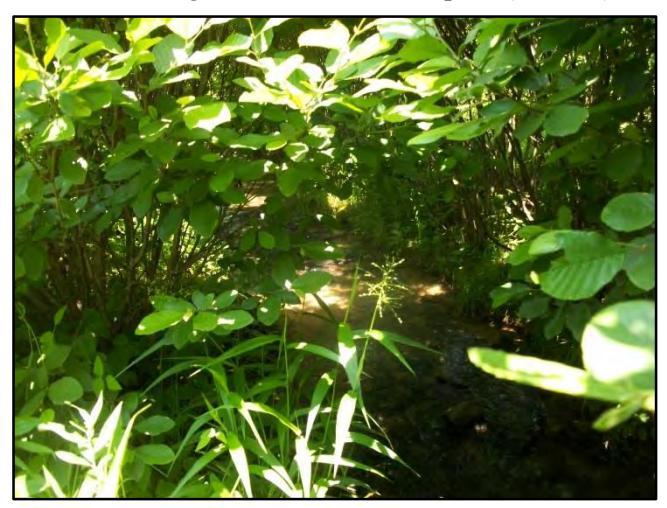
PID 5 – Constructed riffle (5/25/16)

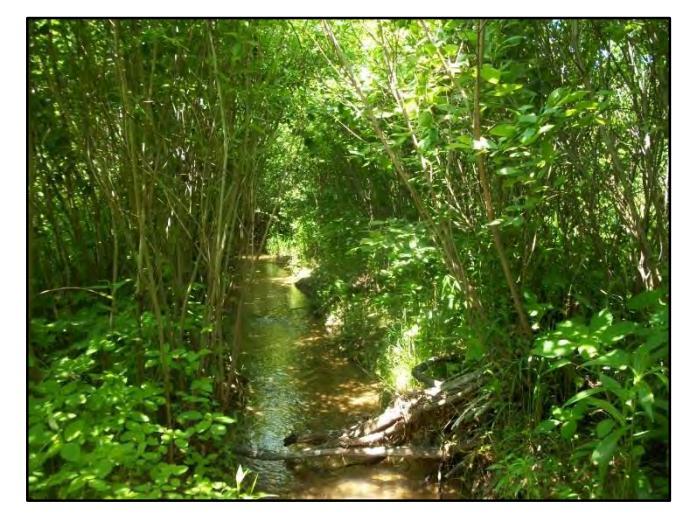
PID 2 – Constructed riffle (5/25/16)

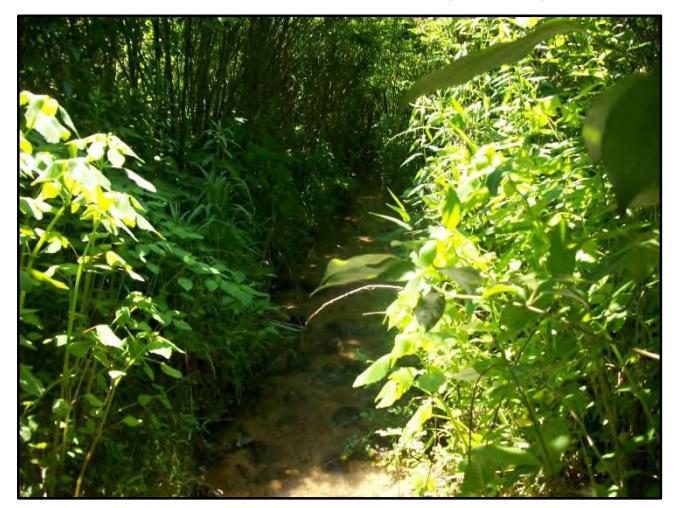
PID 4 – Constructed riffle (5/25/16)

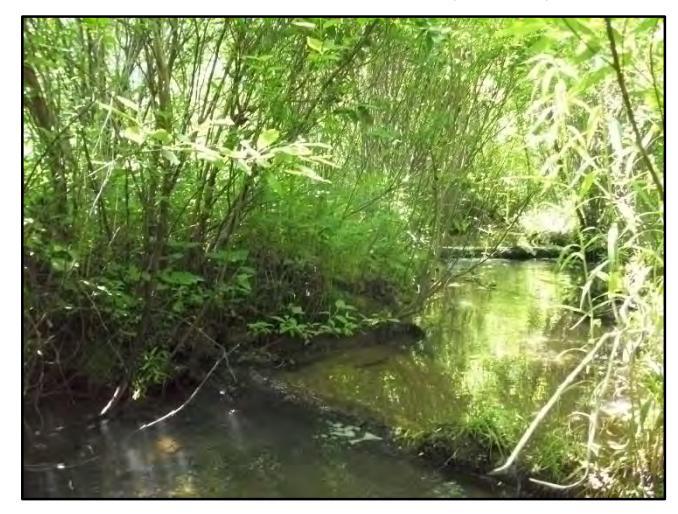
PID 6 - Log sills and root wad (5/25/16)

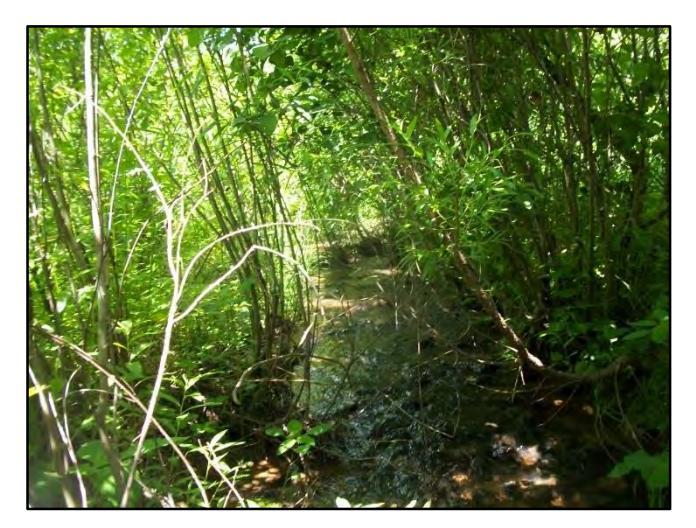
PID 7 – Constructed riffle (5/25/16)

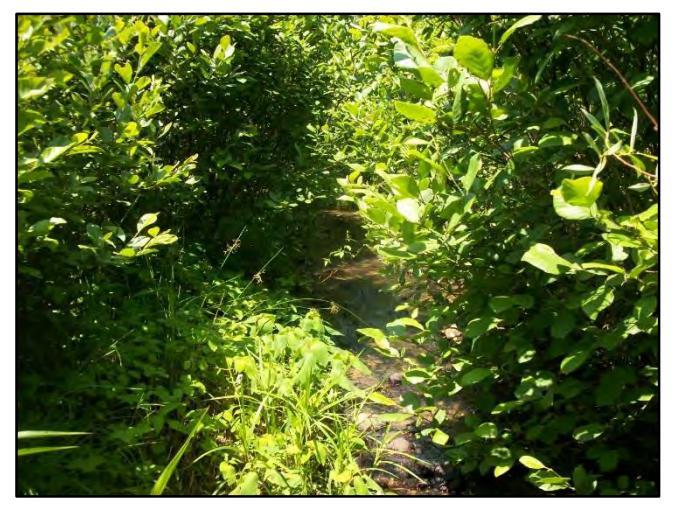
PID 9 – Constructed riffle root wad (5/25/16)

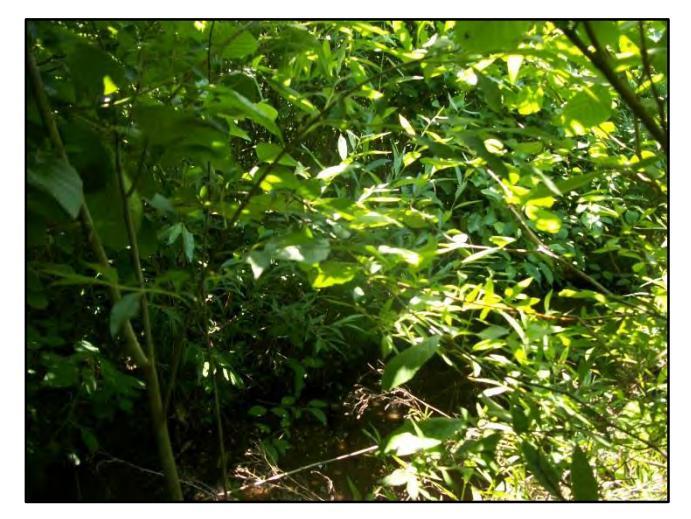
PID 8 – Log sills & root wad (5/25/16)

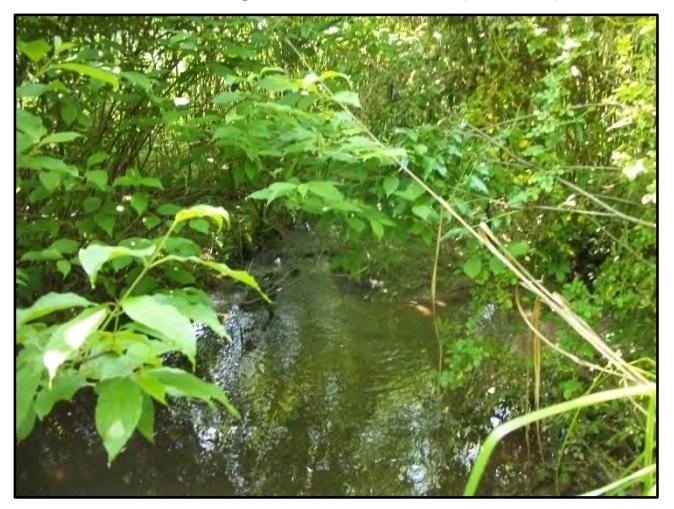
PID 10 – Confluence of UT1 (5/25/16)

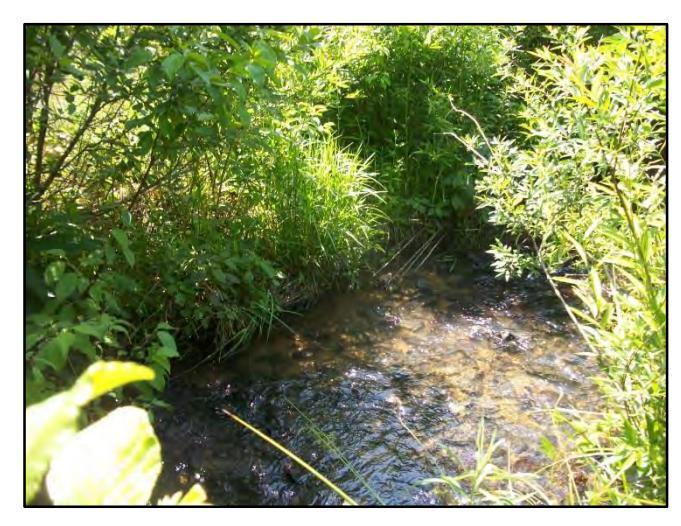
PID 11 – Constructed riffle root wad (5/25/16)

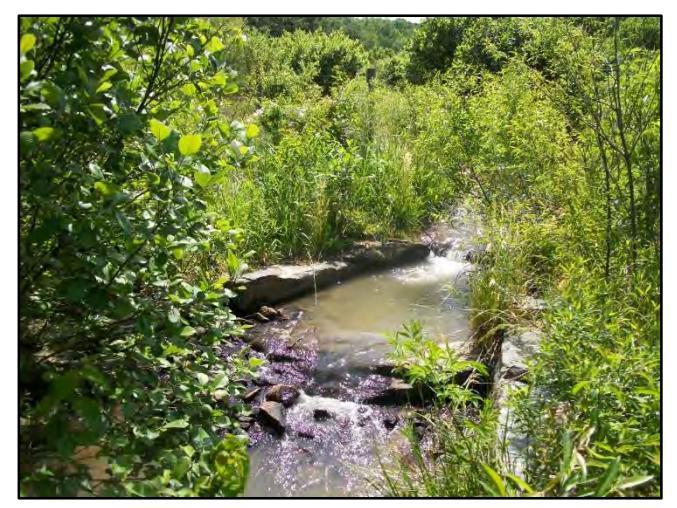
PID 12 – Double drop cross vane below crossing (5/16/16)

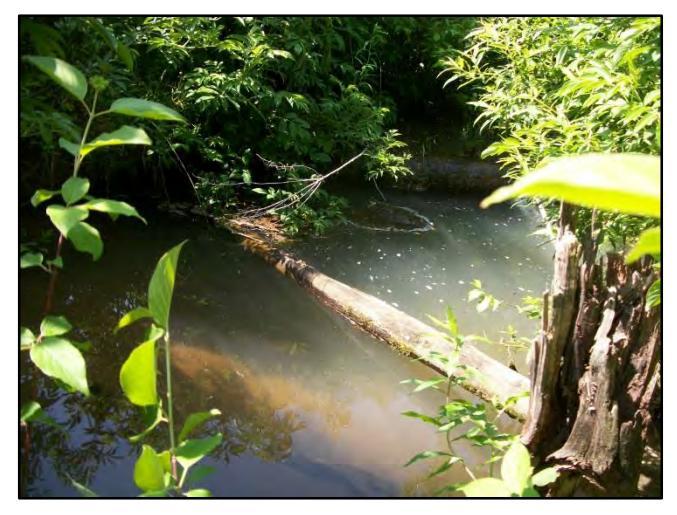
PID 13 – Log sills & root wad (5/25/16)

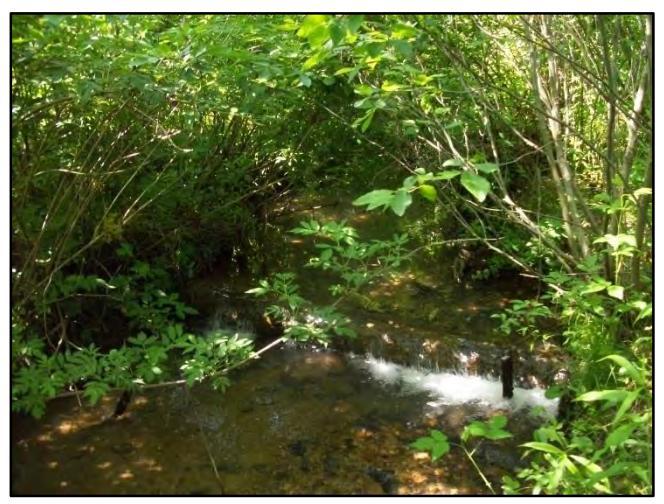
PID 14 – Log sills & root wad (5/25/16)

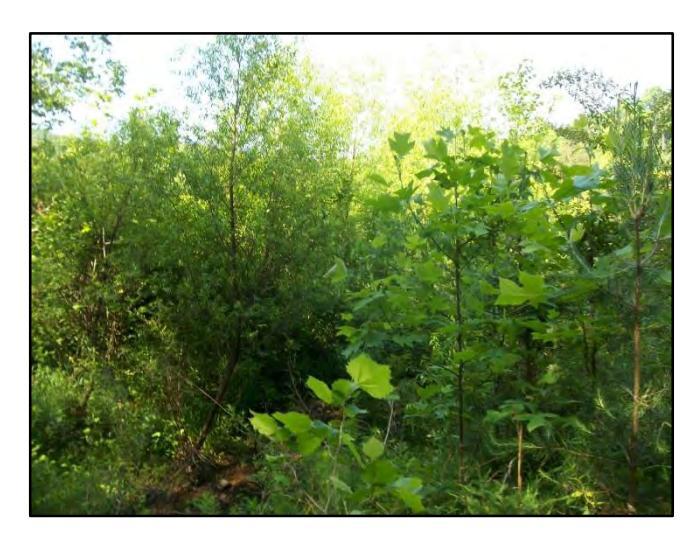
PID 15 – Log Vane (5/25/16)

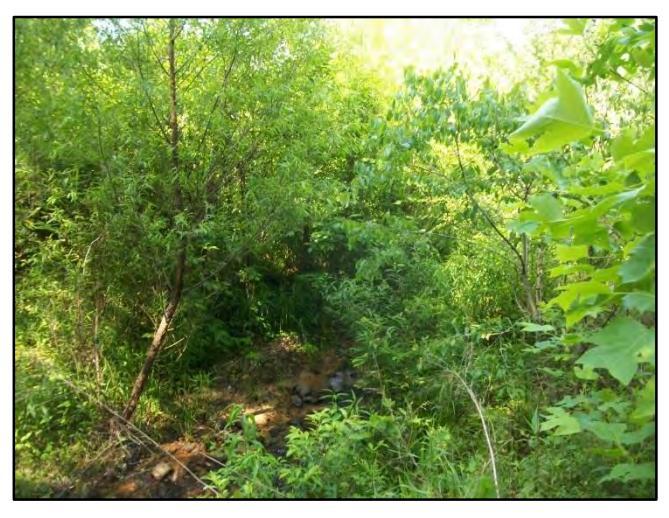
PID 16 – Log vane & matted bank (5/25/16)

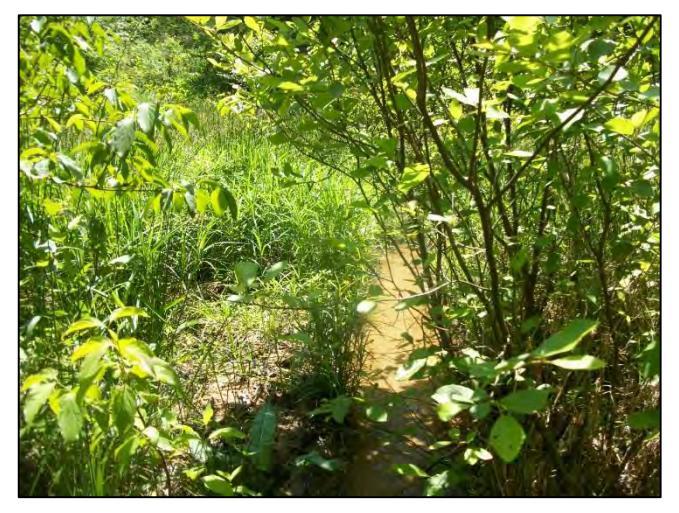
PID 2 – Constructed riffle (5/25/16)

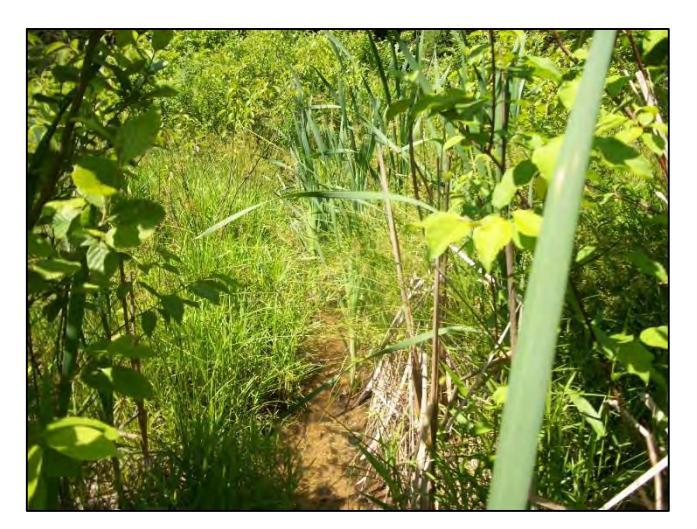
PID 3 – Constructed riffle (5/25/16)

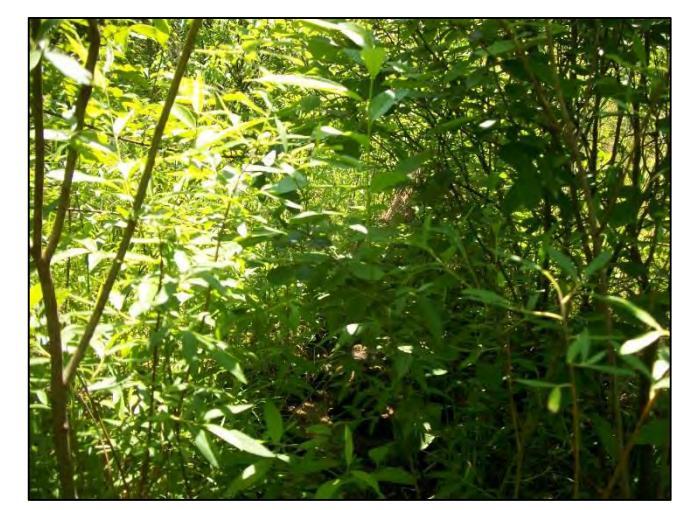
PID 4 – Constructed riffle (5/25/16)

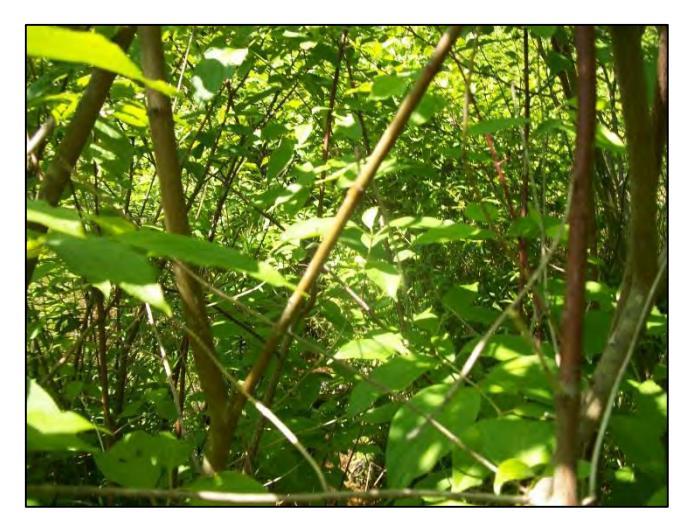
PID 5 – Constructed riffle (5/25/16)

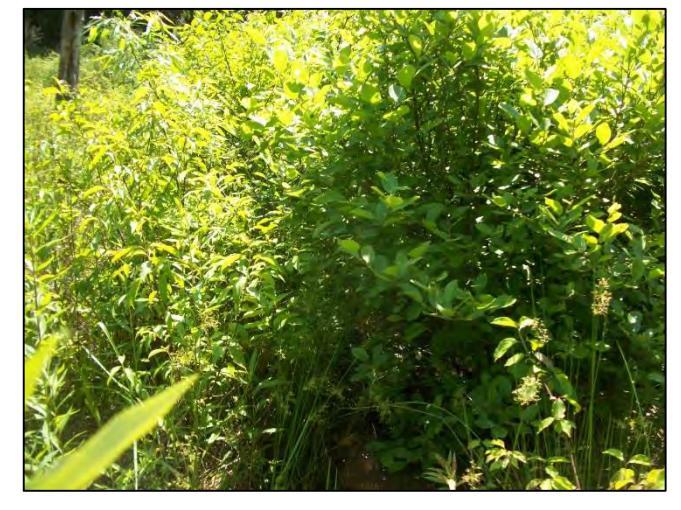
PID 6 – Log sills (5/25/16)

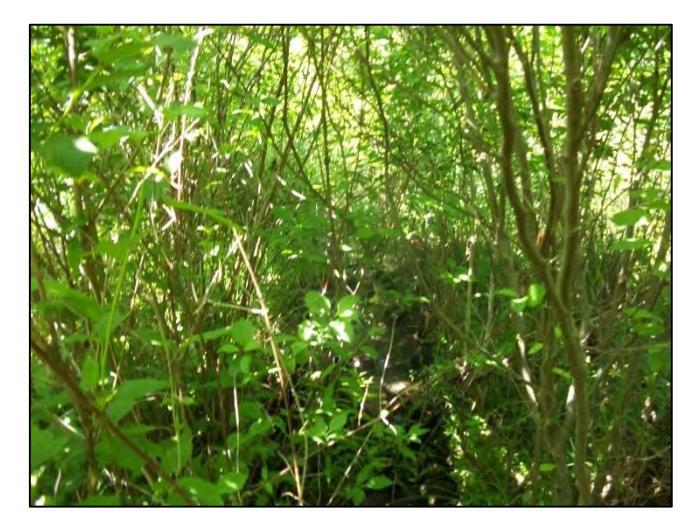
PID 7 – Constructed riffle (5/25/16)

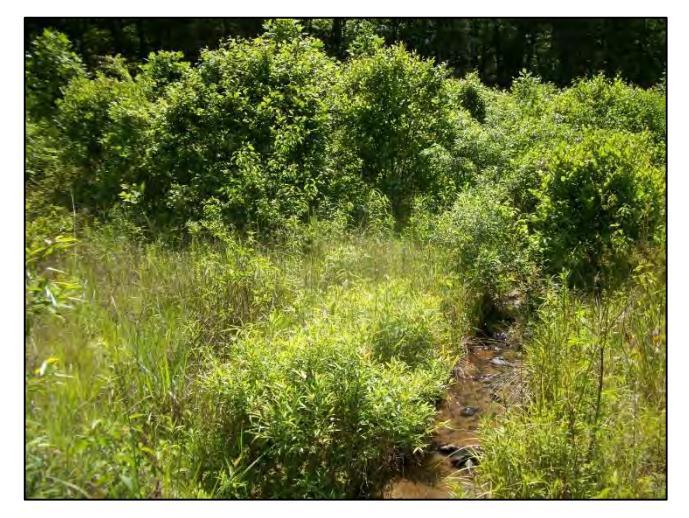
PID 8 – Constructed riffle (5/25/16)

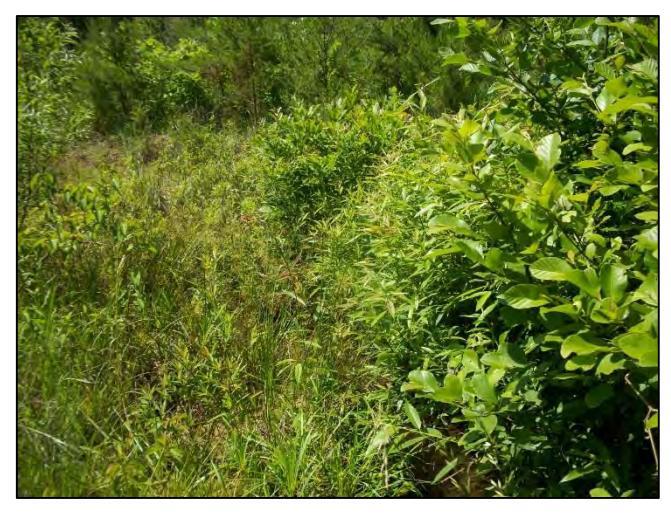
PID 9 – Ephemeral pool in right floodplain (5/25/16)

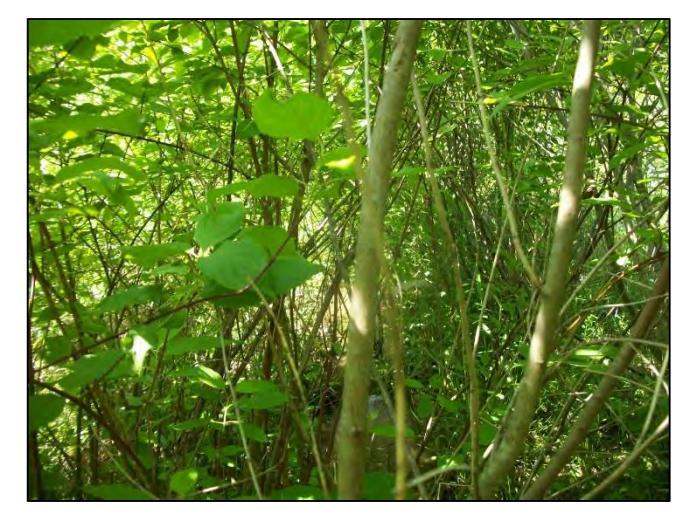
PID 10 – Log sills (5/25/16)

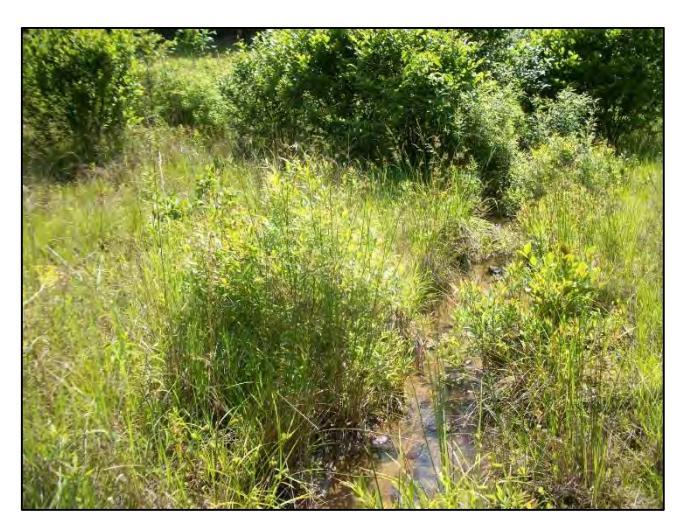
PID 11 - Constructed riffle (5/25/16)

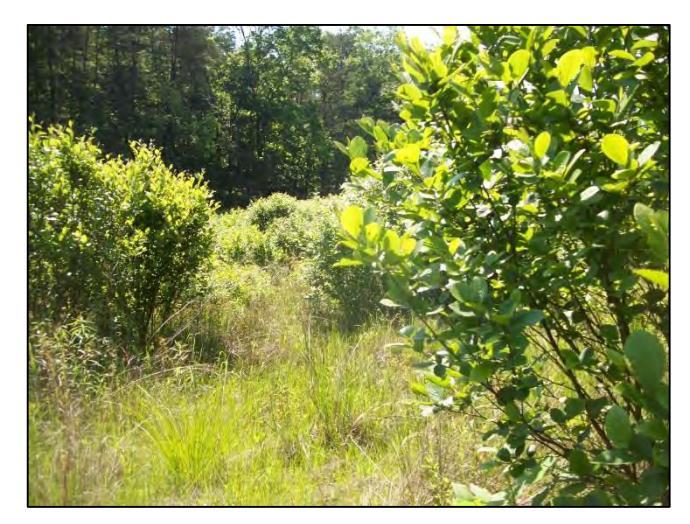
PID 12 – Ephemeral pool in right floodplain (5/25/16)

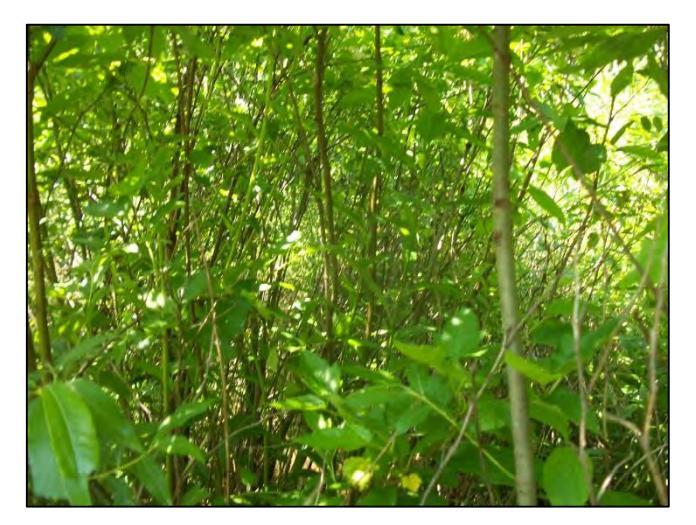
PID 13 – Constructed riffle (5/25/16)

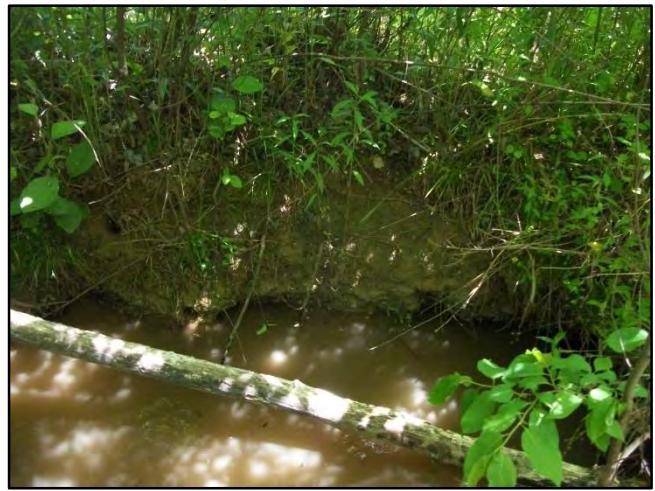
SPA1-2 -Right bank scour (5/16/16)

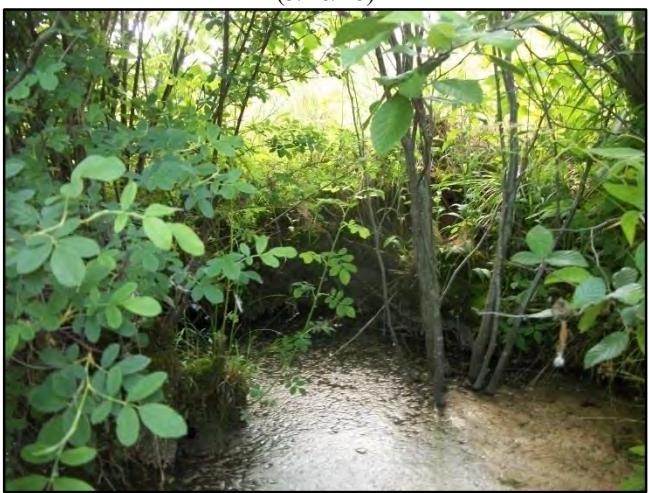
Bank Scour & Engineering Structures - Rootwad and Log Sill Failure	18+30 to 18+45	Localized scour along the left bank behind root wads is causing the root wads to separate from the bank and has compromised the log sill tie-in.	SPA5-4 & 5-7				
Bank Scour	18+60 to 18+75	Localized scour along the left bank diverting water behind bank toe and discharge downstream.	SPA5-8				
	SFHC Reach 2						
Feature Issue	Station No.	Suspected Cause	Photo Number				
Undercut Banks & Engineering structures - Rootwad & Log Sill Failure	20+20 to 20+40	Rootwad failure and undercut banks along the left bank immediately downstream of log sill invert/left bank tie-in. Appears to be caused by bank scour upstream and beneath the rootwad resulting from flow (velocity vector) directed at the left bank by log sill orientation which eventually undermined the rootwad and the log sill. The root wad and the sill's header log are still tied-in to the bank; however, it appears that the sill's header and footer have separated. Currently the header log is suspended across the channel above the surface water elevation.	SPA4-1 & 5-5

SPA5-4 – Bank scour along left bank behind root wads (5/16/16)

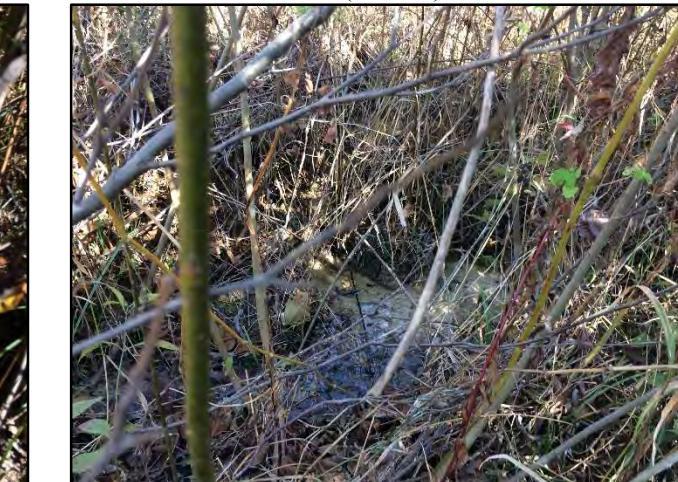
SPA 5-7 – Bank scour from SPA5-4 has led to water to be diverted behind the bank toe and discharging downstream (10/19/16)

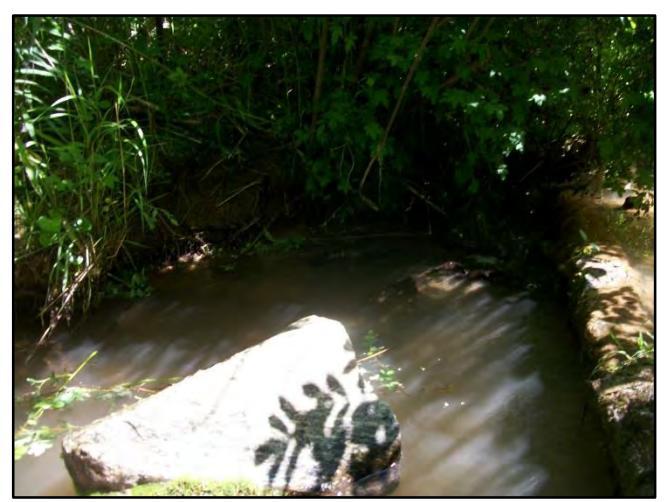
Undercut Banks 20+45		Undercutting of right bank between root wads immediately downstream of compromised log sill. Appears to be a localized area of high near bank stress caused by flow (velocity vector) directed at the right bank.	SPA5-6				
Undercut Bank & Engineering structures - Rootwad Failure		Rootwad failure along right bank due to undercutting along bank. Appears to be caused by high near bank stress caused by flood flow stream energy vectors being directed at bank.	SPA4-2

SPA5-6 – Undercut bank causing erosion around root wad (5/16/16)

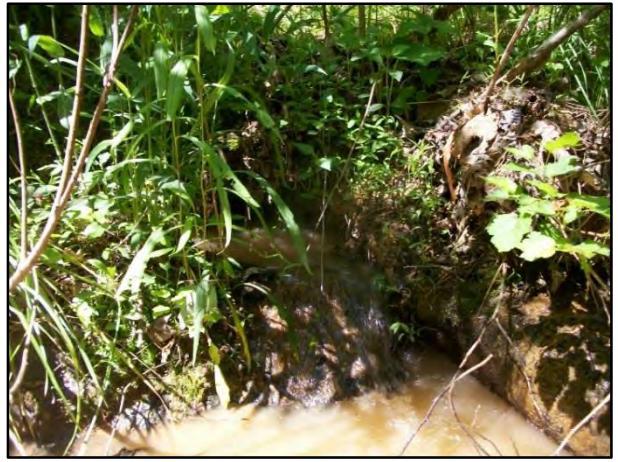
SPA1-5 – Piping within riffle cascade around log sill

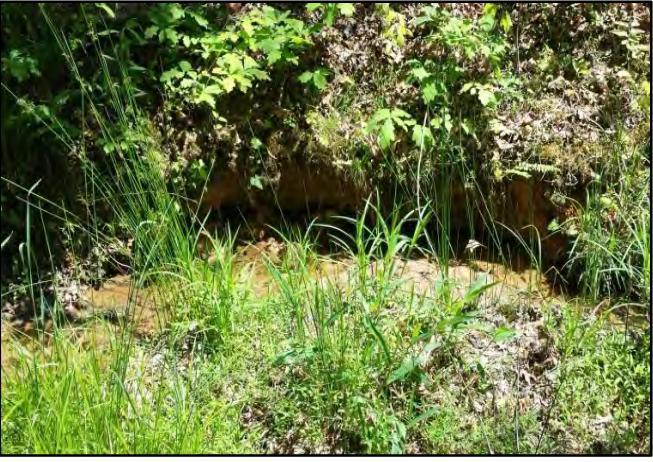
SPA4-3 – Small area of bank left bank erosion.

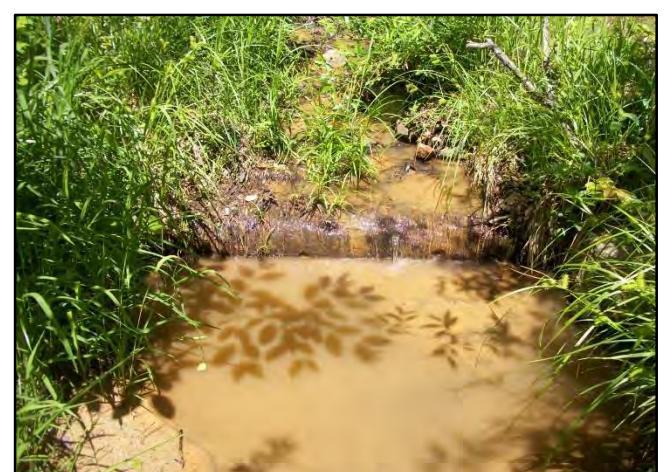
SPA5-1 –Pool below log sill is filling with sediment (5/16/16)

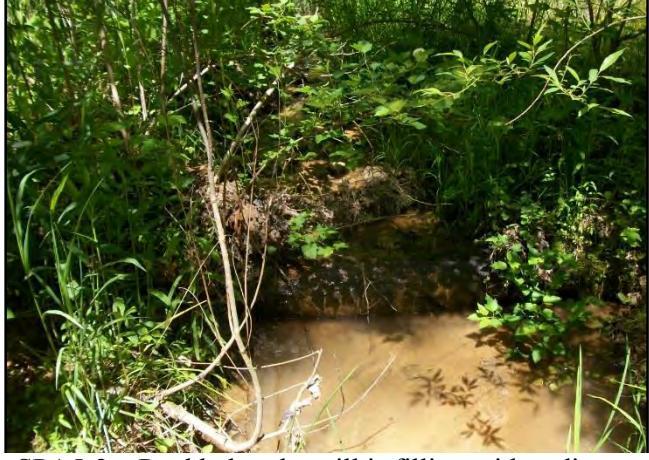
Table 5e cont. Stream Problem Areas Hoppers Creek-Melton Farm Stream Restoration Project: Project No. 92251							
South Fork Hoppers Creek (SFHC) Reach 1							
Feature Issue	Station No.	Suspected Cause	Photo Number*				
UT2 Reach A							
Feature Issue	Station No.	Suspected Cause	Photo Number				
Bank Scour	12+36.50 to 12+53.50	Left bank scour on outside bend. Appears to be caused by high near bank stress during bankfull storm events.	SPA4-3				
Engineered Structure/Aggradation	12+92	Step pool filling with sediment. Most likely to be from upstream sediment supply moving through the system.	SPA5-1				
Piping	13+40	Flow piping within riffle cascade and around downstream log sill due to possible tear in filter fabric or lack of sealing from re-sorting of alluvial material and silt.	SPA1-5				
Engineered Structure/Aggradation	13+42	Step pool filling with sediment. Most likely to be from upstream sediment supply moving through the system.	SPA5-2

SPA5-2 – Pool below log sill is filling with sediment (5/16/16)

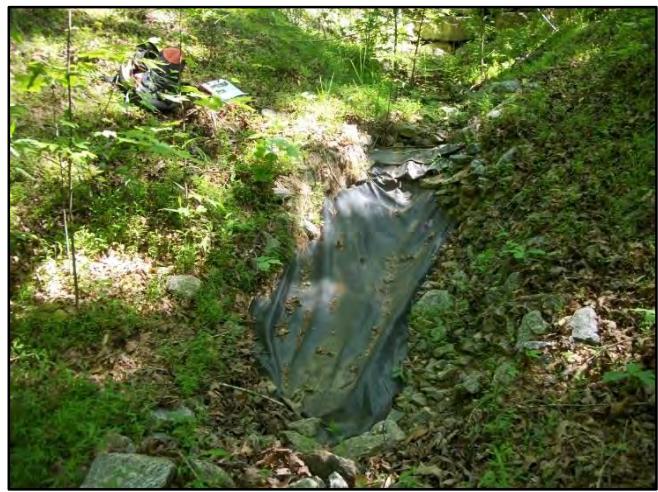
SPA1-6 – Ephemeral drainage channel bed erosion (5/16/16)

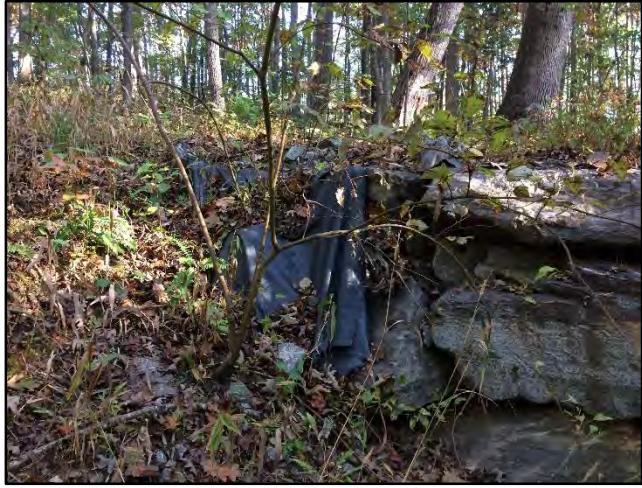
SPA5-11 – Scour around boulder tie-in on first boulder sill of ephemeral drainage channel (10/19/16)

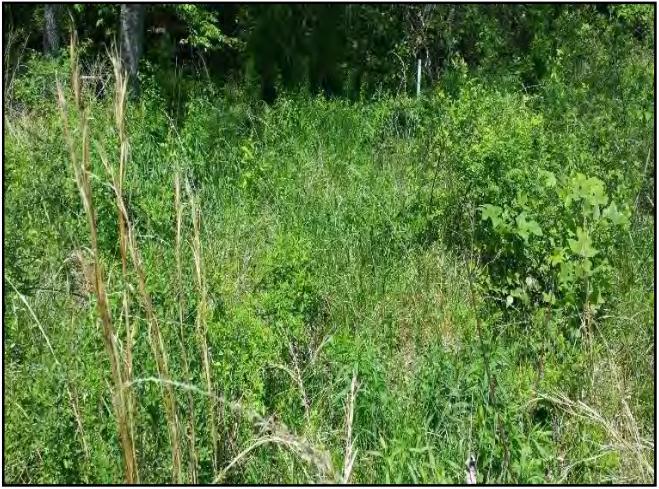
VPA4-3 – Multi-flora rose and Japanese honeysuckle UT1B

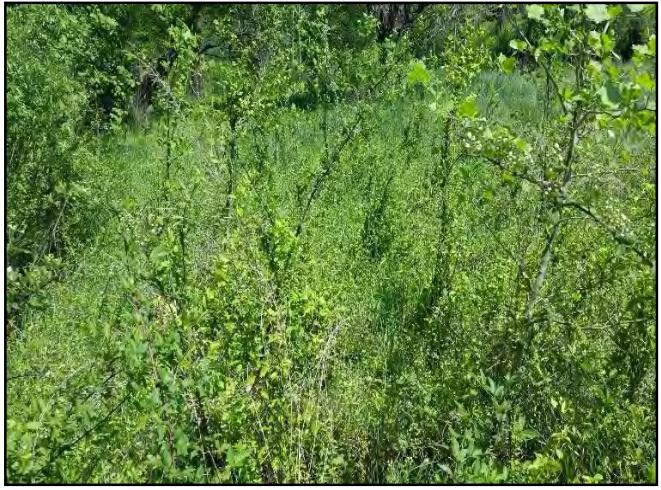
VPA4-5 – Japanese honeysuckle in left floodplain

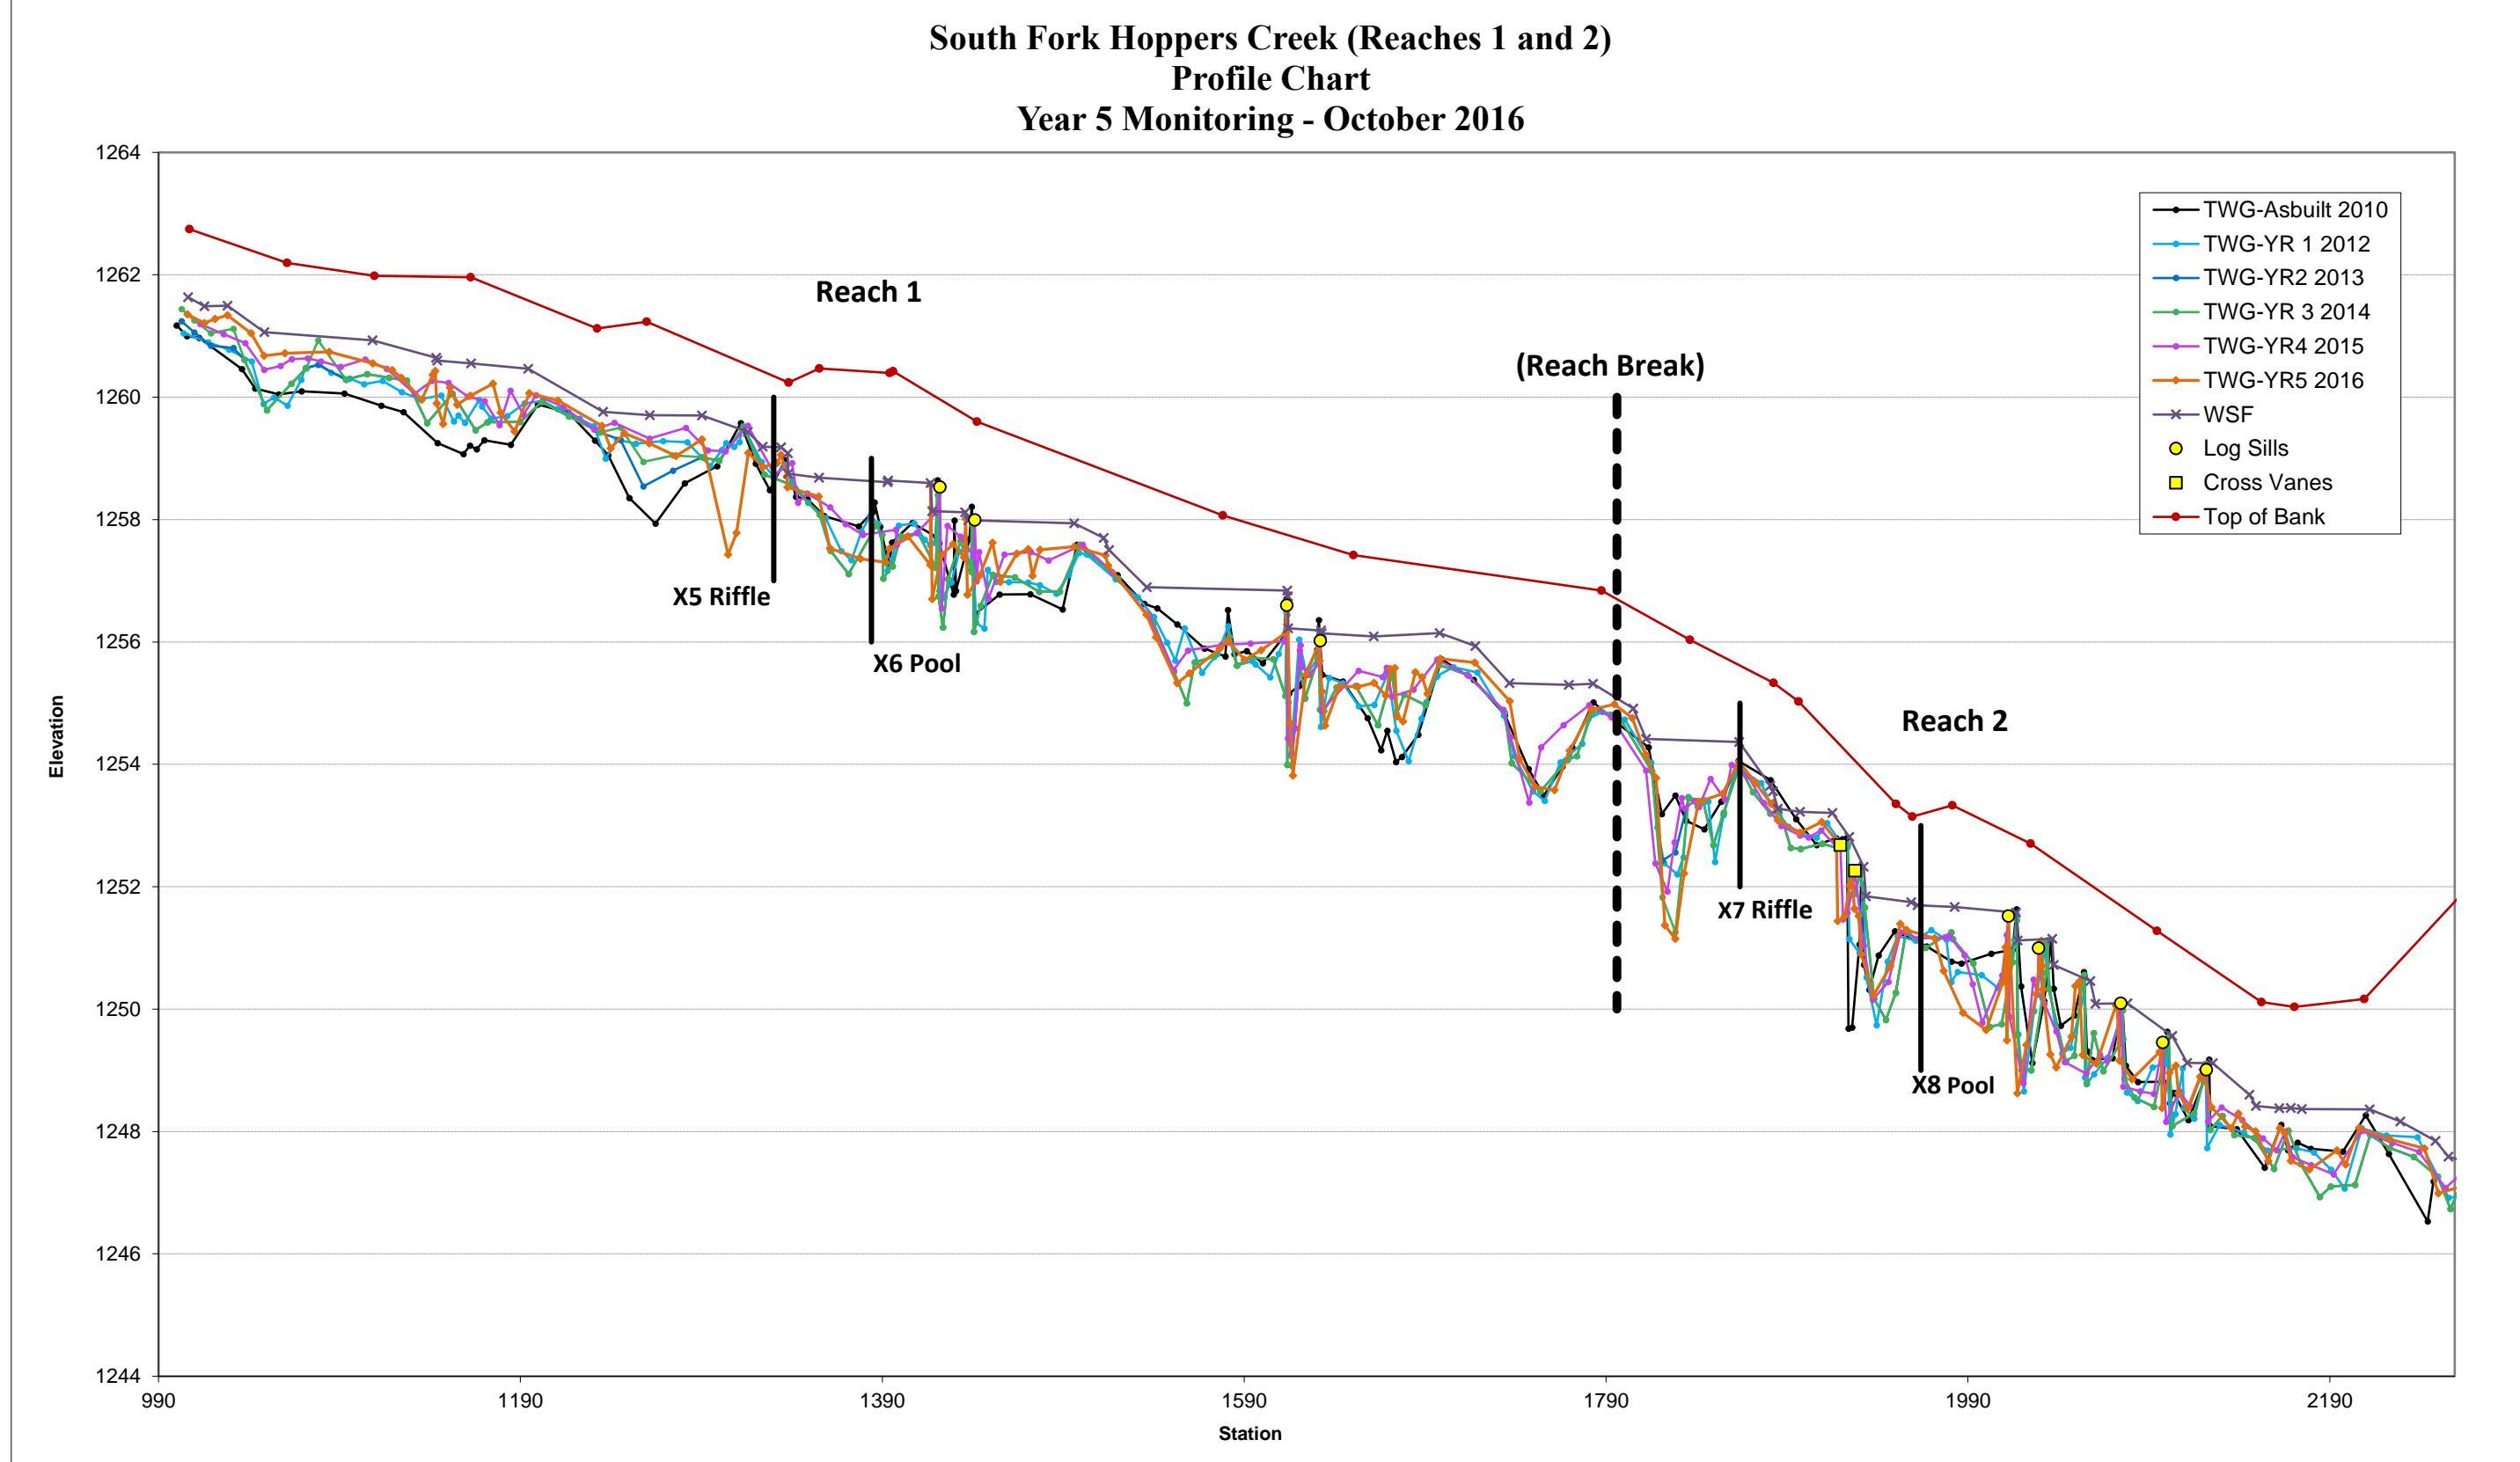
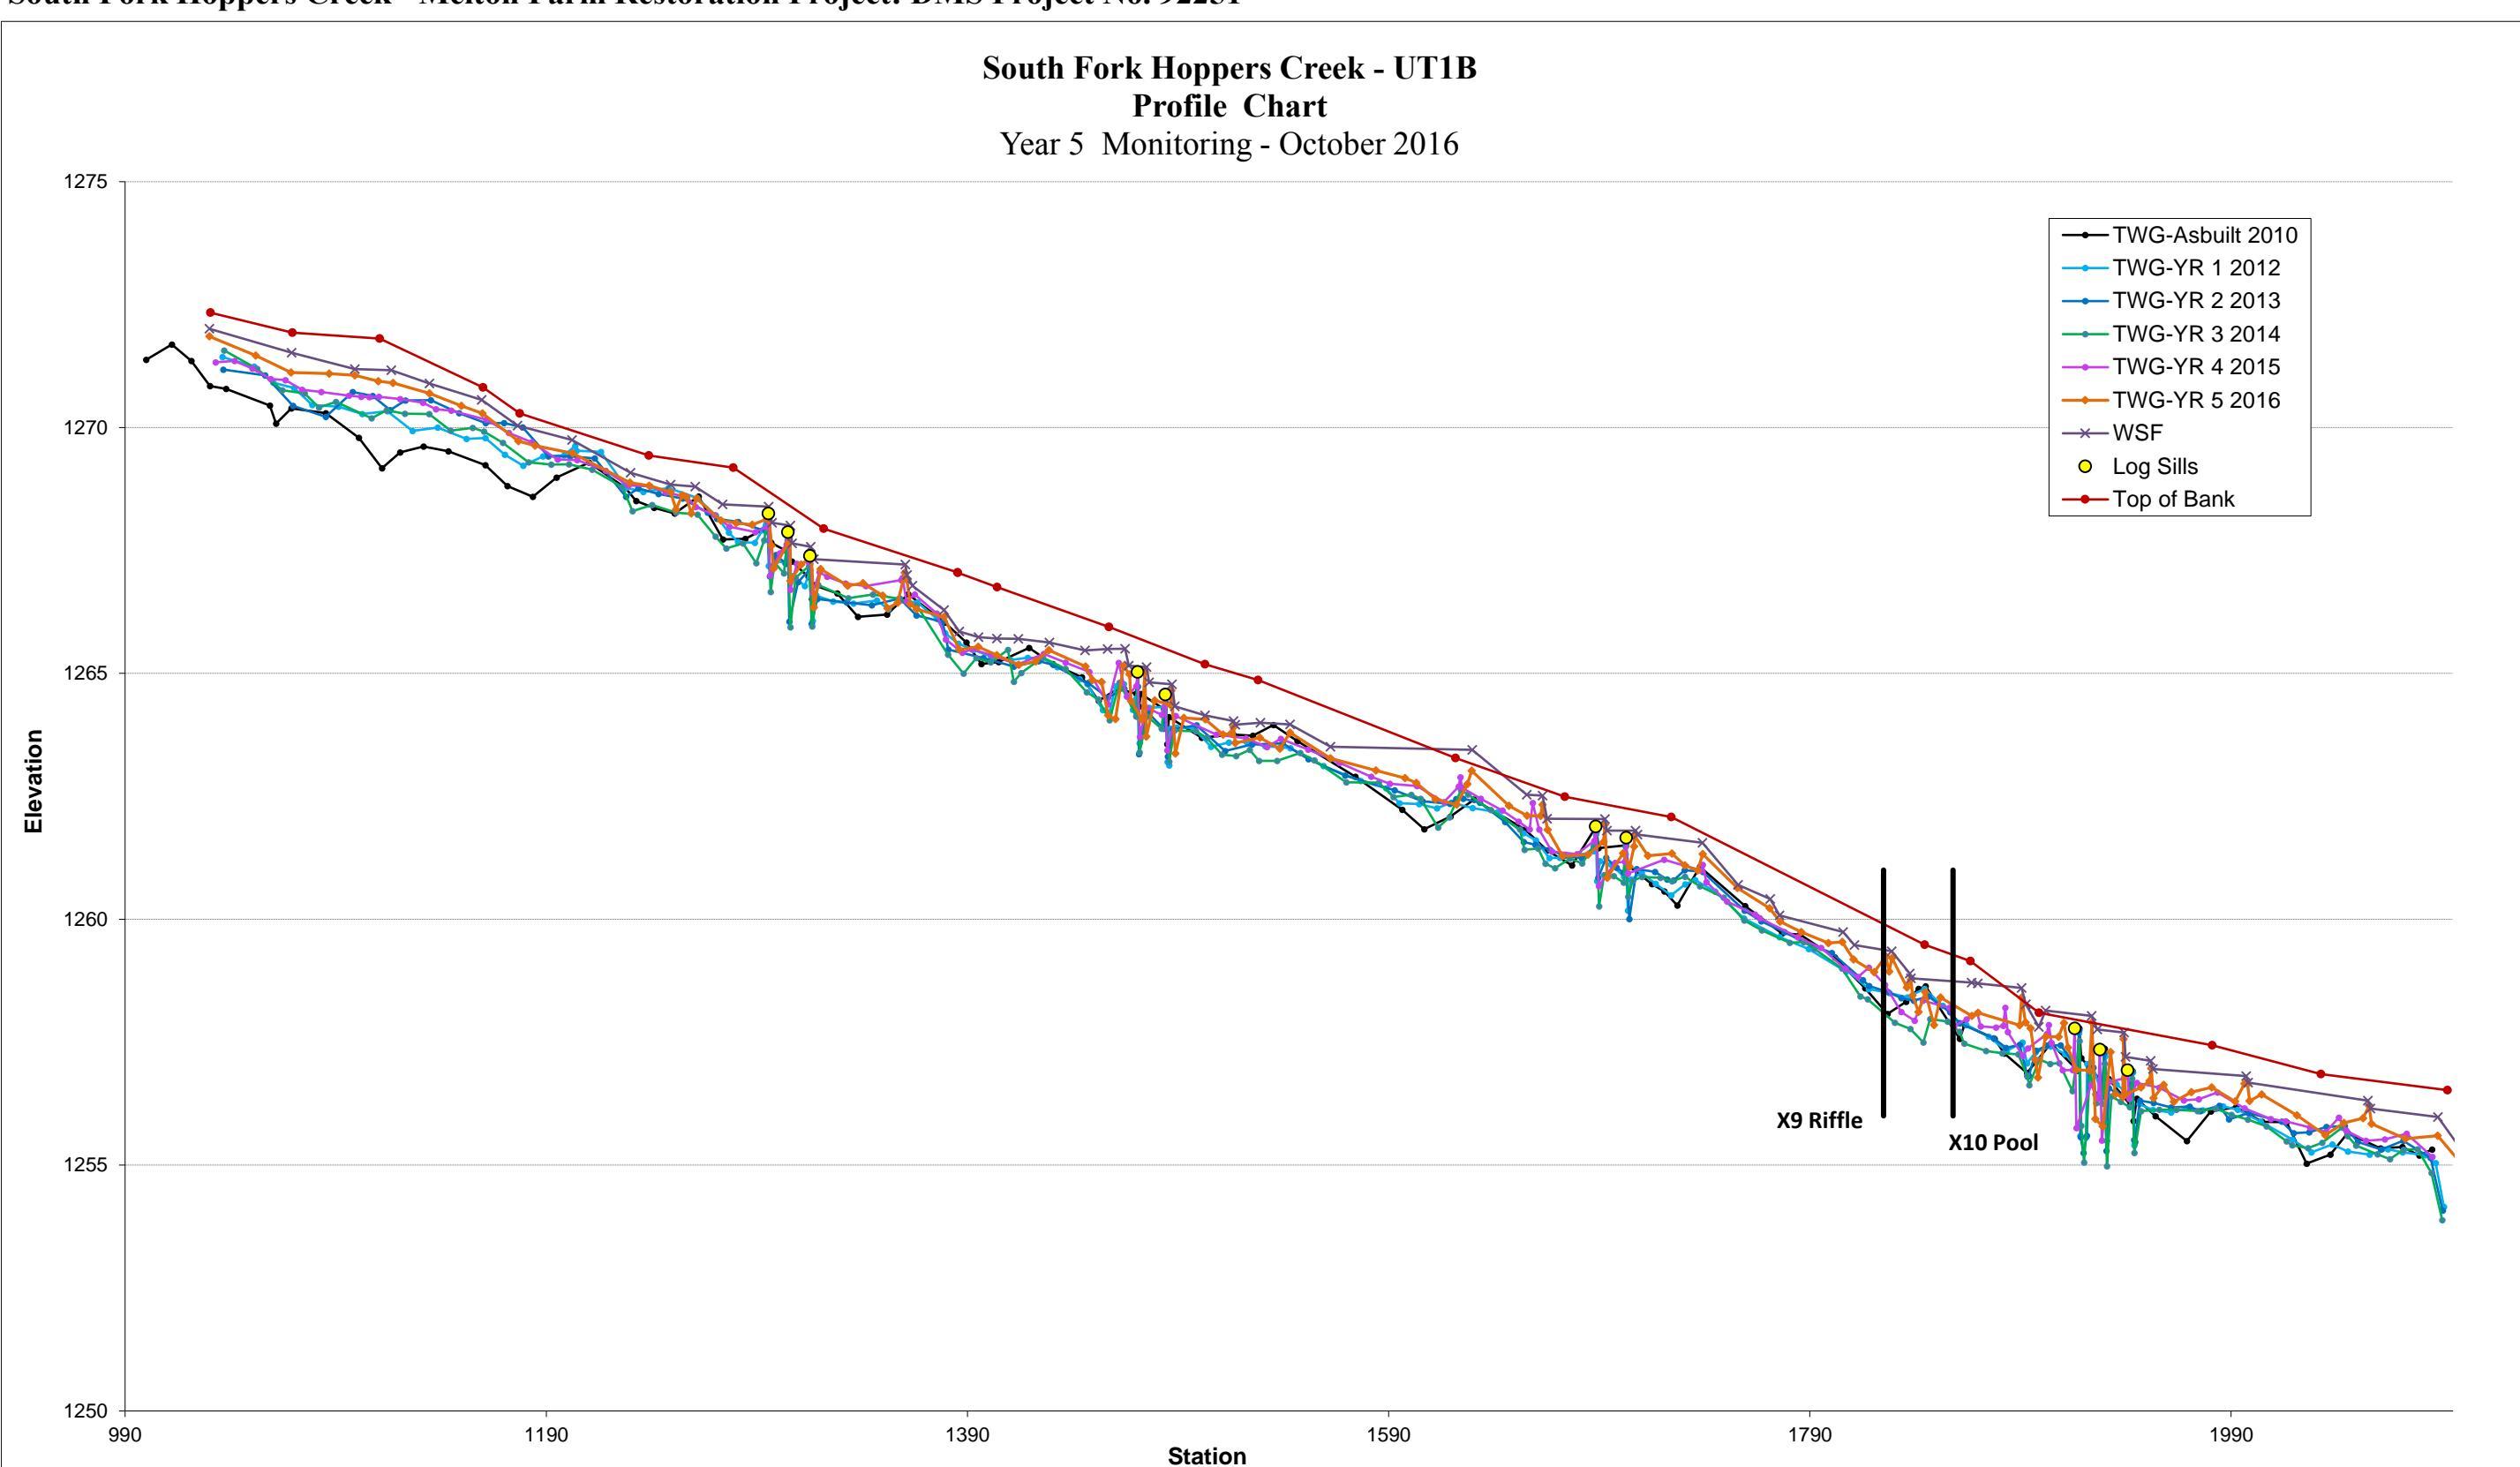
Figure 4 Cont. Longitudinal Profiles with Annual Overlays South Fork Hoppers Creek - Melton Farm Restoration Project: DMS Project No. 92251

The longitudinal profiles show that bed features are stable. Pools are well maintained with only minor filling in the upstream sections of Reach 1 and UT1B, which is most likely due to the natural movement of sediment through the system in areas where the channel gradient is low and the floodplain remains inundated throughout much of the year. Grade control structures (constructed riffles, cross vanes and log sills) continue to help maintain the overall profile desired. As depicted in Figure 4, overall longitudinal profiles for Reach 1, 2, and UT1B have remained geomorphically stable throughout the post-construction five year monitoring period.

Longitudinal profiles were surveyed for the entire restored lengths of Reaches 1 and 2 of South Fork Hoppers Creek and UT1B, and are provided in Figure 4 of Appendix D. Longitudinal profiles were replicated annually during the five year monitoring period.
