South Fork Hoppers Creek - Melton Farm Stream Restoration Project Year 5 Monitoring Report

McDowell County, North Carolina

NCDMS Project Number – 92251

<u>Site Assessment Report – Monitoring Year 5</u>

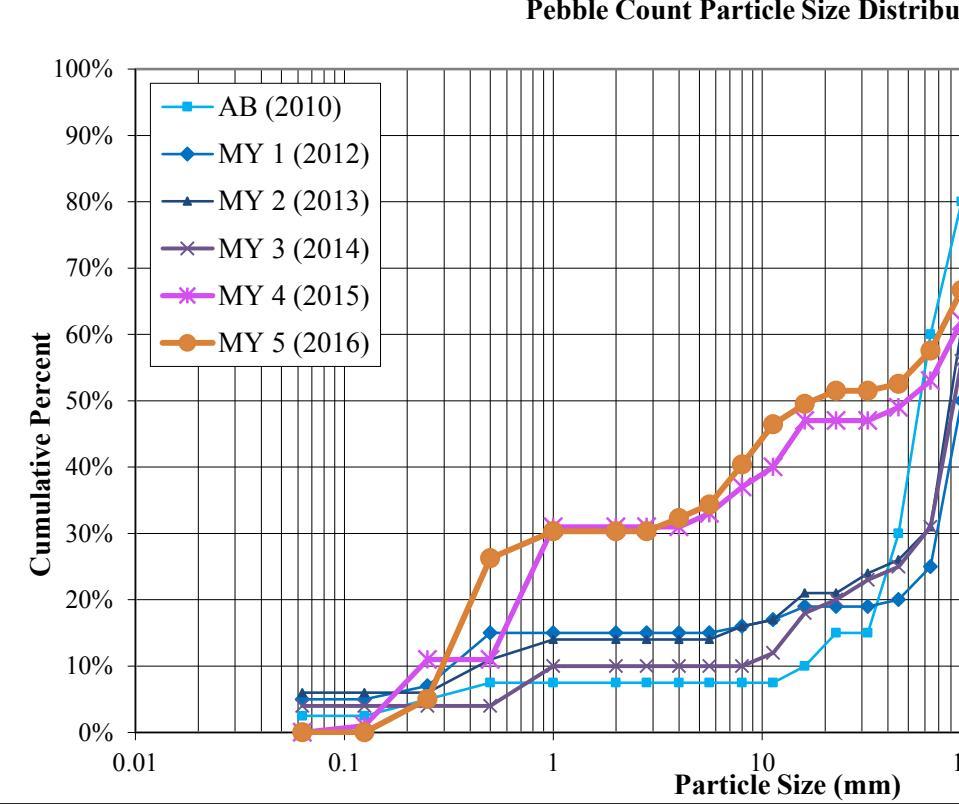
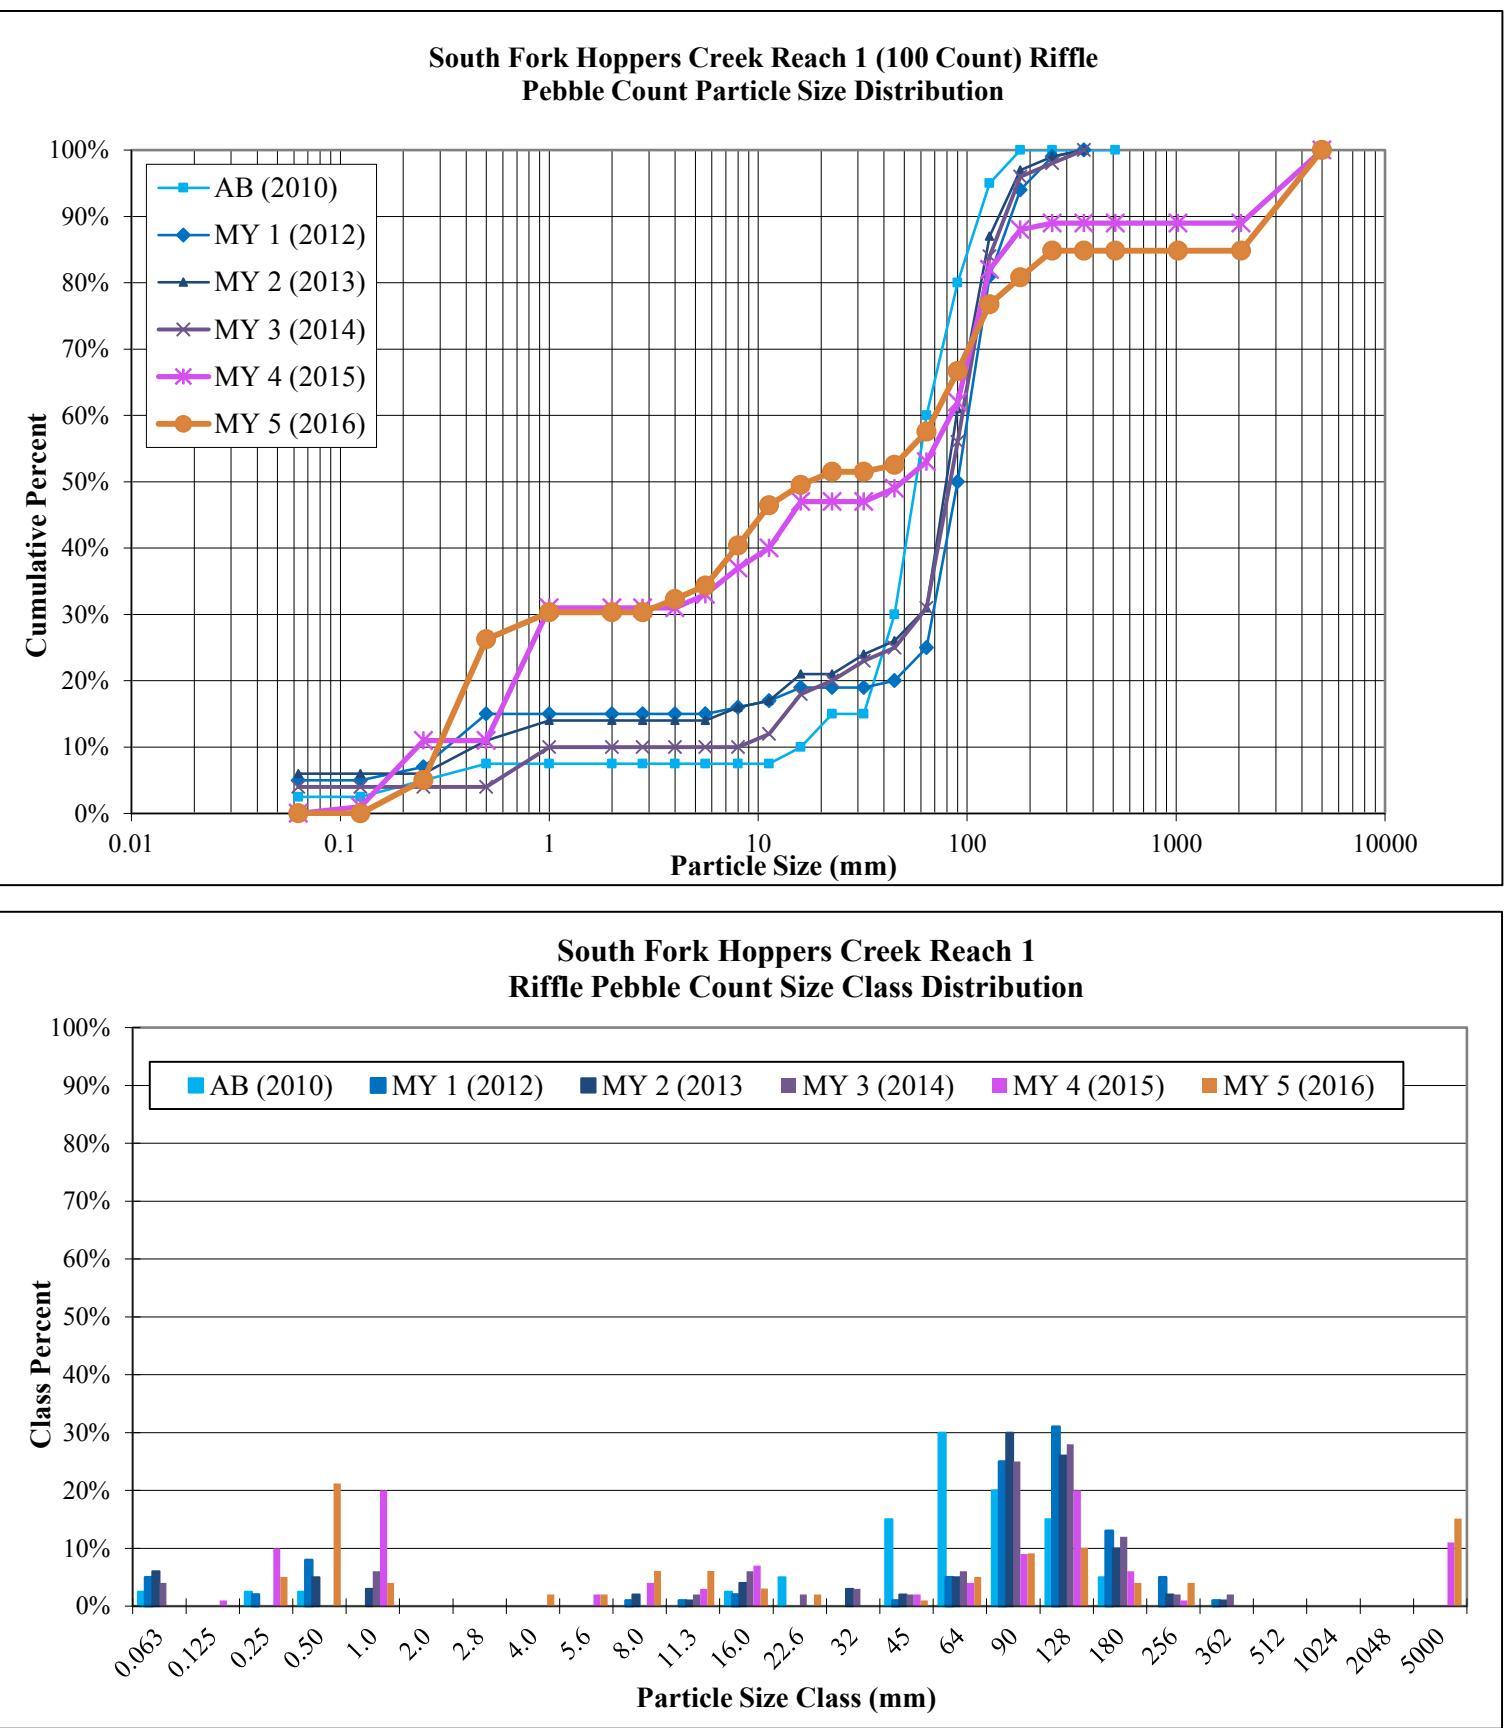
#### Figure 5a. Riffle Pebble Count Size Class Distribution with Annual Overlays South Fork Hoppers Creek - Melton Farm Restoration Project: DMS Project No. 92251

Visual observations and a review of pebble count data collected during Year 5 monitoring did not yield any signs that sediment transport functions have been hampered by the mitigation project. The pebble count data for South Fork Hoppers Creek and UT1B indicate that the stream is moving fines through the system and a mix of substrates make up the bed material. Pebble count data is provided in Figures 5a - 5c in Appendix D.

Bed load material analysis consists of a pebble count taken in the same constructed riffle during annual geomorphic surveys of the Project site. One sample was collected at the riffle cross-section corresponding with each of the three restored Project reaches for a total of three sediment samples (cross-sections X5, X7, X9). These samples, combined with evidence provided by changes in cross-section and profile data will reveal changes in sediment gradation that occur over time as the stream adjusts to upstream sediment loads. Significant changes in sediment gradation were evaluated with respect to stream stability and watershed changes. Bed material distribution data are located in Figure 5 of Appendix D.

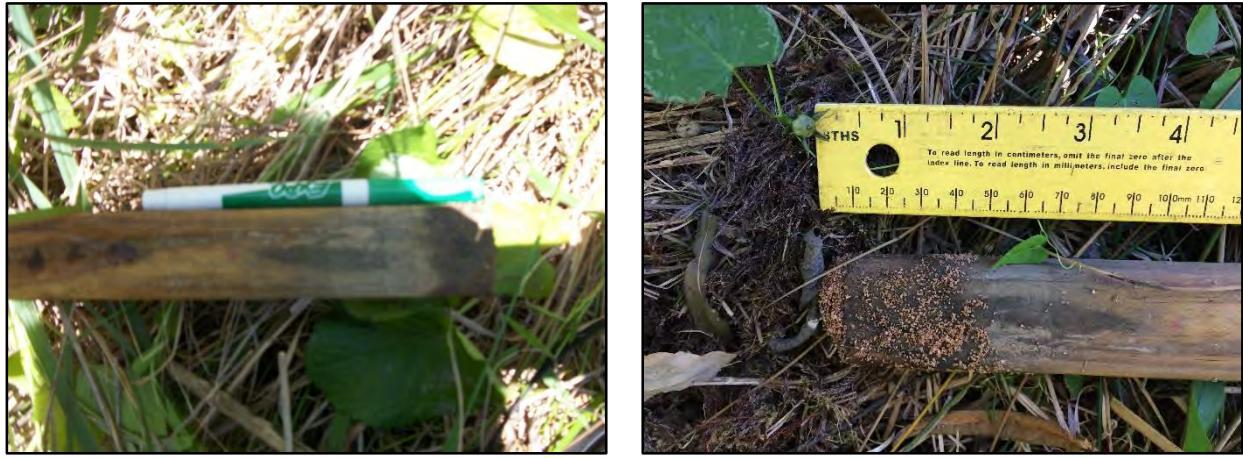
# South Fork Hoppers Creek – Bankfull Photolog

Crest Gauge Photo (5/16/16)

Crest Gauge Photo (10/19/16)
