Monitoring Report
FINAL VERSION
Horne Creek Tributaries Mitigation Project
Monitoring Year 2
Calendar Year of Data Collection: 2021

NCDEQ DMS Project Identification # 100026
NCDEQ DMS Contract # 7181
Yadkin River Basin (Cataloging Unit 03040101)
USACE Action ID Number: SAW-2017-01510
NCDEQ DWR Project # 2017-1156
Surry County, NC
Contracted Under RFP # 16-006993
Data Collection Period: October 2021
Submission Date: December 2021

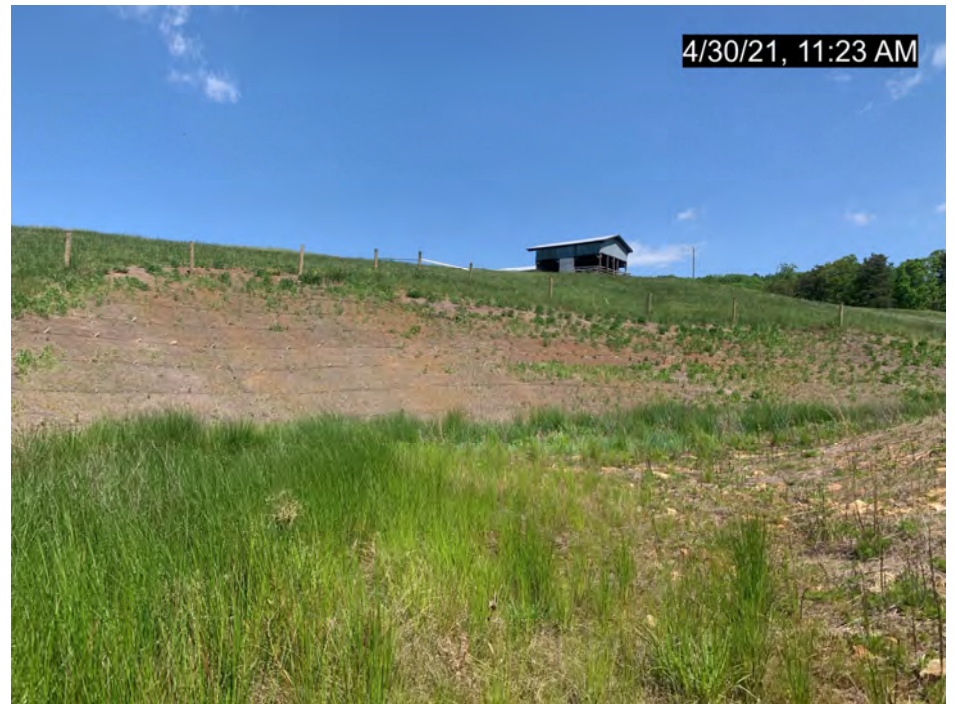
PS-7, R4, Right Floodplain Slope (MY-01)

- Todd noted erosion from the field on R5 in one spot and asked it be closely monitored. Emily responded that we are monitoring this area and have done seeding/livestaking. Erin asked if WLS takes photos of this area. Emily responded that photos are included in monitoring reports.

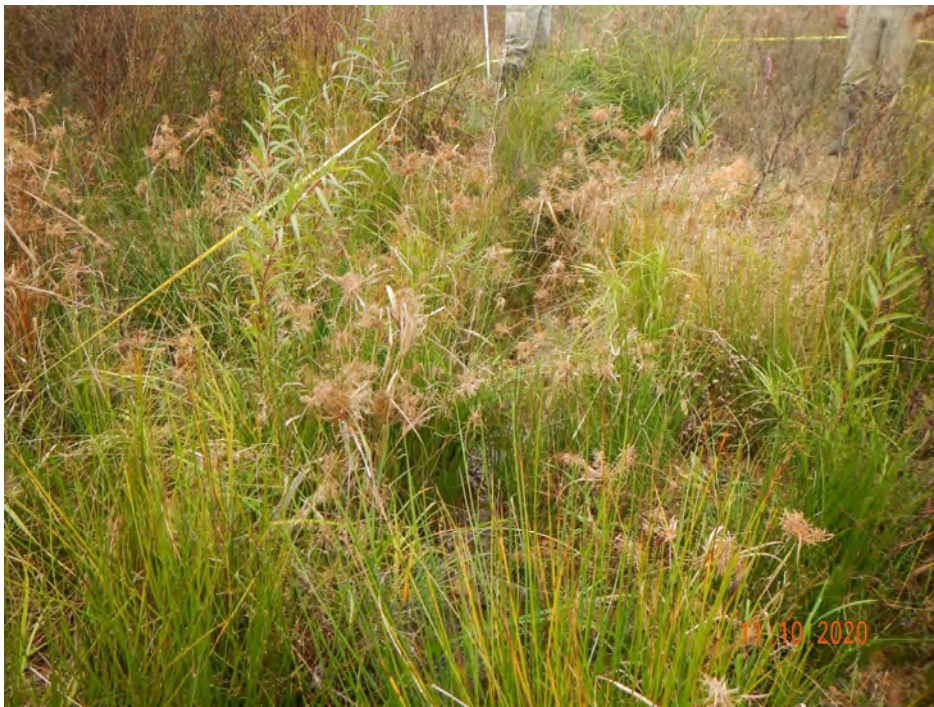
SPA5, R5 Left Floodplain, Minor Erosion (MY-02)

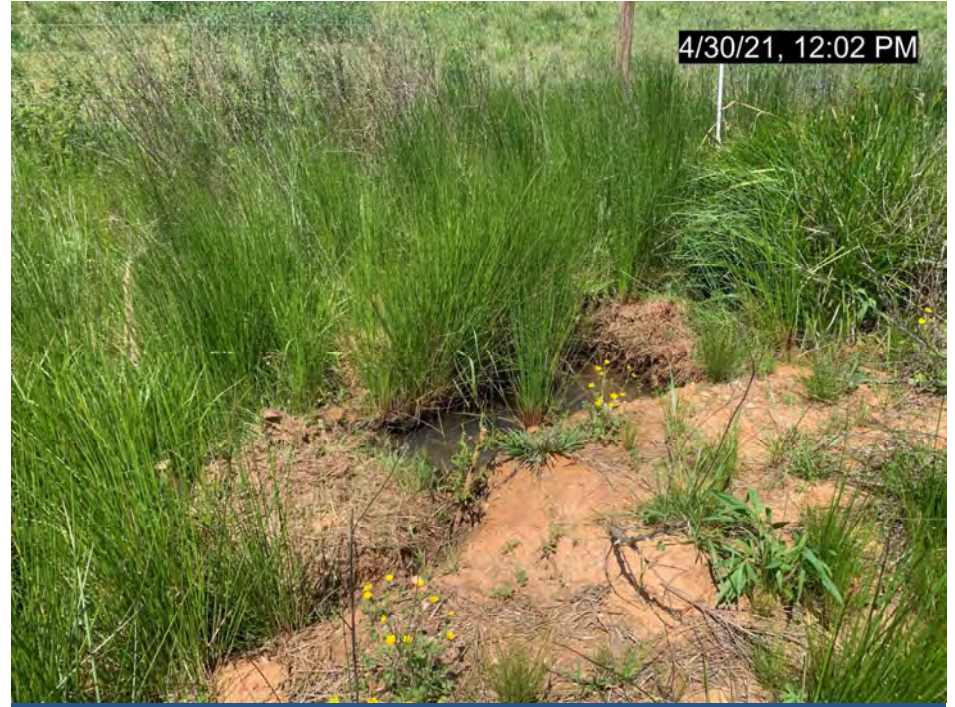
SPA6, R5 Right Floodplain, VP10, Secondary Channelization (MY-01)

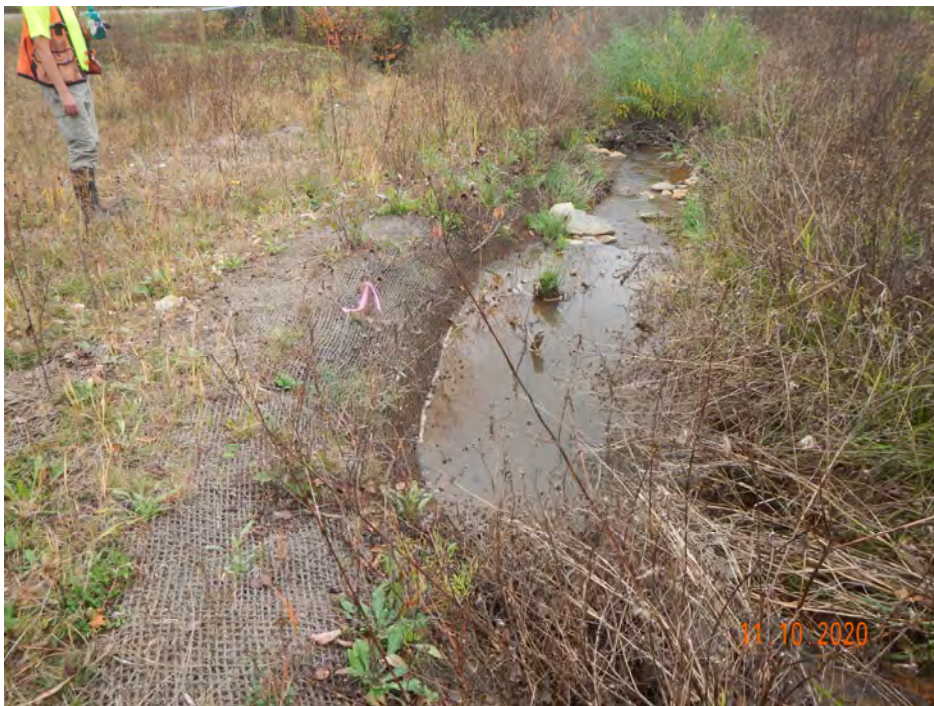
SPA6, R5 Right Floodplain, VP10, Secondary Channelization (MY-02)

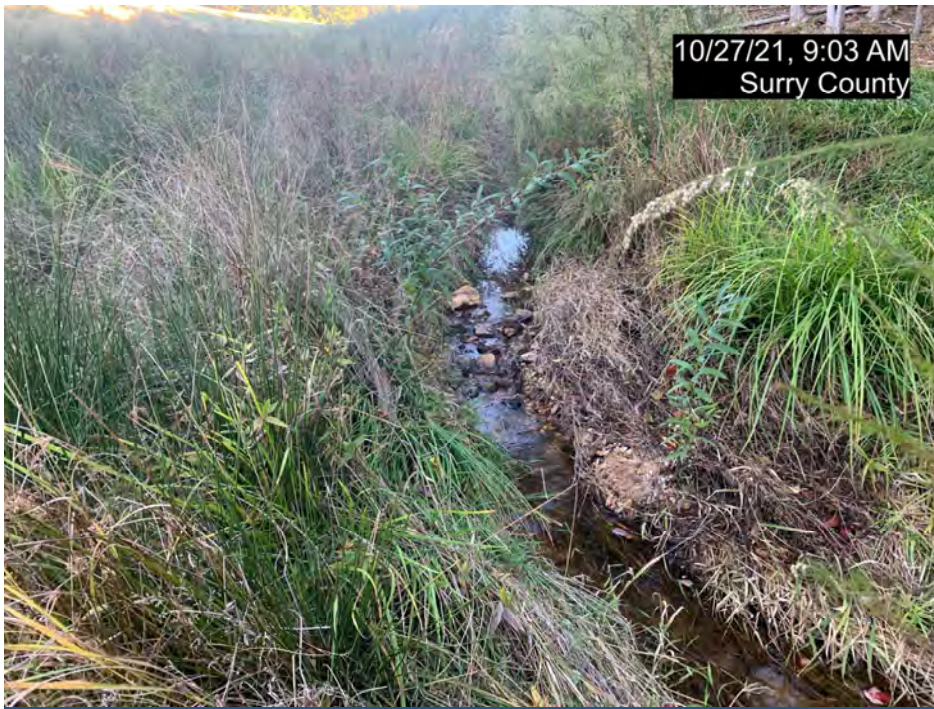
SPA7, R5 Left Bank, Functioning at Risk (MY-02)

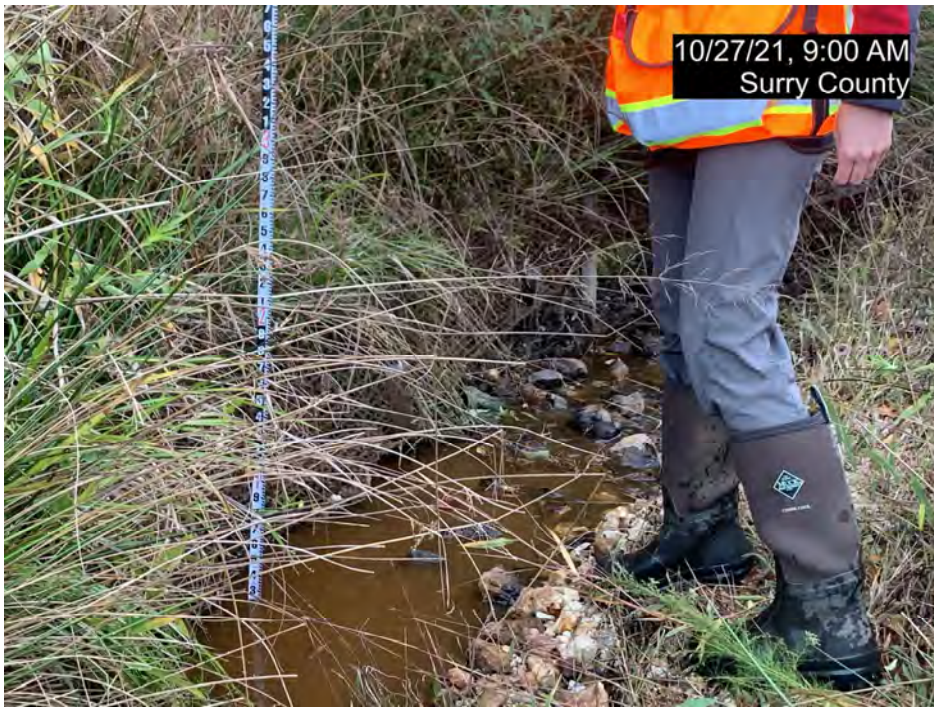
SPA8, R4, STA 20+75, Channel Bed Erosion (MY-02)

- Todd noted the new stream problem area on R4 (riffle blown out and channel cut down) should be monitored closely. Daniel responded the area will be monitored and supplemental cross section data will be included in MY2 report.
- Todd asked if any rilling was occurring under the blanket of the large right slope on R4. Emily responded that no rilling is occurring and herbaceous vegetation is slowly establishing.
- Erin asked if trees are growing on the large right slope of R4. Emily responded that trees are there, they are just difficult to see.

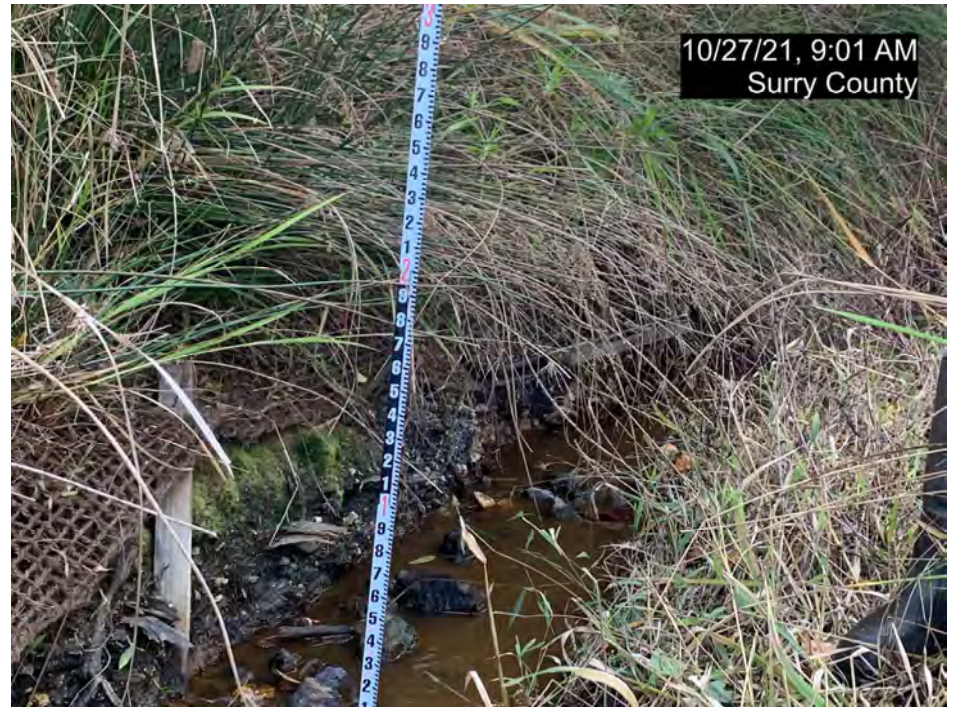
SPA8, R4, STA 20+75, Channel Bed Erosion (MY-02)

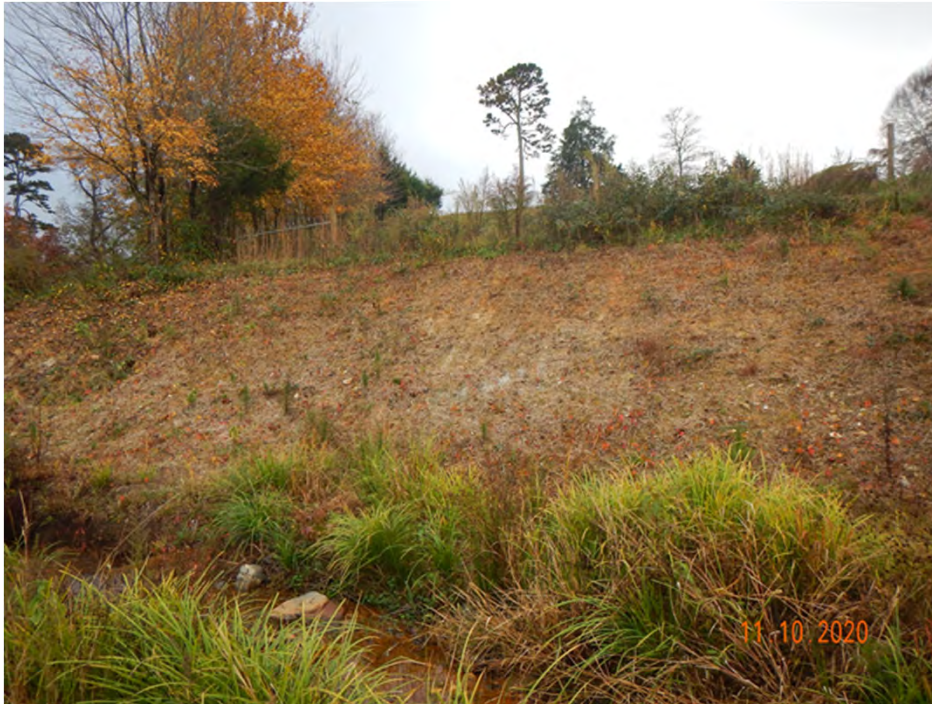
SPA8, R4, STA 20+75, Channel Bed Erosion (MY-02)

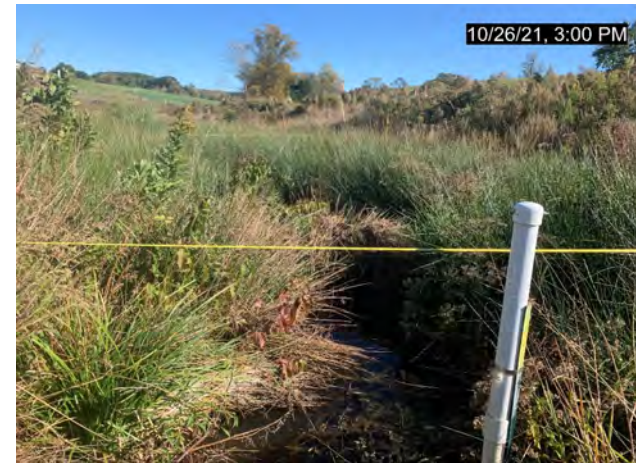
XS-1 Pool, STA 12+85

Dimension Data Summary: MY2 2021	
Bankfull Elevation (ft)	944.1
Low Bank Height Elevation (ft)	944.6
Bankfull Max Depth (ft)	2.1
Low Bank Height (ft)	2.6
Bank Height Ratio	1.24
Bankfull X-section Area (ft ²)	11.1
% Change Bank Height Ratio	24.0%

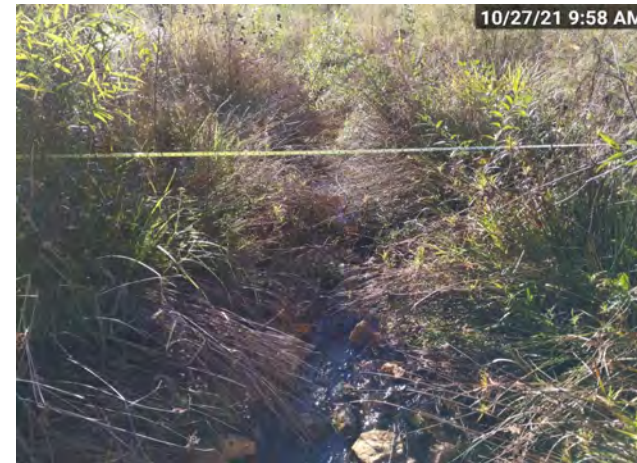
Project Name	Horne Creek Tributaries Mitigation Project
Project ID	100026
Reach ID	R5
Cross Section ID	XS-10
Field Crew	K. Obermiller, C. Durham

Dimension Data Summary: MY2 2021	
Bankfull Elevation (ft)	950.7
Low Bank Height Elevation (ft)	951.3
Bankfull Max Depth (ft)	1.4
Low Bank Height (ft)	2.0
Bank Height Ratio	1.41
Bankfull X-section Area (ft²)	6.9
% Change Bank Height Ratio	41.0%

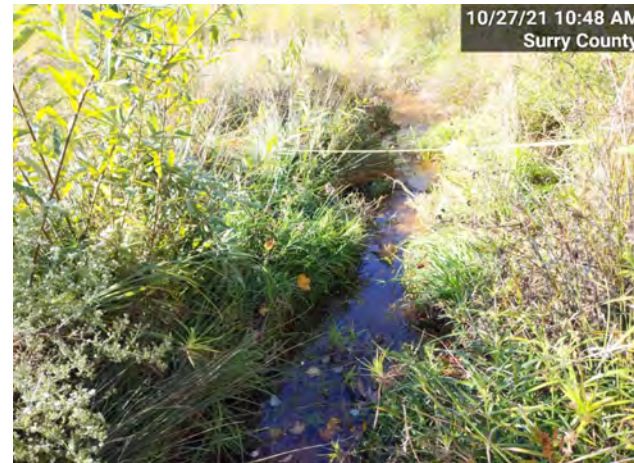
XS-12 Riffle, STA 32+88

Dimension Data Summary: MY2 2021	
Bankfull Elevation (ft)	935.8
Low Bank Height Elevation (ft)	936.2
Bankfull Max Depth (ft)	1.3
Low Bank Height (ft)	1.8
Bank Height Ratio	1.34
Bankfull X-section Area (ft²)	4.5
% Change Bank Height Ratio	34.0%

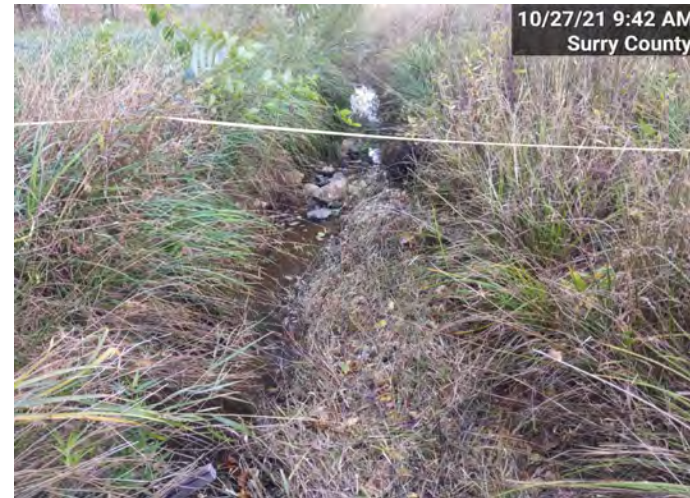
Project Name	Horne Creek Tributaries Mitigation Project
Project ID	100026
Reach ID	R4
Cross Section ID	SPA-8
Field Crew	K. Obermiller, C. Durham

Dimension Data Summary: MY2 2021	
Bankfull Elevation (ft)	961.9
Low Bank Height Elevation (ft)	962.4
Bankfull Max Depth (ft)	1.8
Low Bank Height (ft)	2.3
Bank Height Ratio	1.30
Bankfull X-section Area (ft²)	*4.9

*SPA-8 Bankfull area was estimated off design parameters for constructed rock riffles on R4
