# Lick Creek Stream Restoration Site MONITORING REPORT 2008 (Year 3)

Cataloging Unit: 0303004 EEP Contract #: D04013-1

**November 20, 2008**

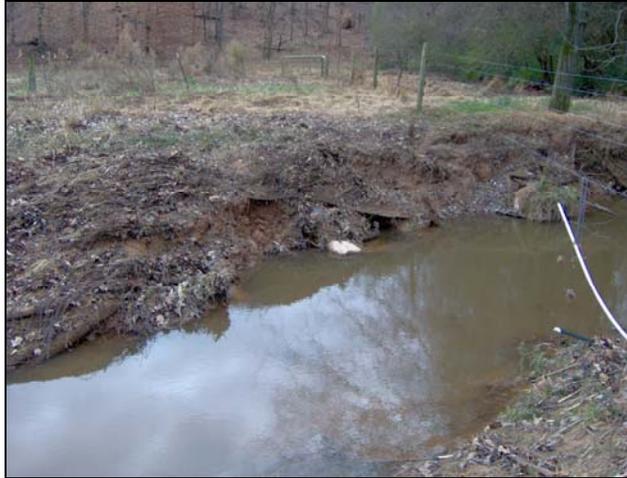
Bank Erosion at Wallace Branch, STA 10+00 12/03/06  
Photo No. 19

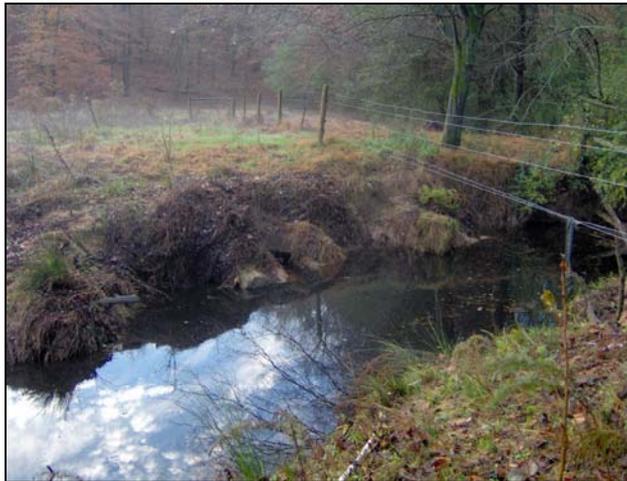
Bank Erosion at Wallace Branch, STA 10+00 11/27/07  
Photo No. 20

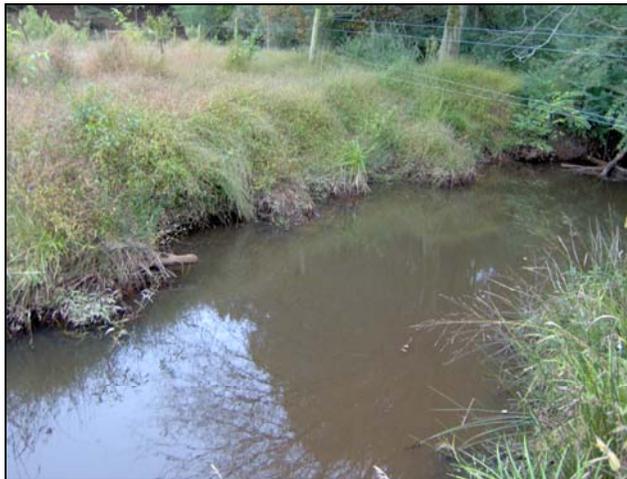
Bank Erosion at Wallace Branch, STA 10+00 10/24/08  
Photo No. 21

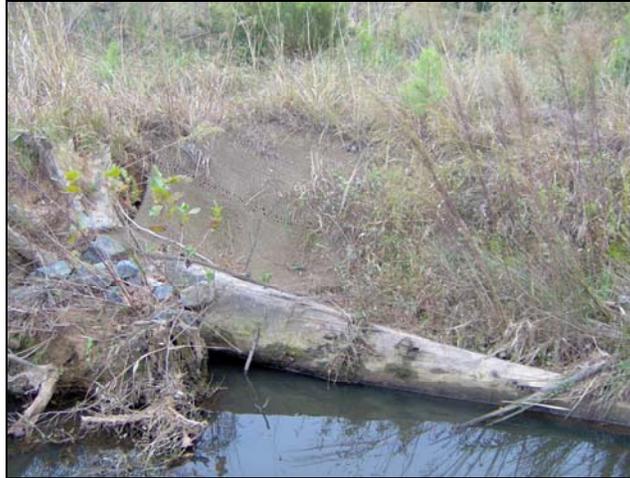
Piping at Log Vane on Wallace Branch, STA 29+50 10/24/08  
Photo No. 22
