Monitoring Report Year 2 FINAL Little Buffalo Creek Stream Mitigation Project

NCDEQ-DMS Project Number: 94147 Contract Number: 2029 USACE Action ID: 2014-0386 DWR Permit: 14-0129 Cabarrus County

Data collection: September 2016 Submitted: March 2017

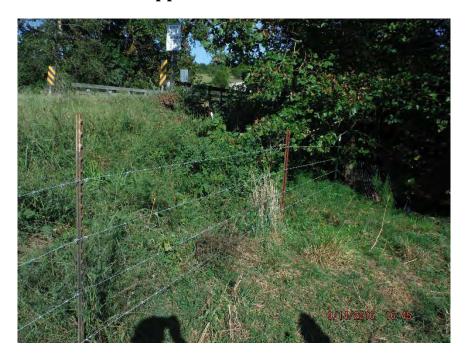
Barbed wire fence installed at Old Mine Rd.

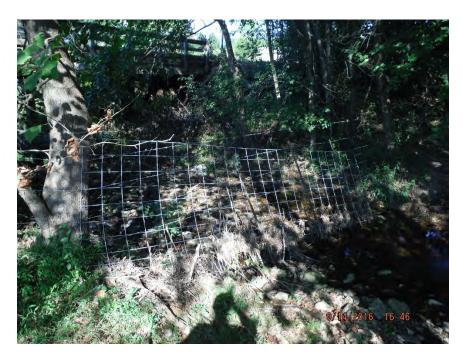
Fence installed across mainstem at Old Mine Rd. has since been removed. Upstream view.

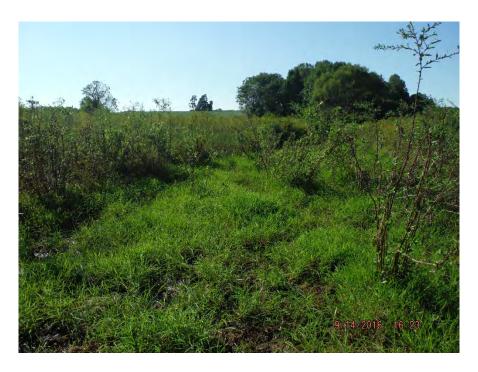
UT2 – Lower trib filled in with mud due to cattle trampling. Upstream view.

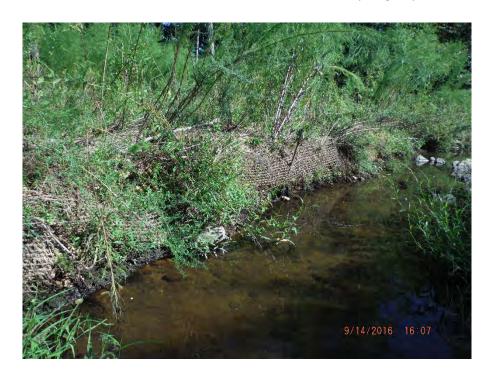
Headcut forming on bank in the middle mainstem. Downstream view.

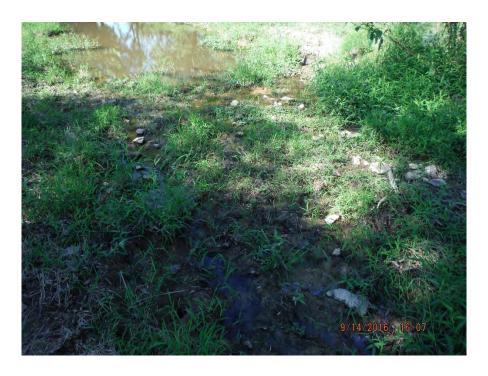
Fill in middle mainstem due to cattle trampling. Upstream view.

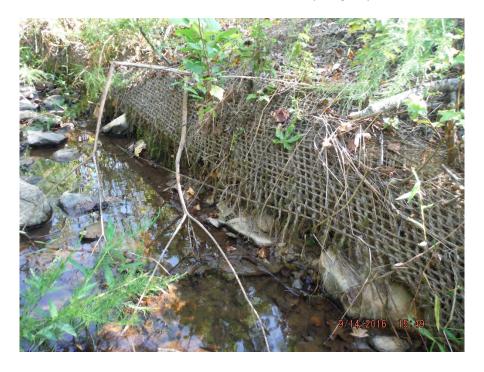
UT4 – Minor undercut in toe of bank. Upstream view.

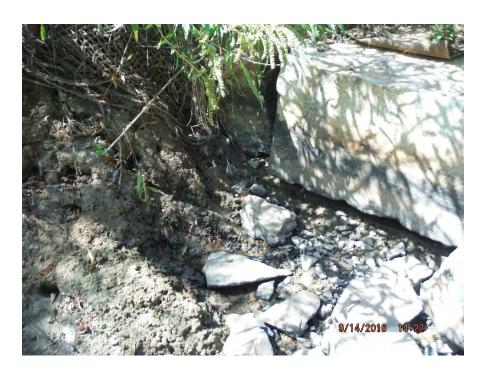
UT7 – Water beginning to move under stone blocks in step pools.

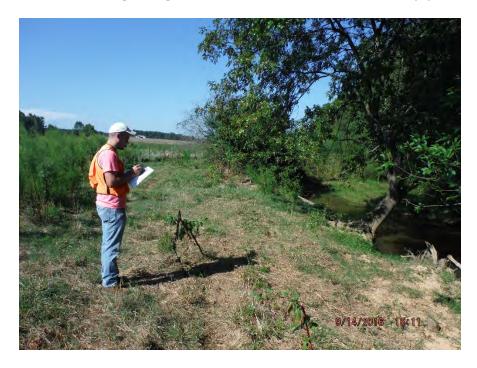
Heavy grazing by cattle along reach 3. Upstream View. Herbaceous vegetation and planted trees affected.

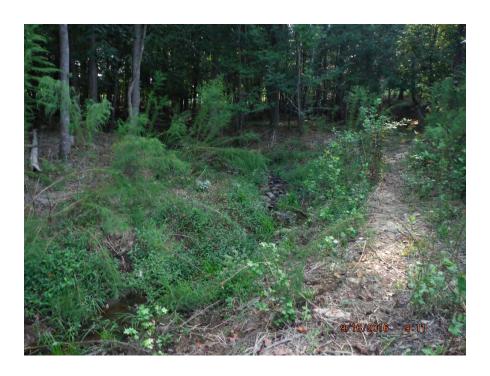
UT4 – Cow path and grazing at top of trib. Upstream view.

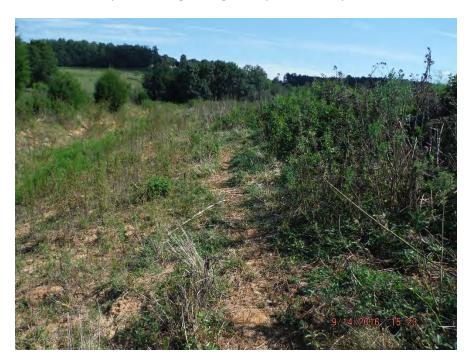
UT3 – Cow path and heavy grazing along UT3. Downstream view.

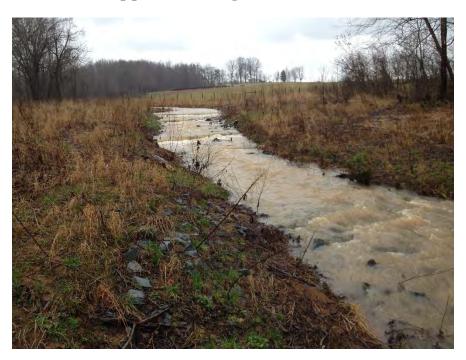
UT7 – Lower step pool section. Rock debris in floodplain. February 2016.

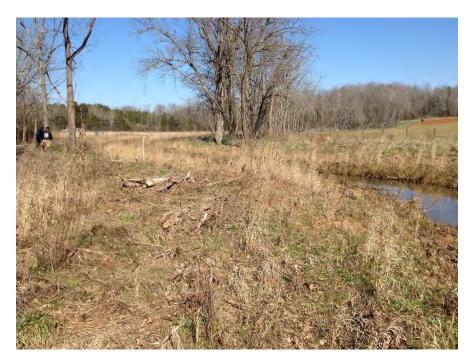
UT7 – Lower section before step pools. Rack deposits after bankfull event. February 2016.

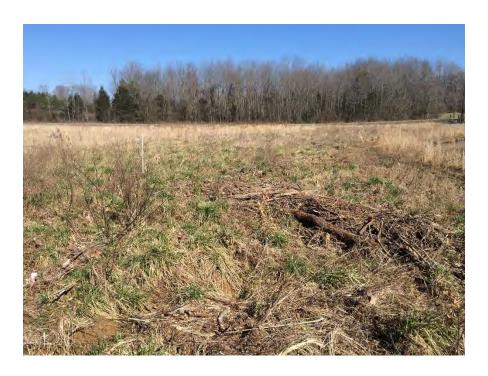
UT7 – Rack deposits in Veg Plot 1 after bankfull event. February 2016.

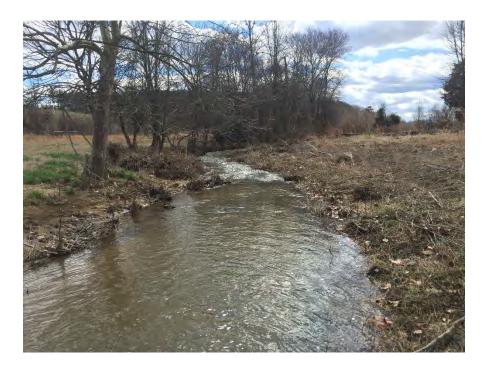
Mainstem – Concrete removal section, vegetation above bankfull bent to direction of flow. February 2016.

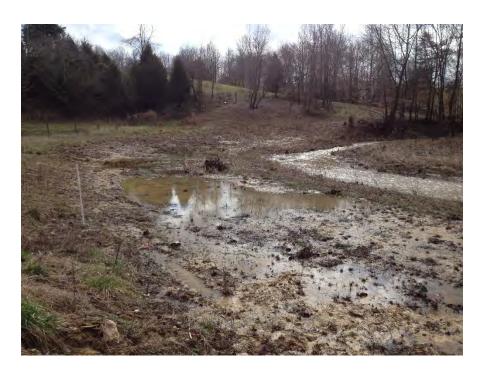
Mainstem – Upstream restoration area. Area flooded after bankfull event. February 2016.
