FINAL
YEAR 6 (2021) ANNUAL
MONITORING REPORT

**NEIGHBORS BRANCH/WALTON CRAWLEY BRANCH
STREAM & WETLAND RESTORATION SITE**

NCDMS Project No. 92872
Contract No. D09023S
USACE Action ID No. SAW-2009-917 & NCDWR Project No. 10-0123v2
SCO No. 08-07308-01
McDowell County, North Carolina

Data Collection: April-November 2021
Submission: December 2021

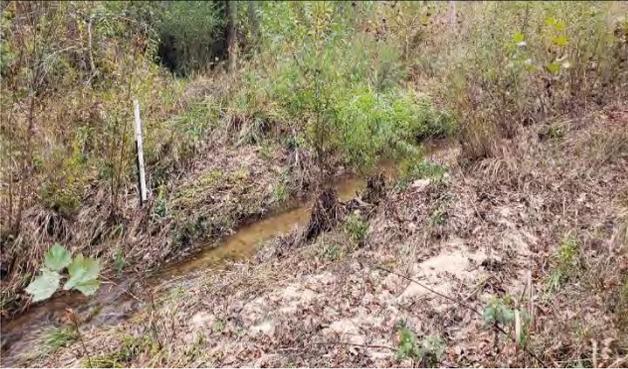
Photo 3: Wrack, sediment, and laid-back vegetation in the floodplain of Neighbors Branch

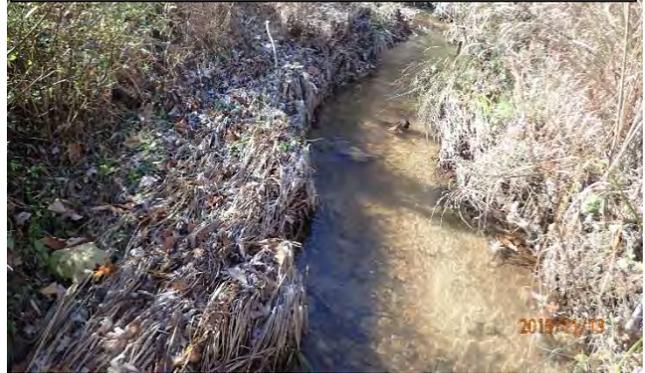
Photo 4: Reclining vegetation in the floodplain of Neighbors Branch

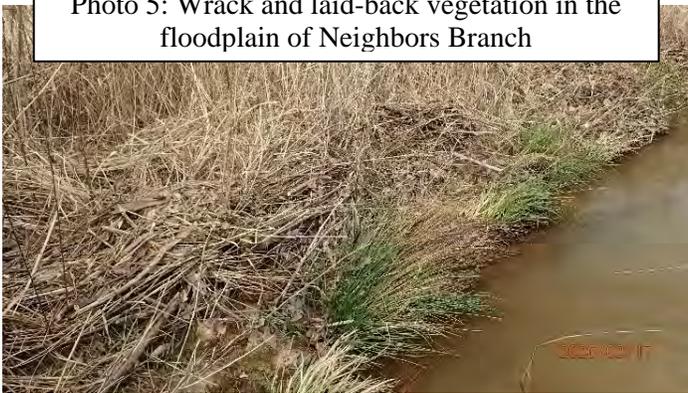
Photo 5: Wrack and laid-back vegetation in the floodplain of Neighbors Branch

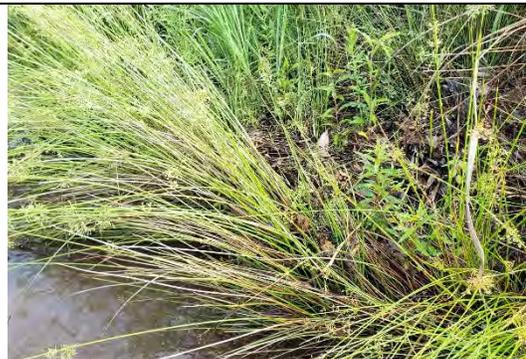
Photo 6: Wrack on the top of bank of Walton-Crawley Branch
