**Newtown Stream and Wetland  
Restoration Project  
Union County, North Carolina  
EEP Project #94150  
Contract No. 002025**

**MY-04 Monitoring Report**

Data Collected: May & September 2014

Submitted: October 2014

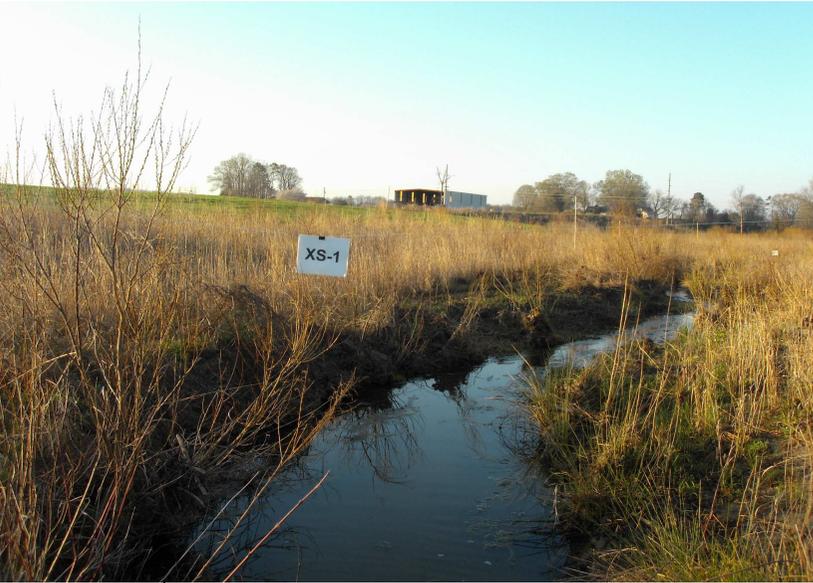
Cross Section 1

Photo of XS-1, looking in the downstream direction

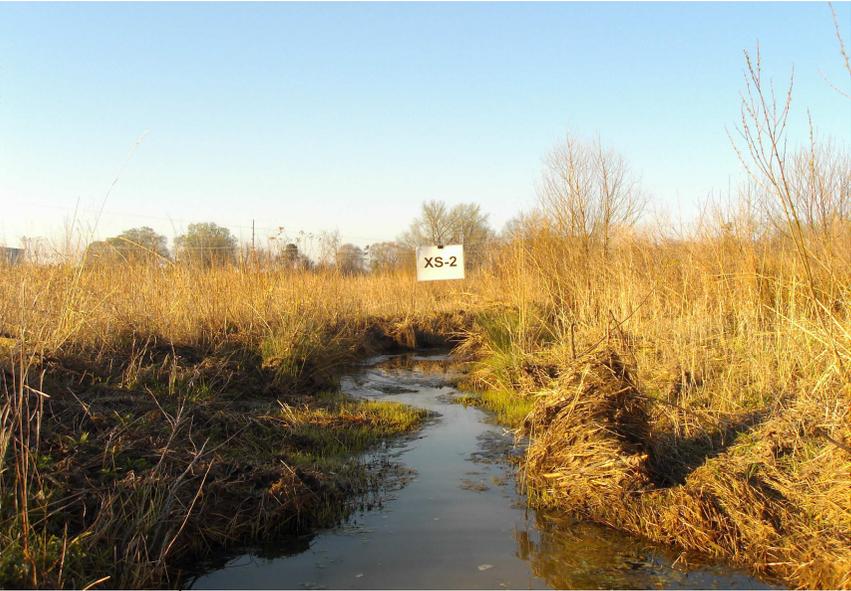
Cross Section 2

Photo of XS-2, looking in the downstream direction

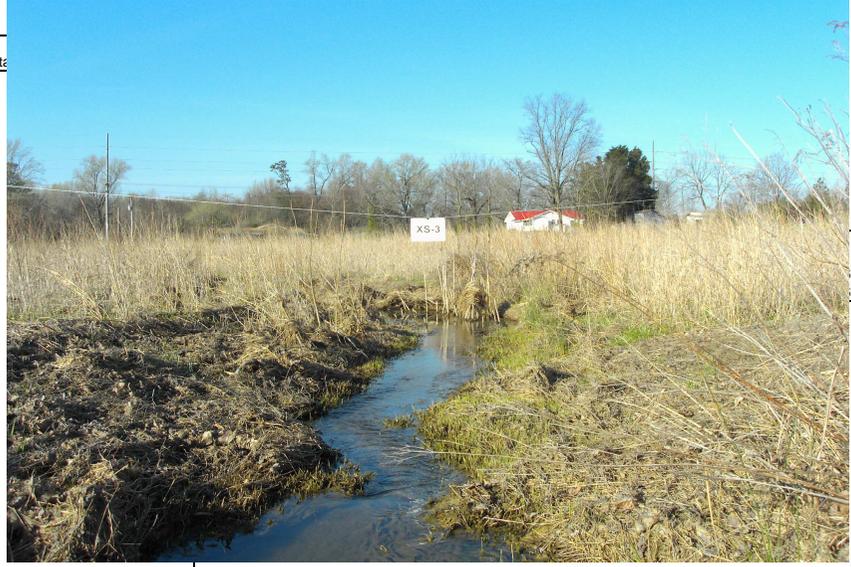
**Cross Section 3**

Photo of XS-3 looking in the downstream direction

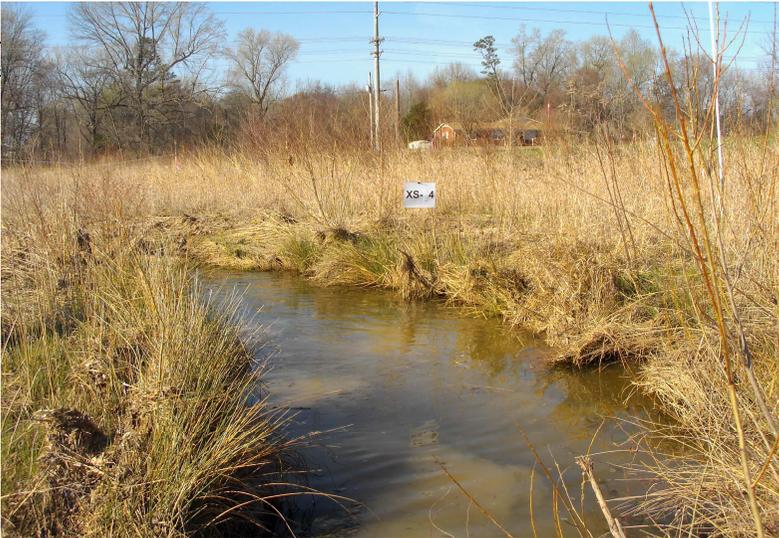
Cross Section 4

A comparison of the cross section data shows little change in geometry between MY-03 and MY-04 for all sections. In MY-03, Cross Section 4, a pool, appeared to be narrowing however it may have been due to the heavy herbaceous vegetation present in the channel during data collection as the MY-04 data compares well with earlier monitoring data. As noted in previous monitoring years, the root ball from the fallen tree in the floodplain adjacent to cross section 1, continues to not be compromising the channel banks. Minor bank erosion was noted near STA 13+00 but is not severe enough to report in the CCPV. A tree growing in the stream near STA 33+50 is causing debris build up and is recommended to be removed. The overall longitudinal profile of the stream is stable. One riffle did appear to be lower than previous monitoring years at STA 31+27 and it will be noted for continued observation in MY-05. Beaver dams were not present during the monitoring process.

Photo of XS-4, looking in the downstream direction

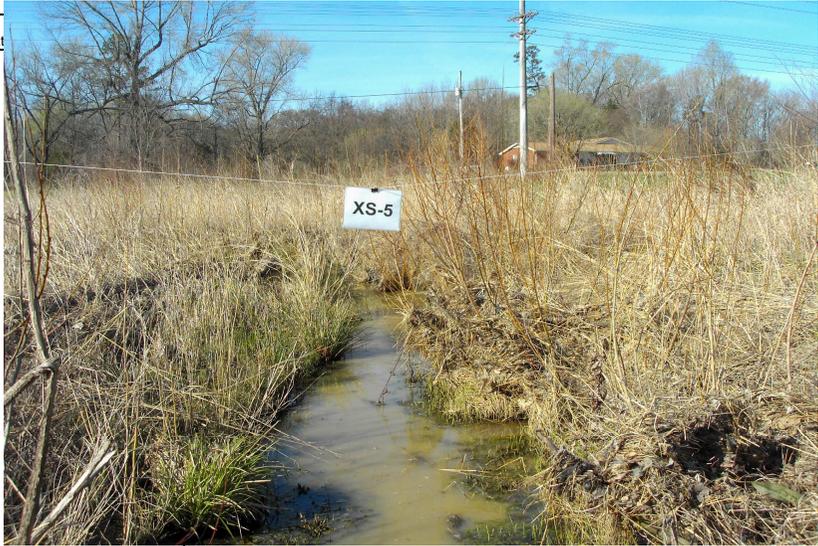
Cross Section 5

Photo of XS-5, looking in the downstream direction

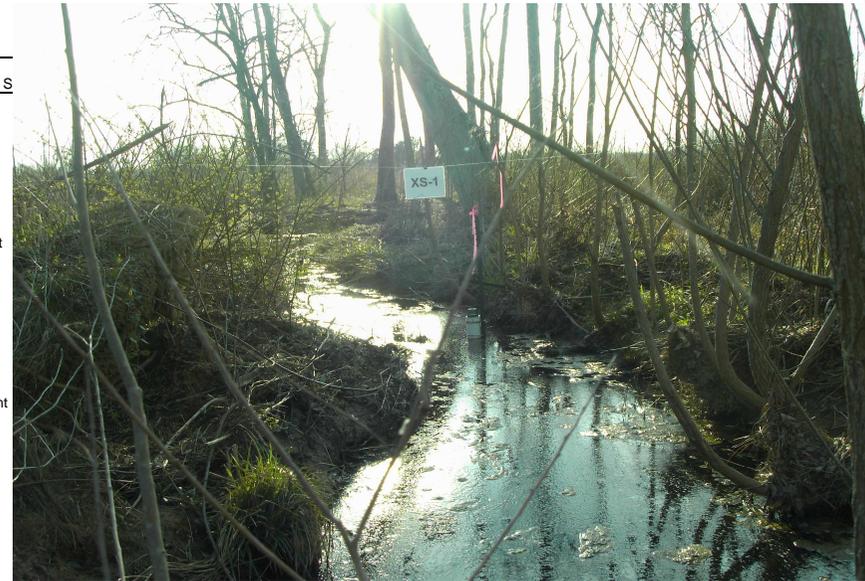
Cross Section 1

Photo of XS-1, looking in the downstream direction

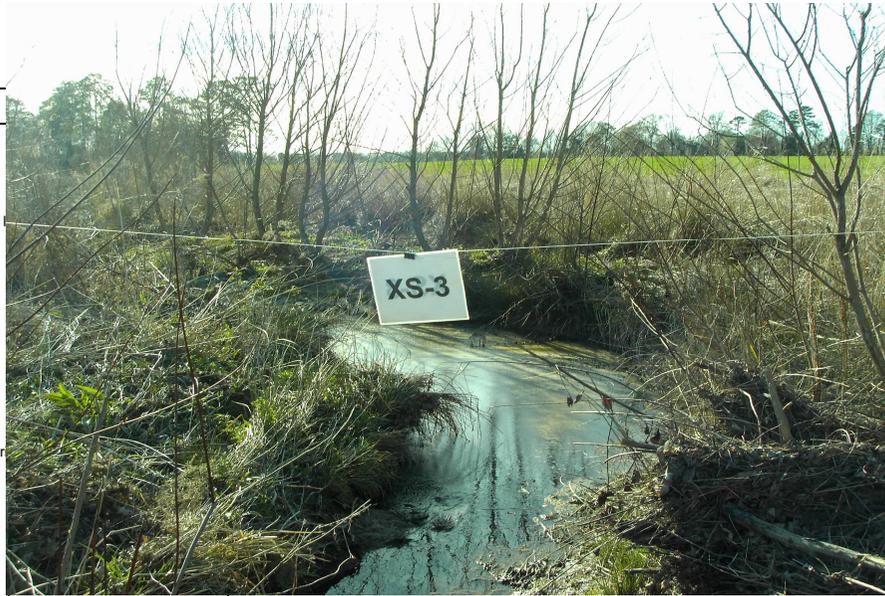
Cross Section 3

Photo of XS-3 looking in the downstream direction

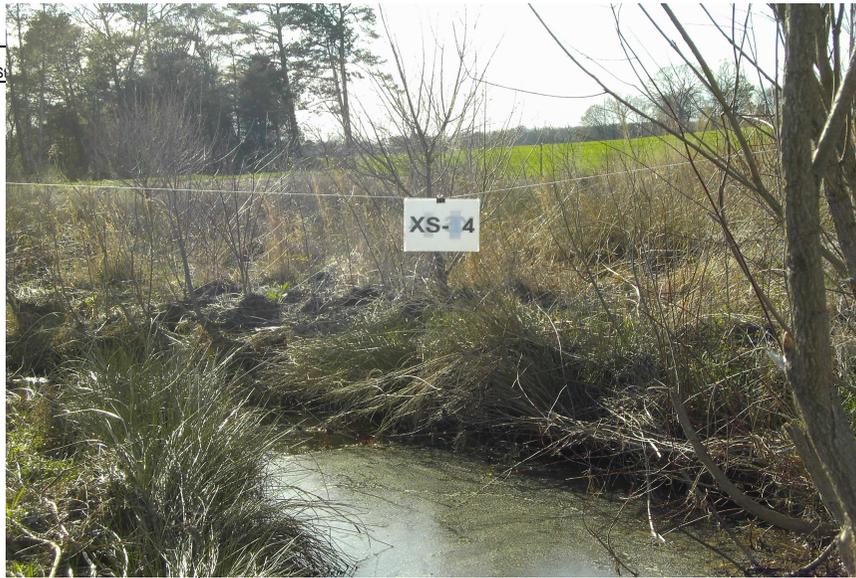
Cross Section 4

Photo of XS-4, looking in the downstream direction

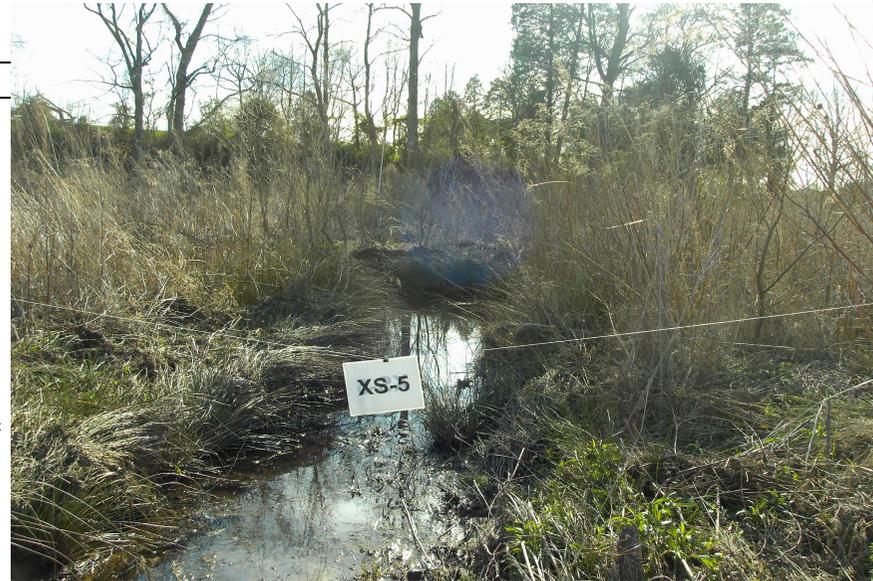
Cross Section 5

Photo of XS-5, looking in the downstream direction

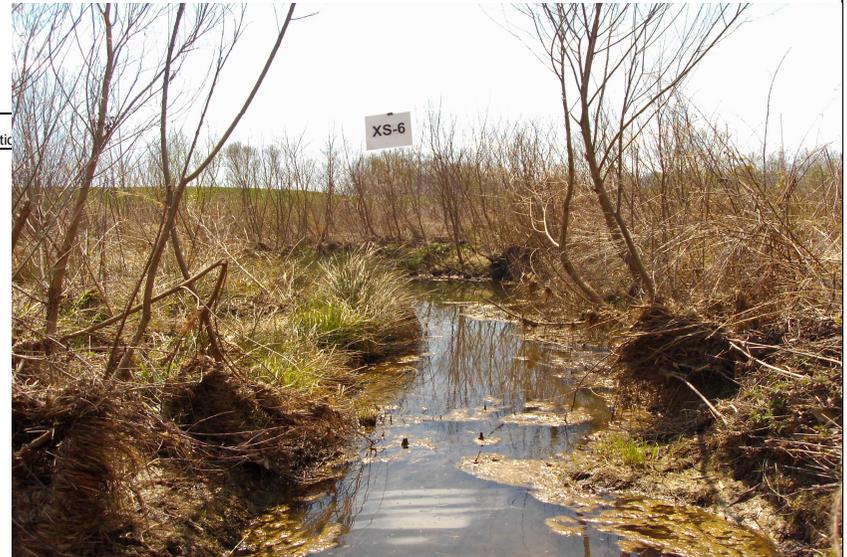
Cross Section 6

Photo of XS-6, looking in the downstream direction

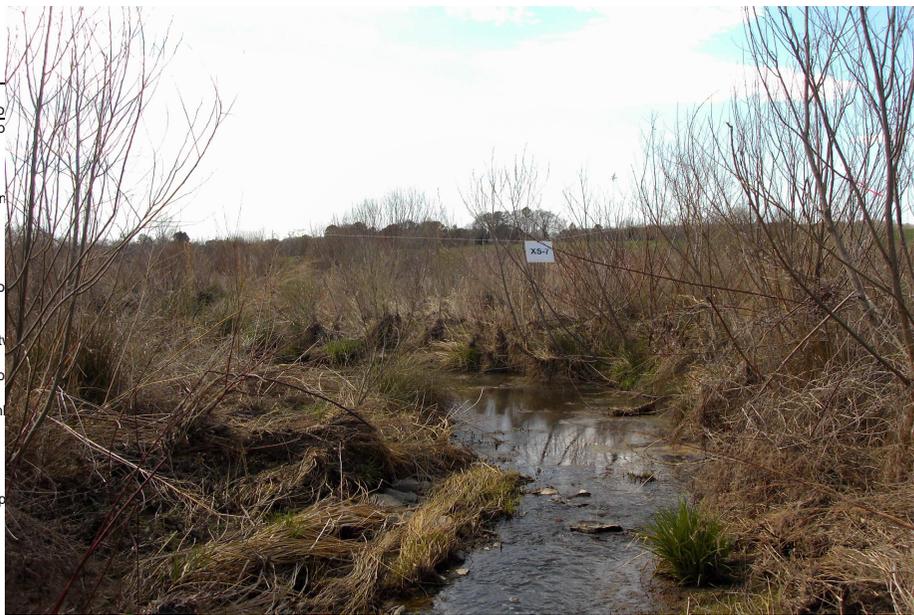
**Cross Section 7**

Photo of XS-7, looking in the downstream direction

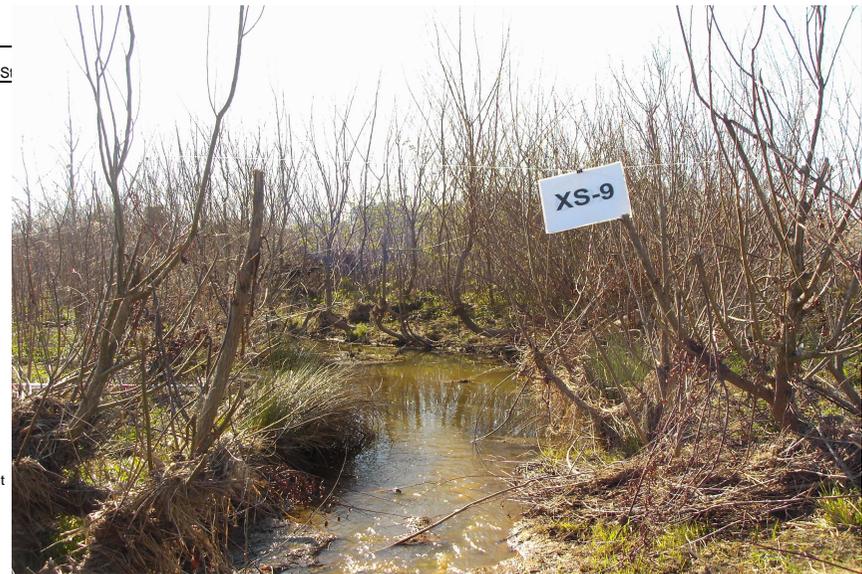
### Cross Section 9

Photo of XS-9, looking in the downstream direction

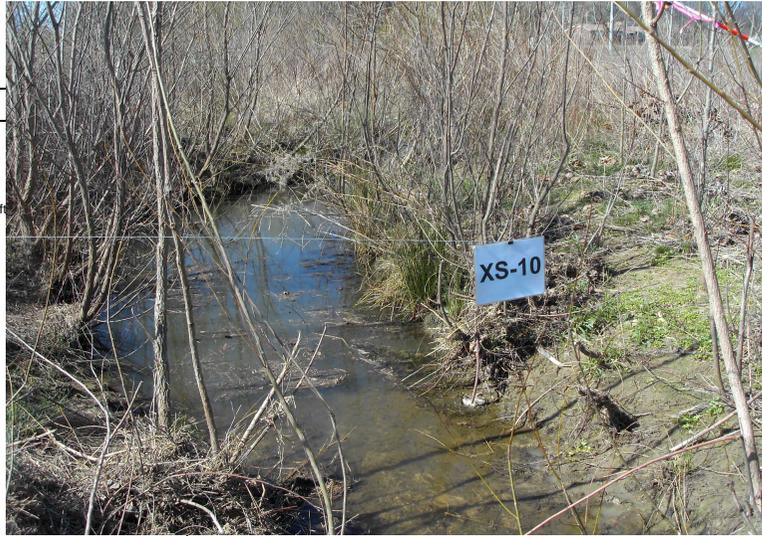
Cross Section 10

Photo of XS-10, looking in the downstream direction
