MONITORING YEAR 1 AND 2 REPORT

PHILLIPS–WILLIS SITE MIDDLE FORK CREEK

FINAL

EEP Project Number: 92703
Contract Number: D06082; Task Order: 07MON1-11

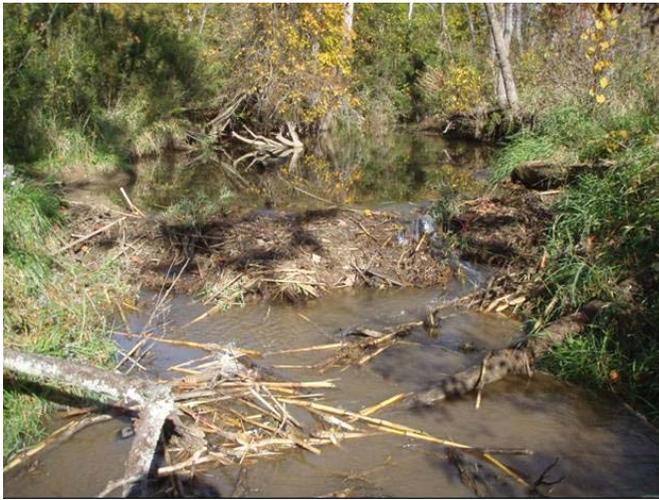
Stream problem area 3, beaver dam, 14 Oct 2008.

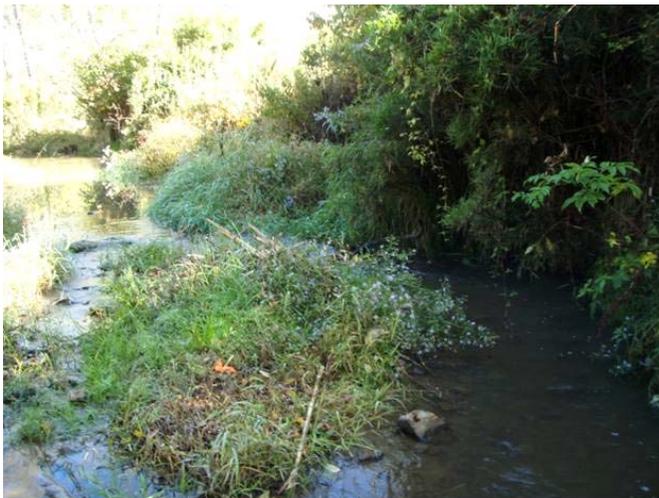
Stream problem area 4, channel bar, 14 Oct 2008.

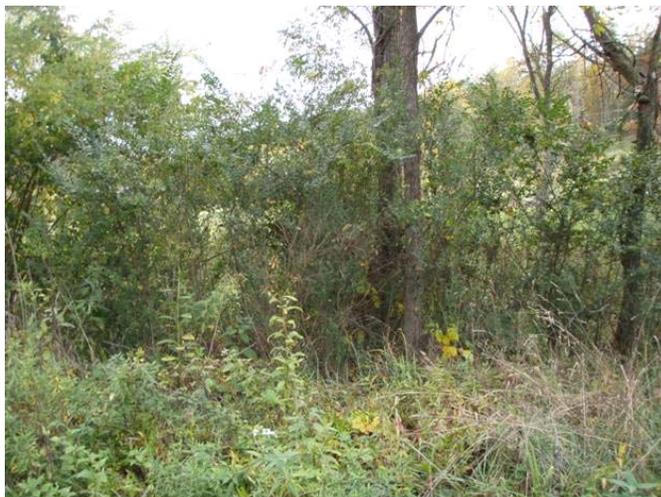
MY2 Vegetation Problem Areas Phillips-Willis Site (EEP project number 92703)			
Feature/Issue	Station Number/Range	Probable Cause	Photo Number
Chinese privet, multiflora rose present	MFC 17+50, left bank	Parent stock	1

Vegetation problem area 1 MFC, left bank, 14 Aug 2008.
