Russell Gap Stream Mitigation Project Year 4 (2023) Monitoring Report FINAL

DMS Project ID No. 100003, DEQ Contract No. 6980

Alexander County, North Carolina, Catawba River Basin: 03050101-120010

MY4 Data Collection Period: January – October 2023

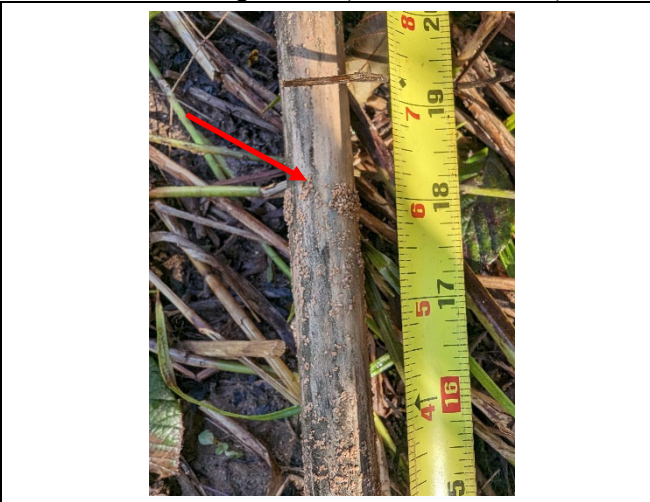
Crest Gauge 3 R4. BKF reading at 1.5 ft
(October 19, 2023)

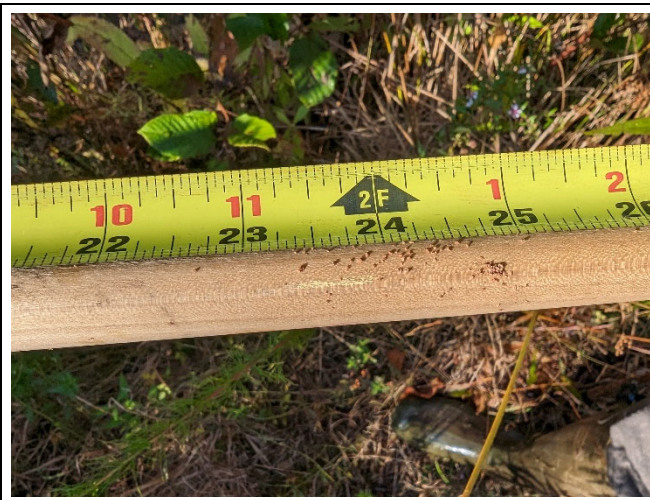
Crest Gauge 4 R6 BKF reading at 2 ft.
(October 19, 2023)
