**Year 2 Monitoring Report for Stream Mitigation of South Muddy Creek
Tributaries
(Queen Property)**

South Muddy Creek Tributaries
McDowell County, NC
SCO # D04006-01

Submitted: January 2008

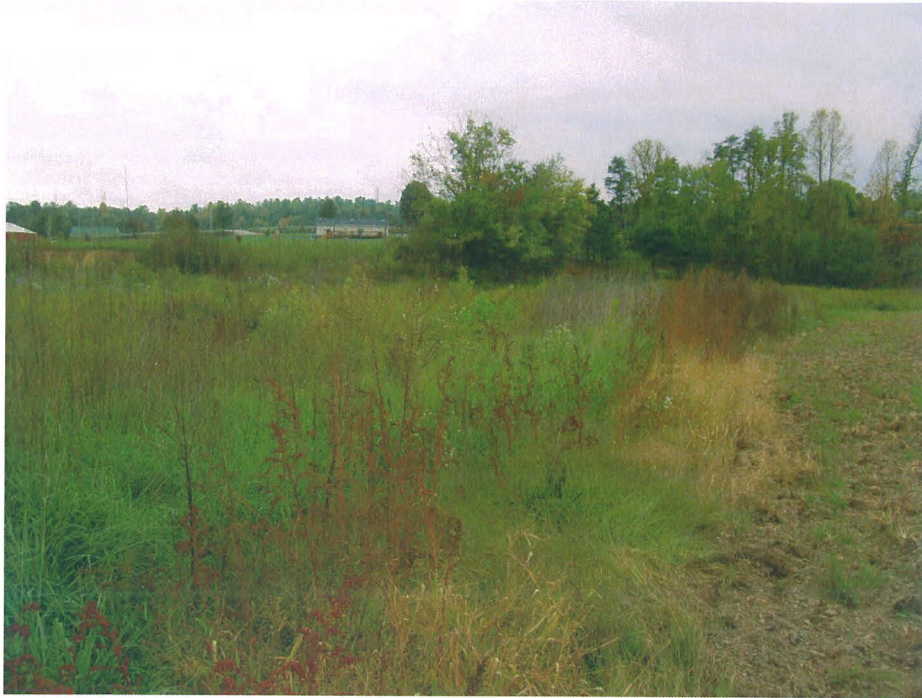
SPA 2

Bank scour along Tributary C at station 15+70.
(EMH&T, Inc. 10/23/07)

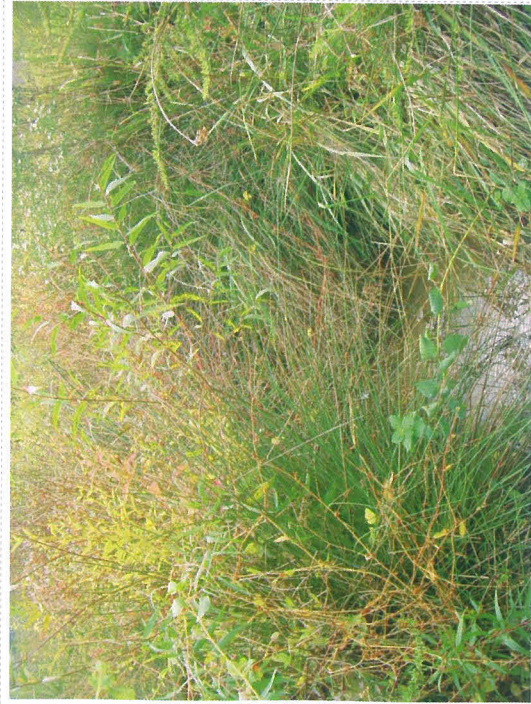
CROSS SECTION: 105+38
FEATURE: Pool

**Cross-section photo – looking downstream
 Channel is obscured by vegetation.**

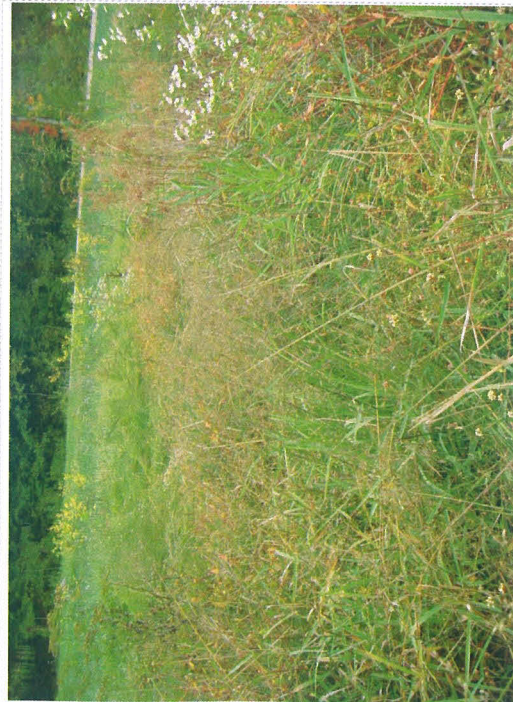
XS 70+96.05 RIF - YR 2

Cross section photo – looking downstream
 Channel is obscured by vegetation.

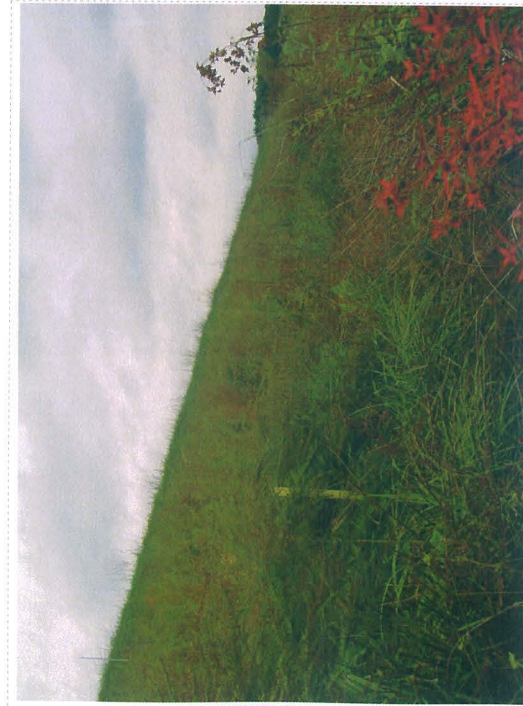
CROSS SECTION: 43+93
FEATURE: Pool

Cross section photo – looking downstream
Channel is obscured by vegetation.

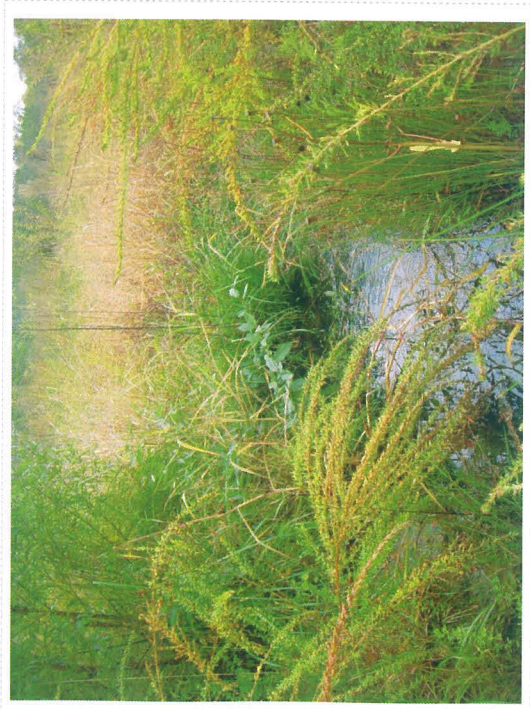
12+10
 Riffle

Bank failure along Tributary B at station 12+10. Buffer vegetation is obscuring the erosion.
(EMH&T, Inc. 10/23/07)

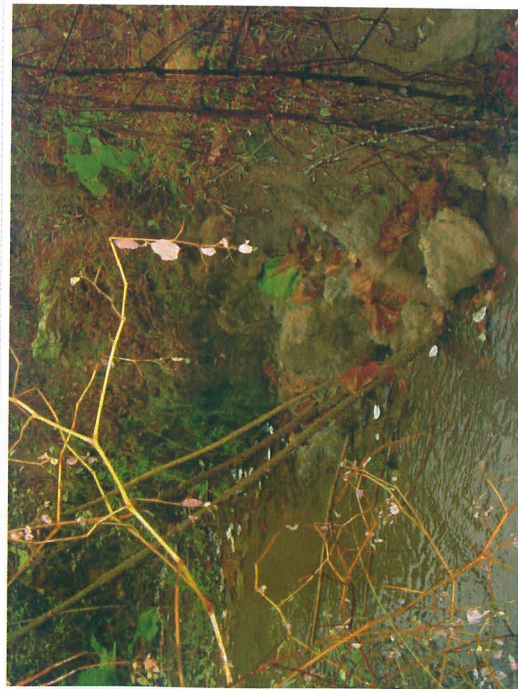
CROSS SECTION: 15+70

Cross-section photo – looking downstream

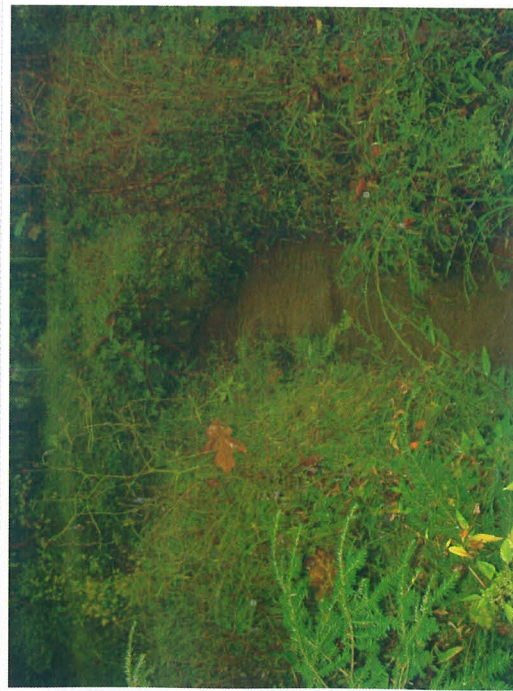
CROSS SECTION: 4+11
FEATURE: Riffle

Cross-section photo – looking downstream

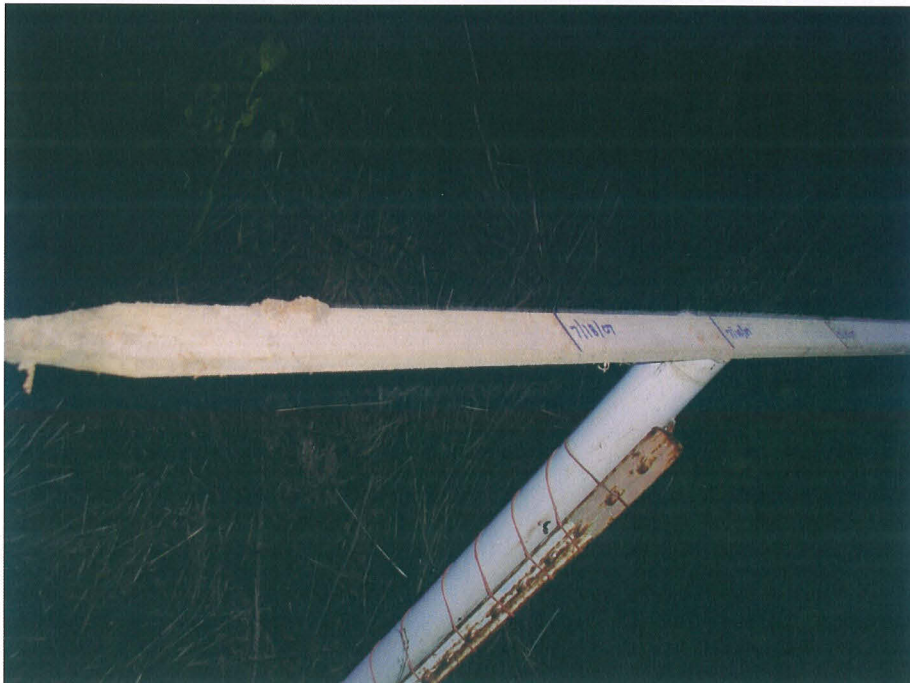
BF 2
Crest Gage at station 54+85 on Tributary A (lower).
(EMH&T, Inc. 7/18/07)

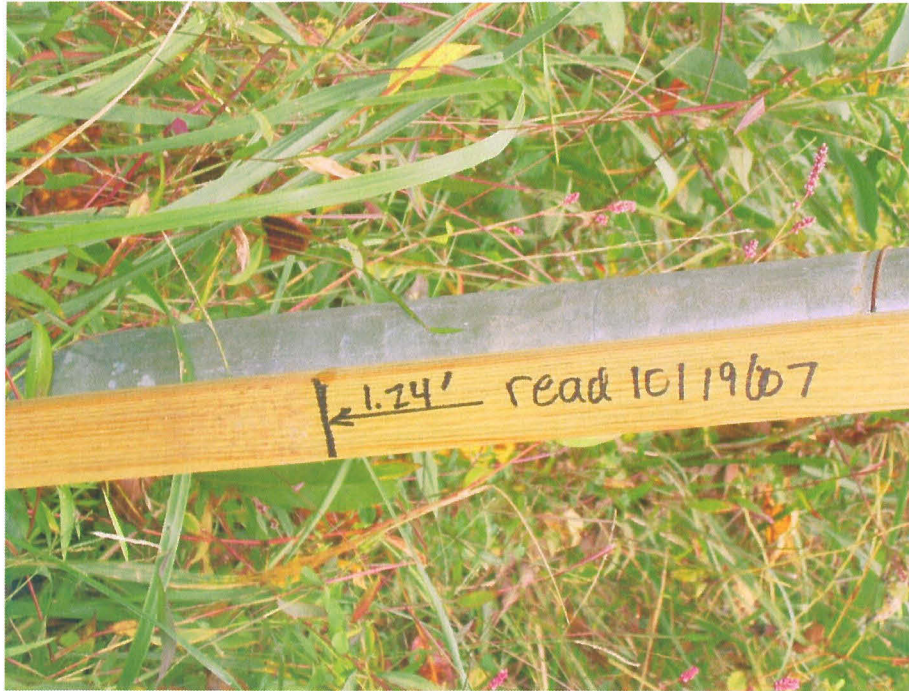
BF 3
Crest Gage at station 113+37 on Tributary A (upper).
(EMH&T, Inc. 10/19/07)
