East Prong of the Roaring River at Stone Mountain State Park Stream Restoration

Annual Monitoring Report

Monitoring Year: 2006

NCEEP Project Number: 364

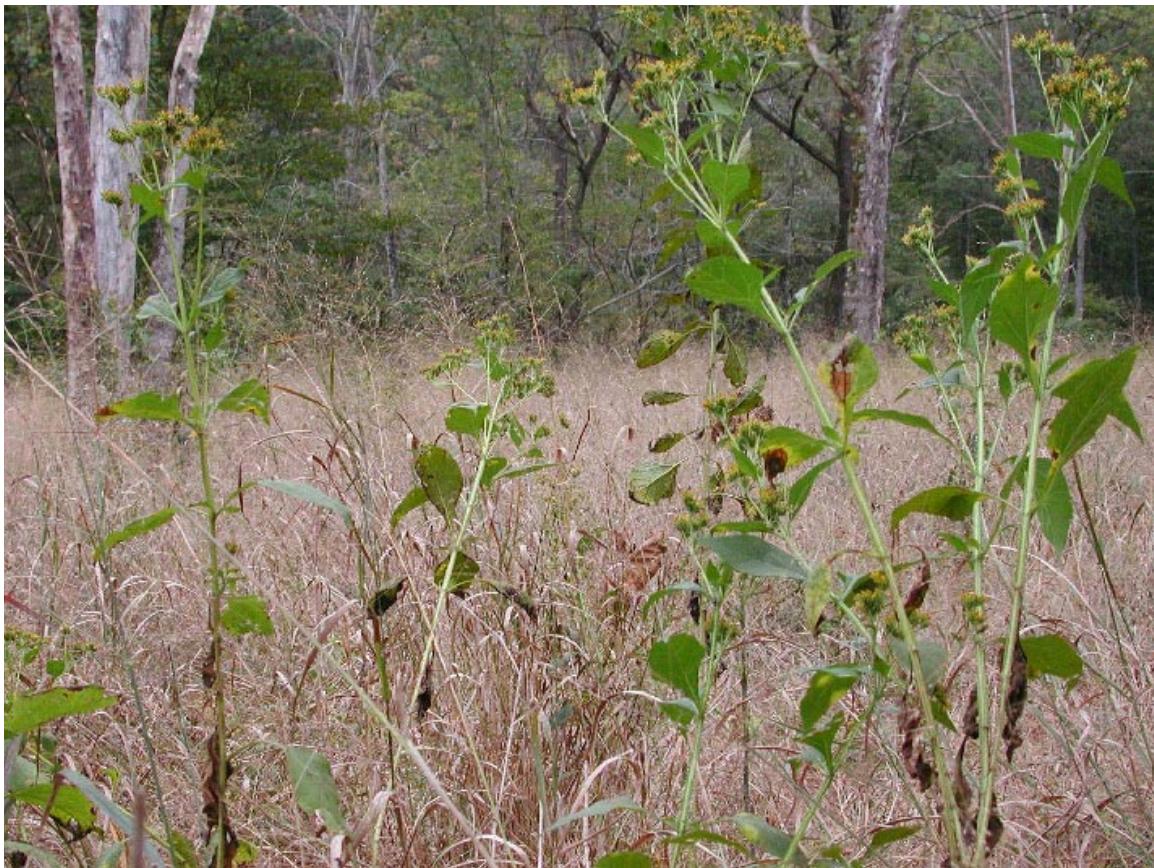
Stone Mt. Reach 2. Corner of plot 1

Bare root survival was poor in all plots. As in 2005, only one plot had a total of 4 planted trees. All other plots were free of planted trees. It should be noted however that naturally regenerating sycamore in select areas has heights close to that of the 4 remaining planted sycamores.

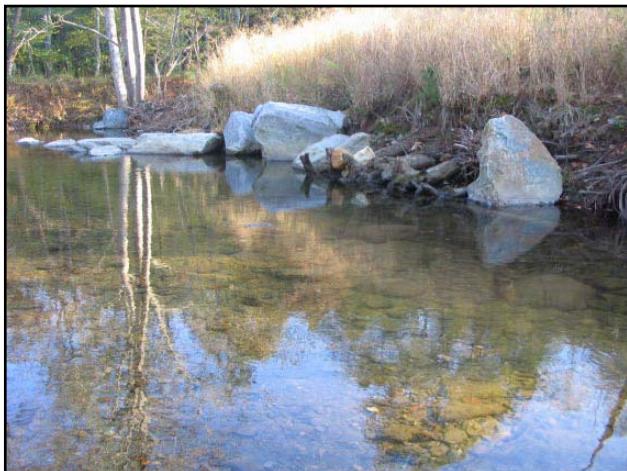
PA1 Left Bank STA 3+50 Bank Erosion

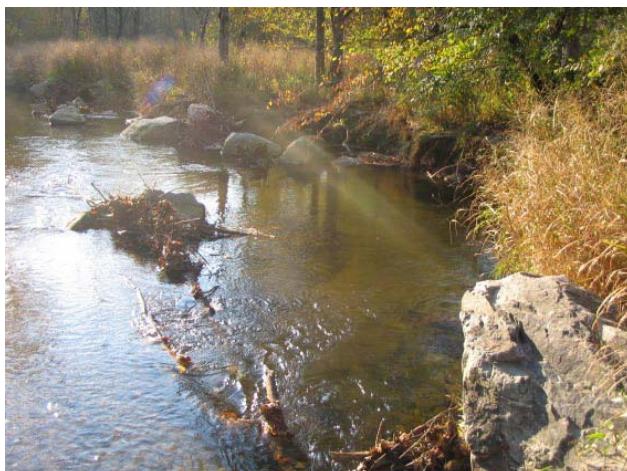
PA2 Looking Down stream STA 5+75 Right Bank Erosion

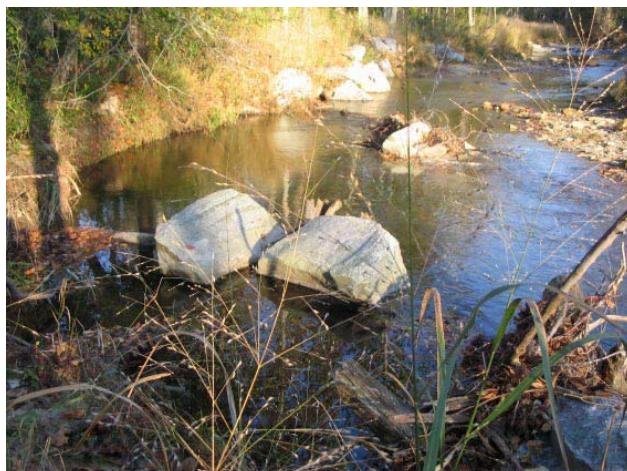
PA3 Looking Upstream STA 6+25 Right Bank Erosion

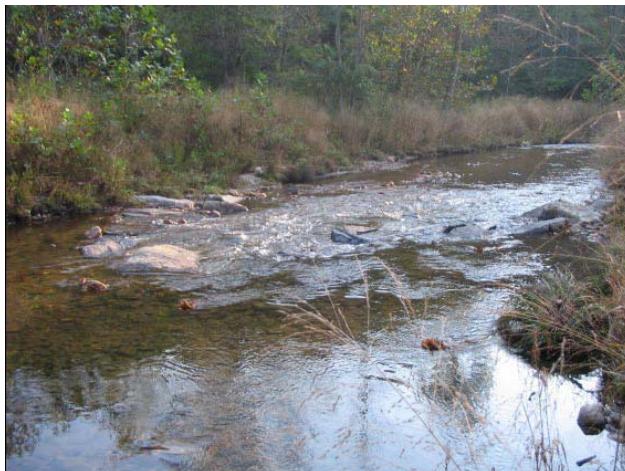
PA5 Looking Upstream STA 7+00 Rock Cross-Vane

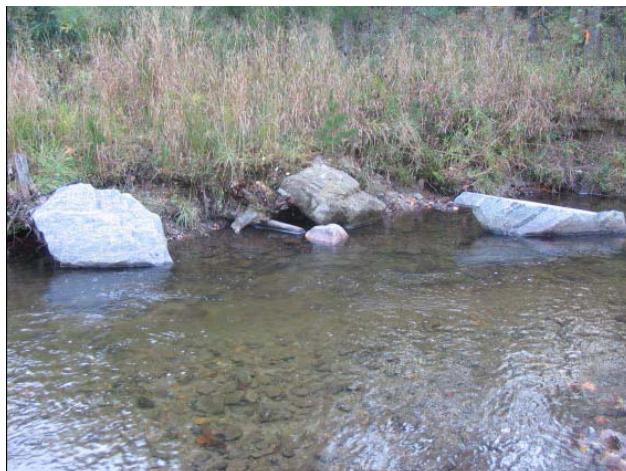
PA6 Left Bank Root Wads and Boulders STA 10+00

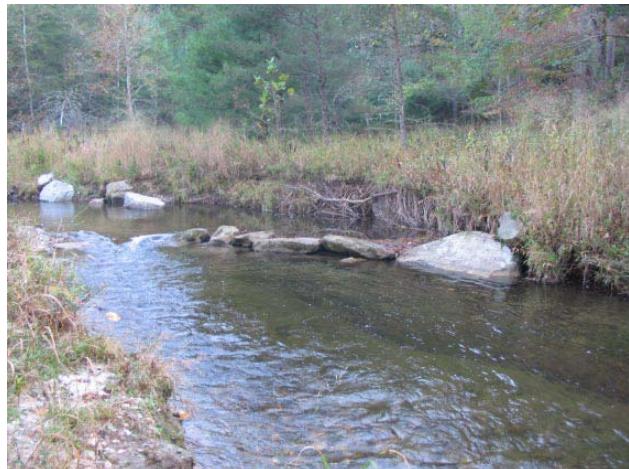
PA7 Looking Upstream STA 10+75 at J-hook and Left Bank Erosion

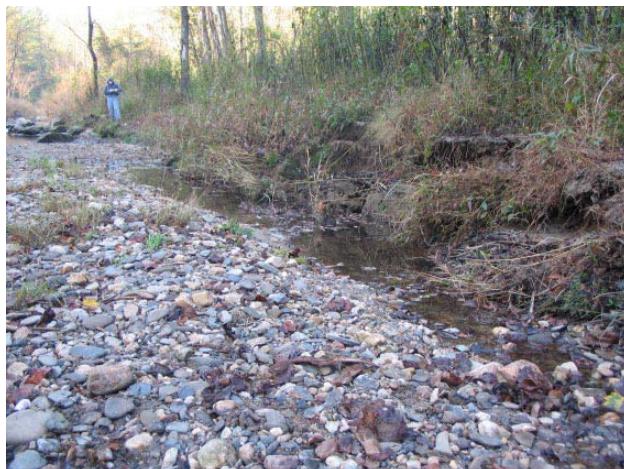
PA8 Looking Downstream STA 11+00 Lateral Channel Bar and Bank Erosion

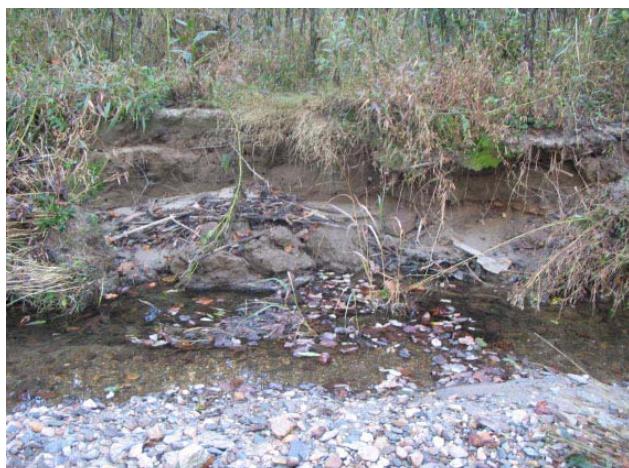
PA9 Right Bank Erosion STA 11+25

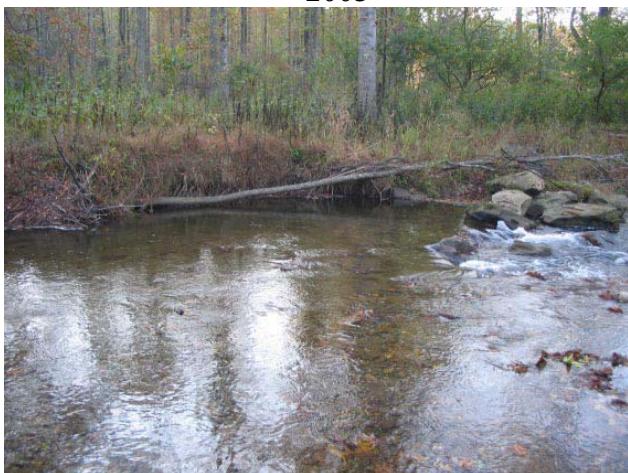
PA10 Left Bank STA 11+25 Erosion Behind Vane

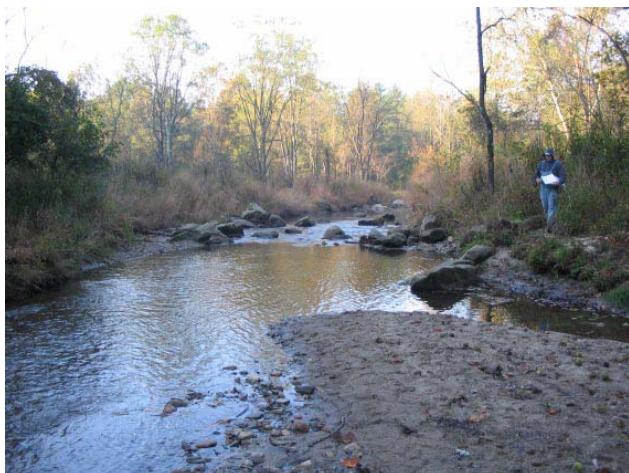
PA11 Looking Downstream STA 11+50 Lateral Bar

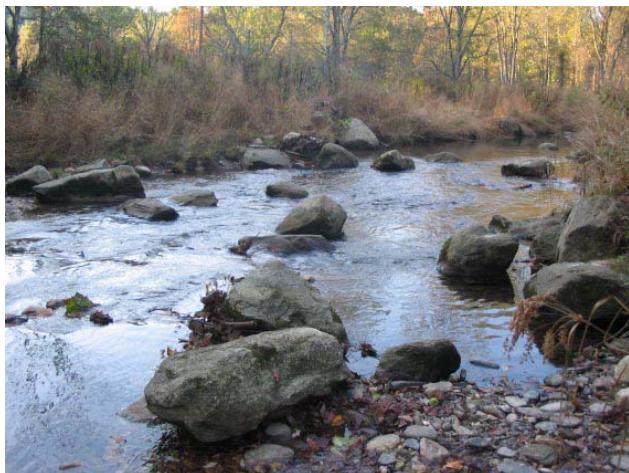
PA12 Looking Upstream STA 11+75 Random Boulder Cluster

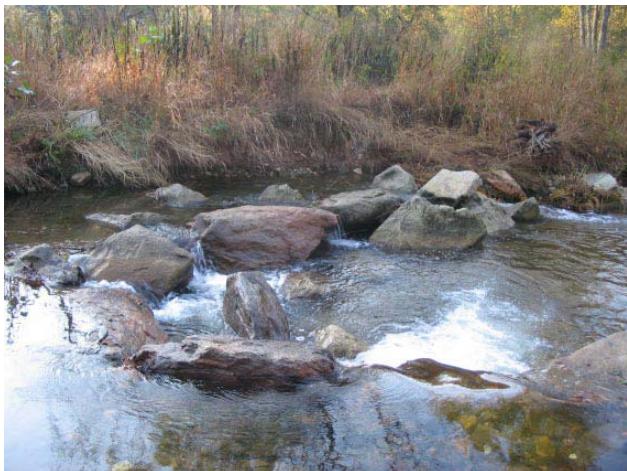
The majority of the rock cross vanes are holding the grade of the stream. The last two vanes are at risk of failure. The river has cut around the left vane arm on both of the cross vanes at the end of the reach. The vanes are located at approximately Sta: 13+00 and 14+50. There is a significant risk to the entire reach if these vanes fail. Failure of these vanes will result in a head-cut that would continue upstream in the reach until it reached a stable grade control. There is a potential of a 4.5ft head-cut if these structures are allowed to fail this would relate to a head cut approximately 500 ft or more upstream from the rock cross vane at Sta: 13+00.

PA 13 Looking Downstream STA 13+00 Bank Erosion and Piping around Structure Arm

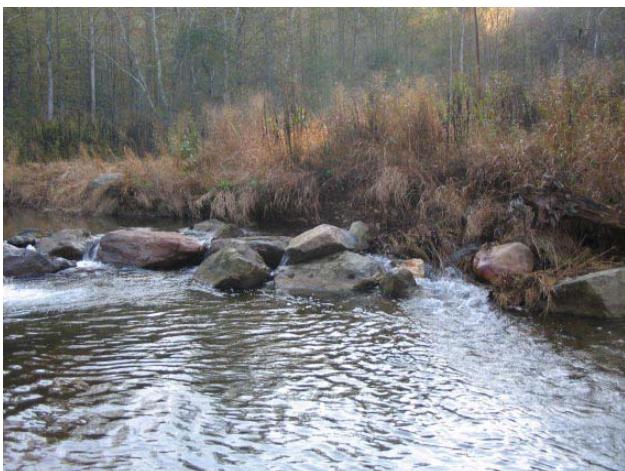
PA 14 Looking Upstream STA 13+75 Bank Erosion Left Bank

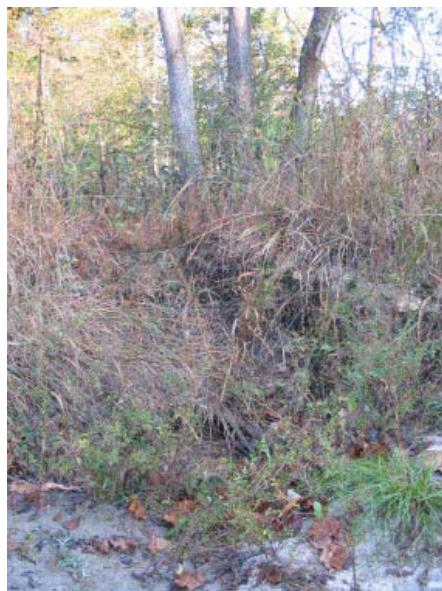
PA 15 Right Bank Erosion STA 14+25 Overflow Drainage from North Pond Phase II

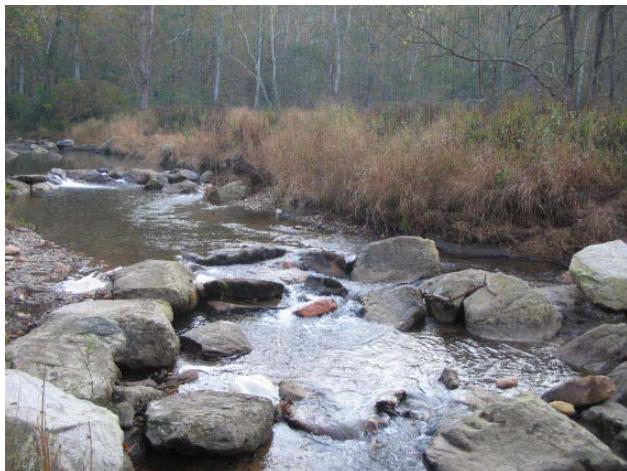
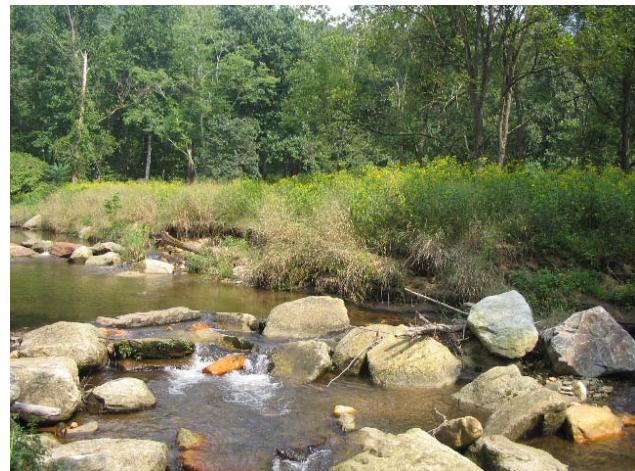
PA 16 Looking Upstream STA 14+50 Bank Erosion Left Bank

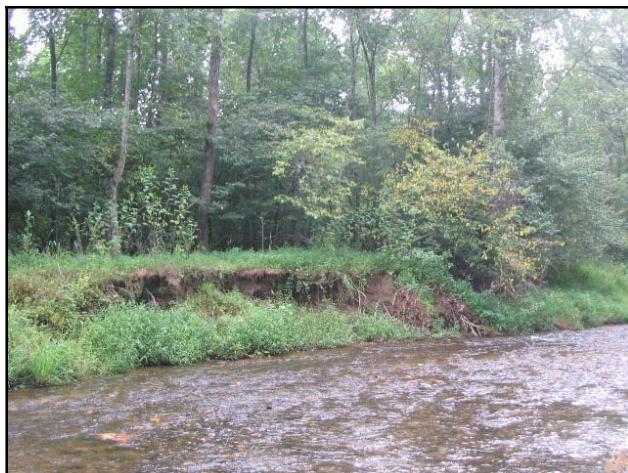
PA 18 Looking Downstream STA 3+50 Left Bank Erosion

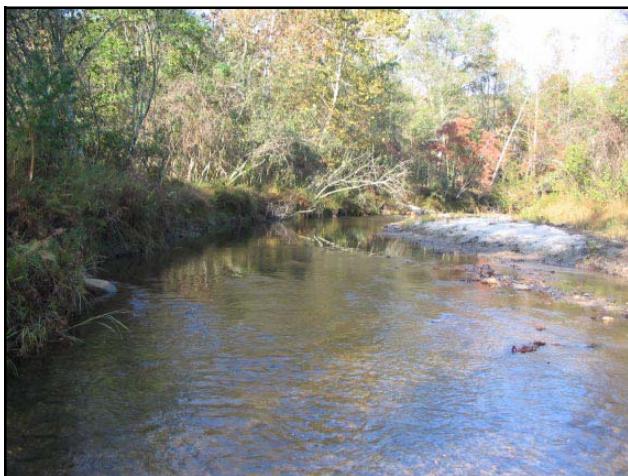
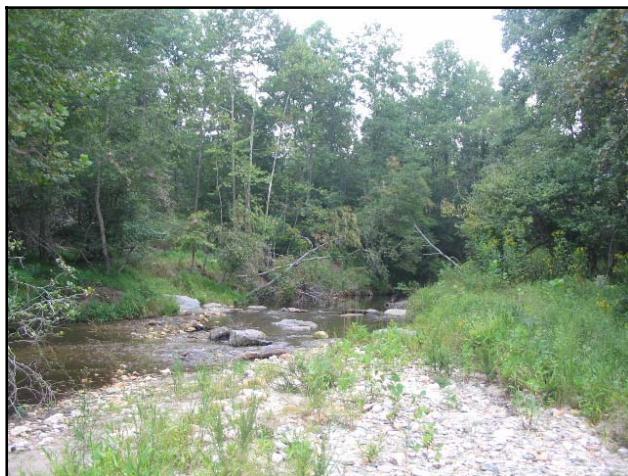
PA 19 Looking Upstream STA 10+00 Right Bank Erosion

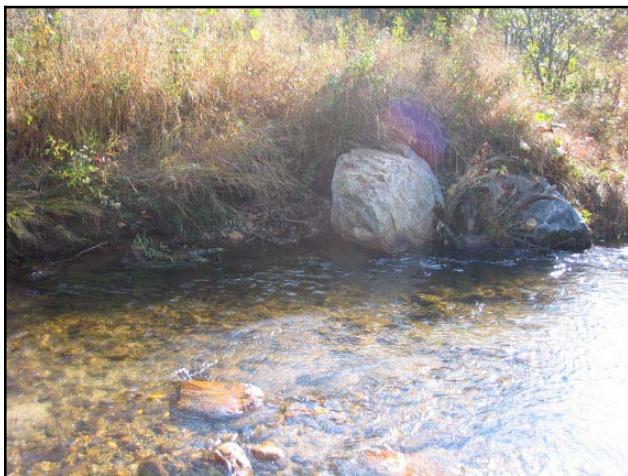
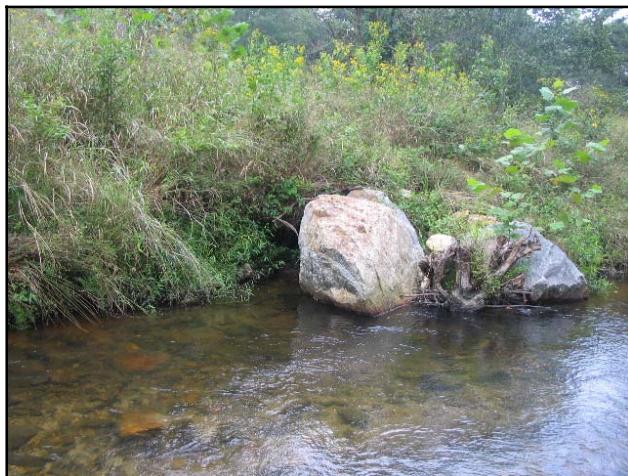
PA 20 Left Bank Root Wad STA 12+00

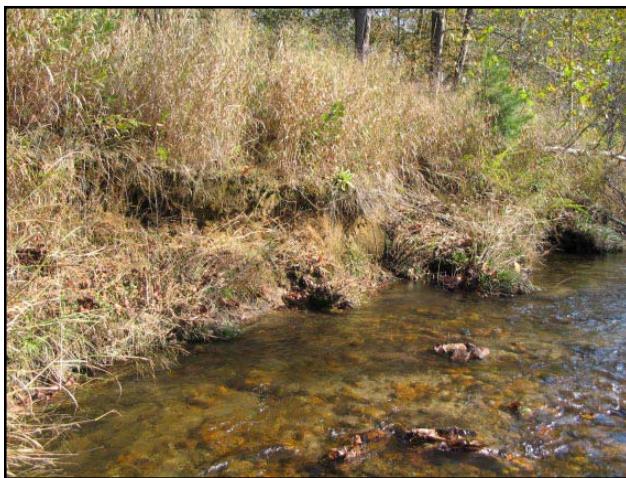
| Problem Number | Feature Issue | Station numbers | Suspected Cause | Photo number |
|---|--|---|---|---|
| PA 20 | Scour around rootwad | 12+20 to 12+60 R4 | Lack of deep rooting vegetation Matting on repair area not adequately secured | PA 20 |

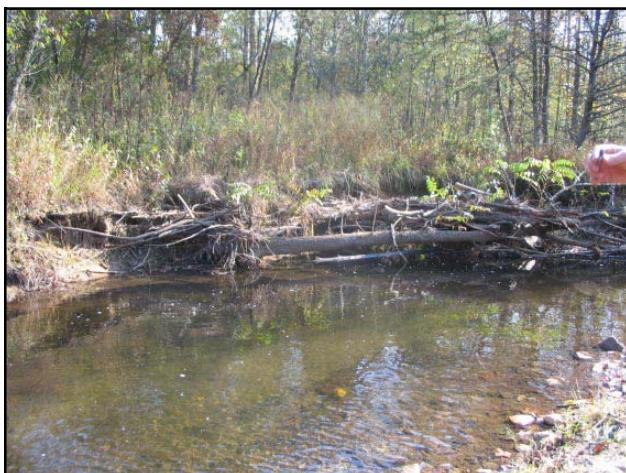
PA 21 Left Bank Erosion STA 19+00

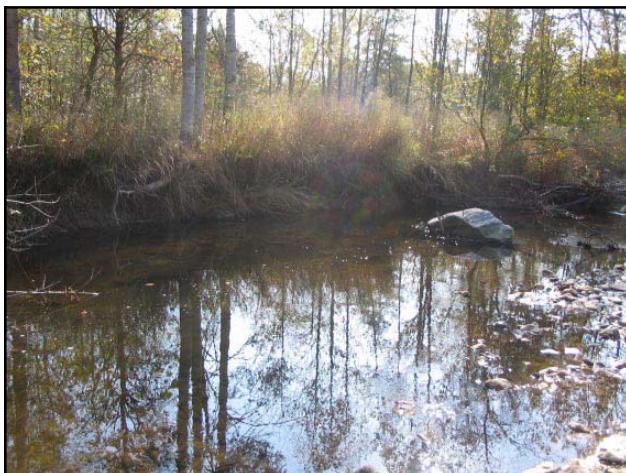
PA 22 Looking Downstream STA 20+25 Left Bank Erosion

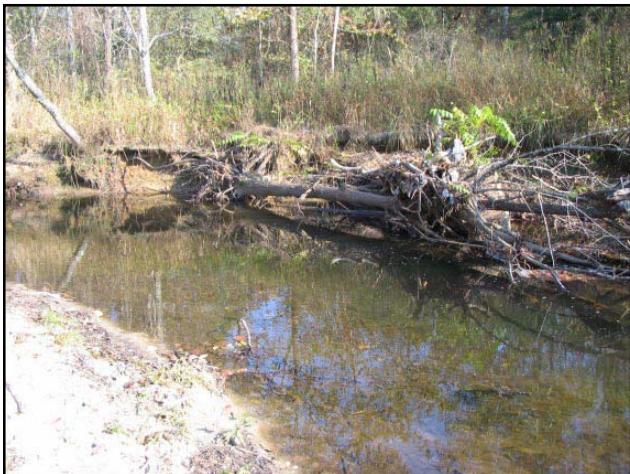
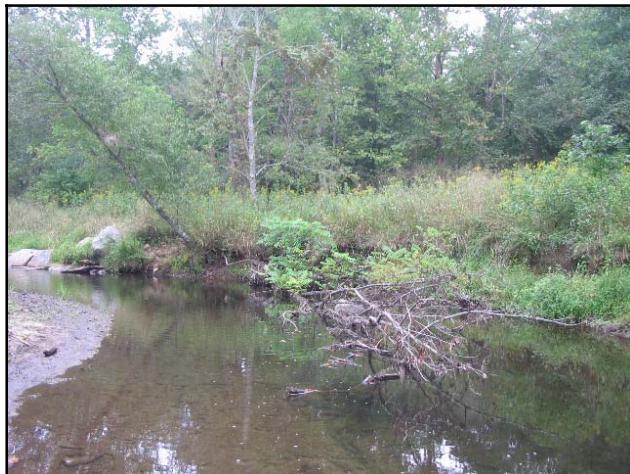
PA 23 Left Bank Erosion and Migration STA 20+75

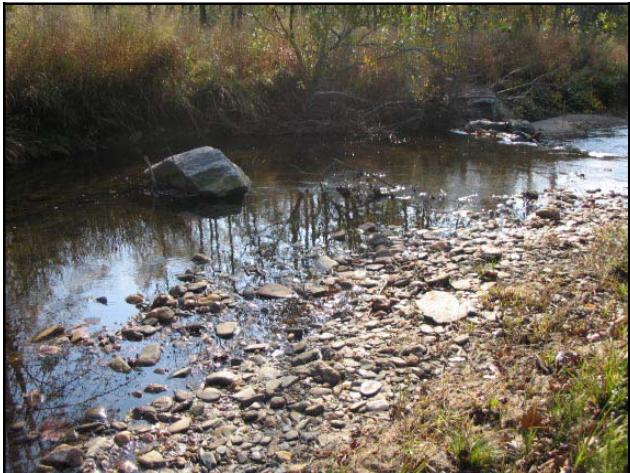
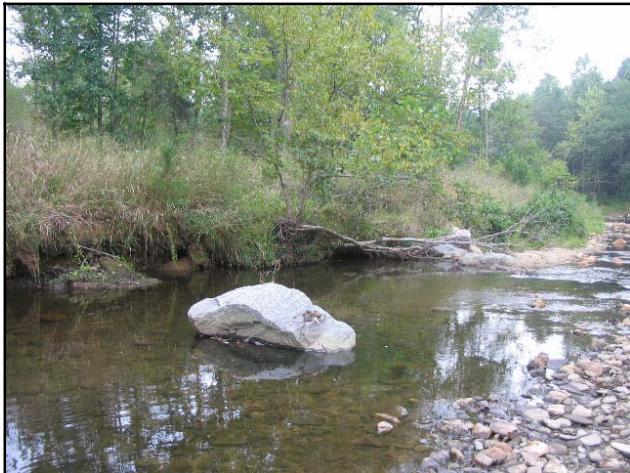
PA 24 Left Bank Erosion Outside Meander Bend STA 20+75

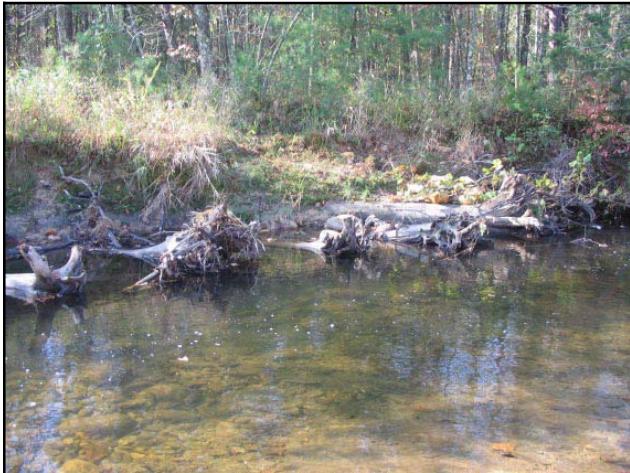
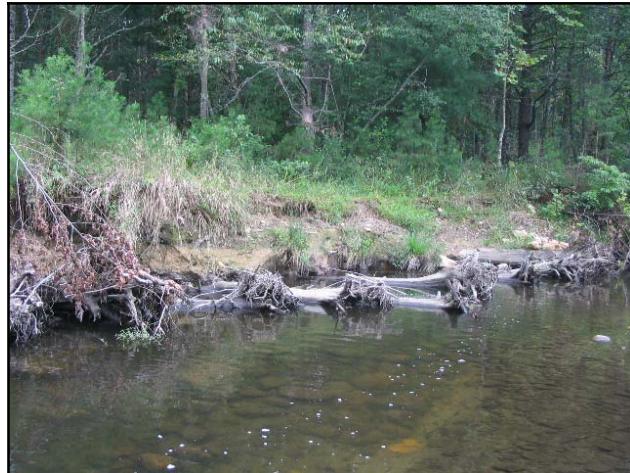
PA 25 Left Bank Erosion and Migration STA 21+00

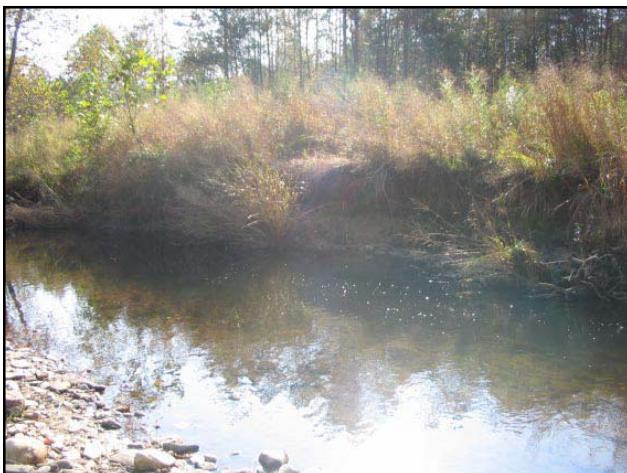
PA 26 Right Bank Erosion Exposed Root Wads STA 24+00

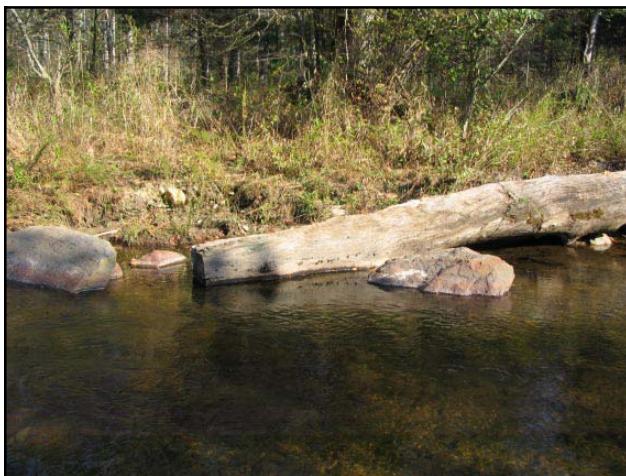
PA 29 Right Undercut Bank Below Rock Vane 25+25

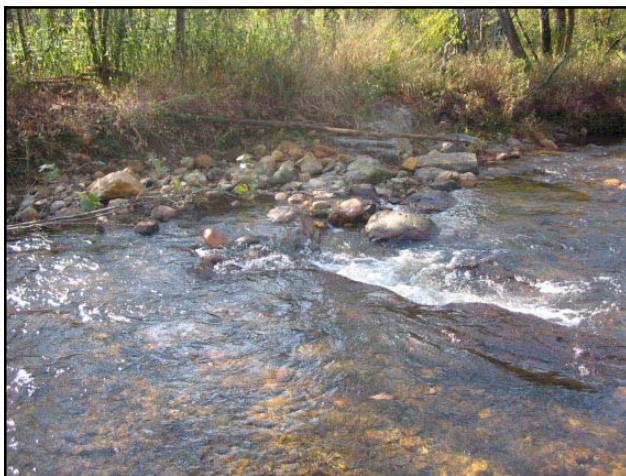
PA 32 Left Bank Erosion and Migration STA 29+75

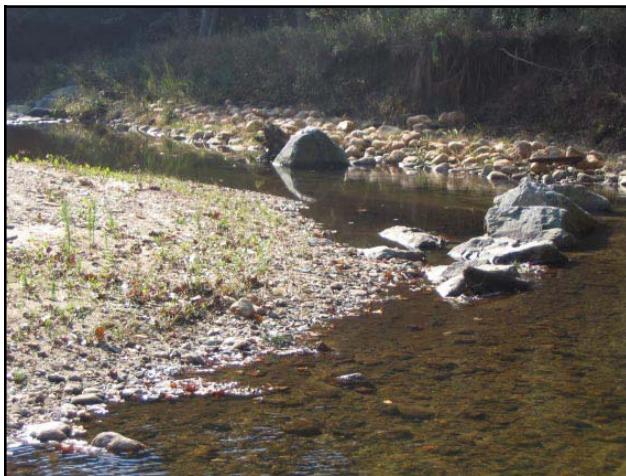
| Problem Number | Feature Issue | Station numbers | Suspected Cause | Photo number |
|---|--|---|---|---|
| PA 33 | Scour behind left vane are and piping | 30+40 to 30+80 | Lack of deep rooted vegetation Improper placed vane | PA 33 |

PA 33 Left Bank Erosion STA 30+50

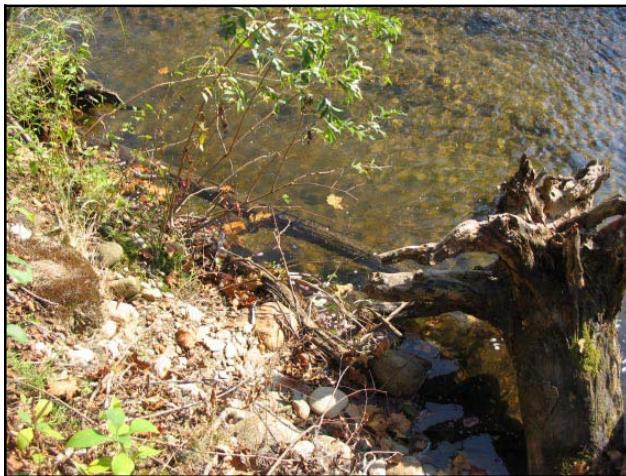
PA 34 Looking Downstream STA 32+50 Right Bank Erosion

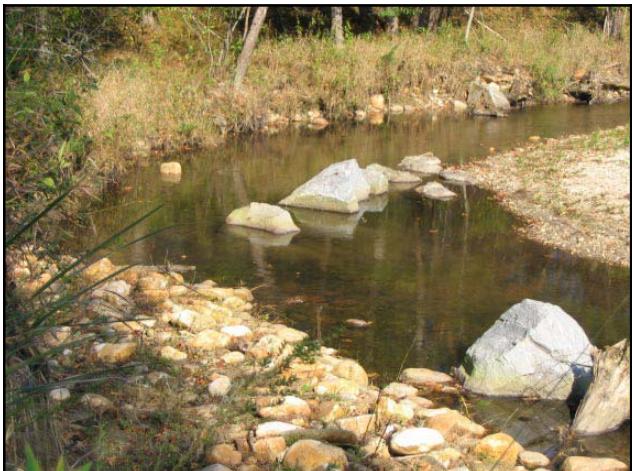
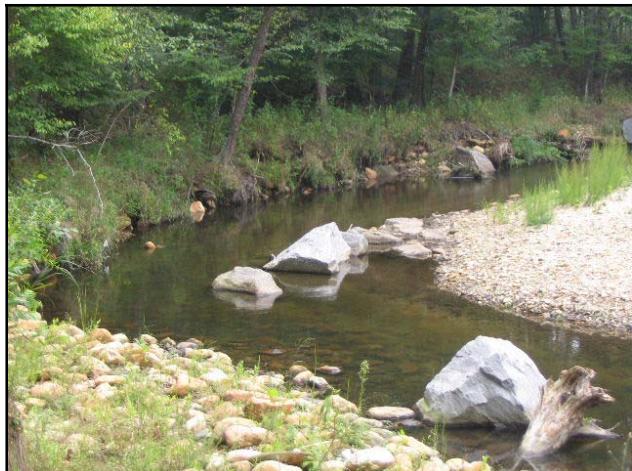
PA 35 Right Bank Exposed Root Wad STA 32+50
