Monitoring Year 5 (2016) Report

FINAL

Upper South Hominy Mitigation Site, South Hominy Creek, French Broad River Basin, Buncombe County, North Carolina

DMS Project Number: 92632

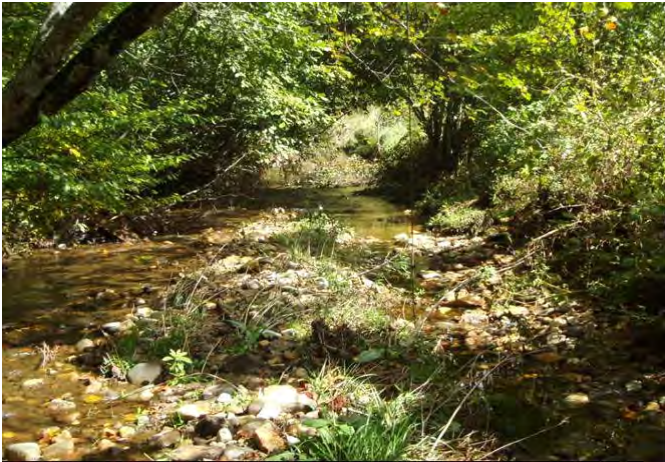
Photo Station 1

Mid channel bar, sta. 0+50, facing downstream, pre-construction.
 30 September 2008.

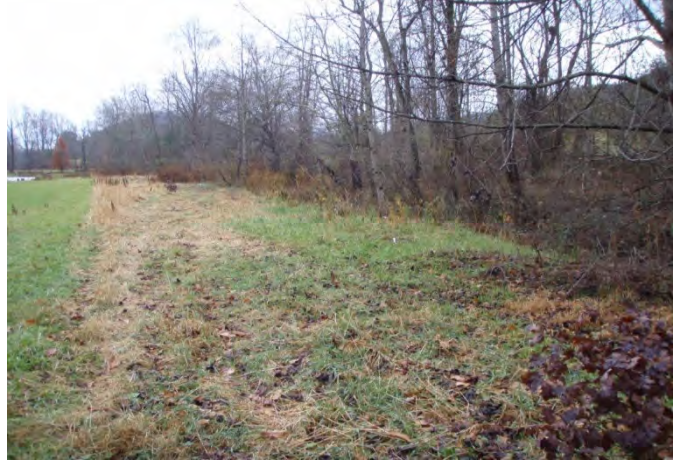
UT2 facing downstream, post invasive removal, 5 December 2011.

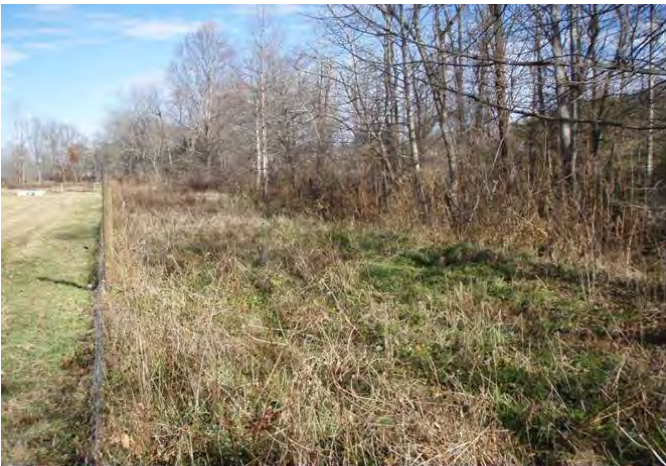
UT2 facing downstream, post invasive removal, 20 November 2012.

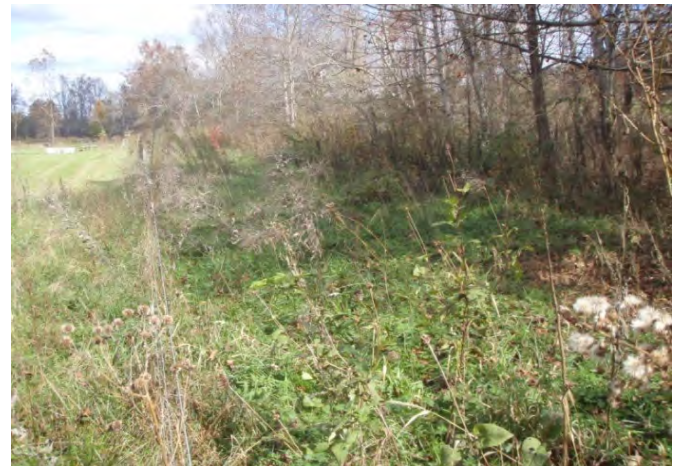
UT2 facing downstream, post invasive removal, 29 October 2013.

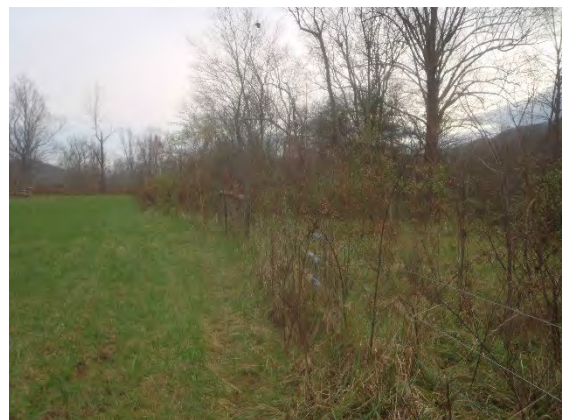
UT2 facing downstream, post invasive removal, 17 November 2015.

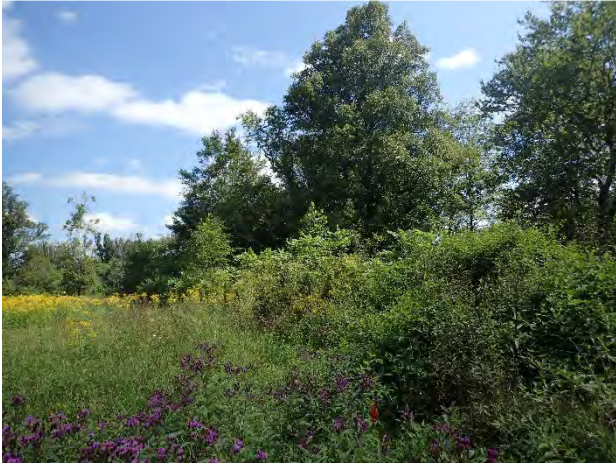
UT2 facing downstream, post invasive removal, 15 September 2016.

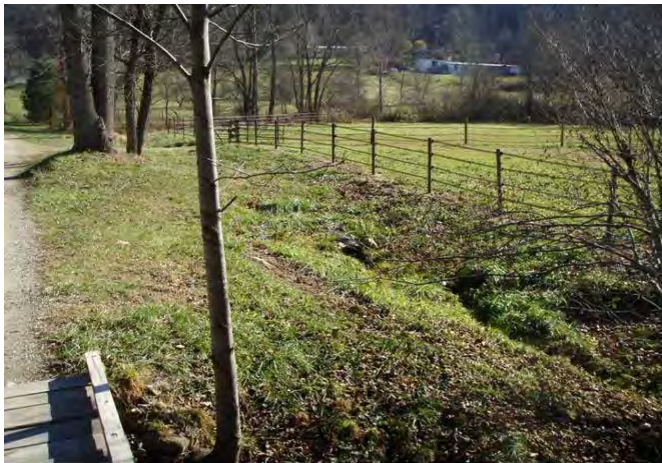
UT2 routed from original channel to a road ditch, pre-construction, 30 November 2007.

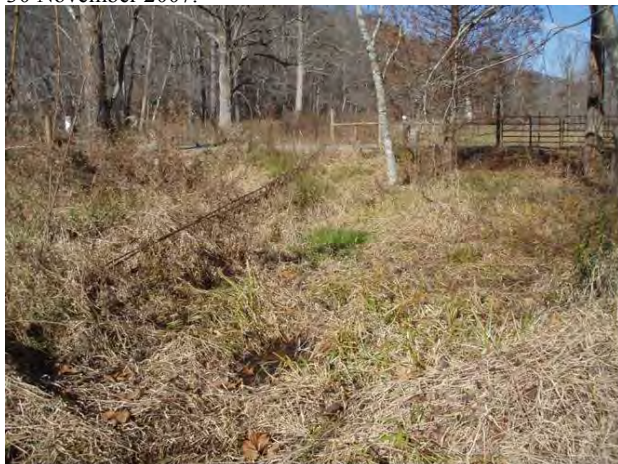
UT2 re-connected under Canterfield Lane to abandoned channel, sta. 0+00 to 0+50, 20 November 2012.

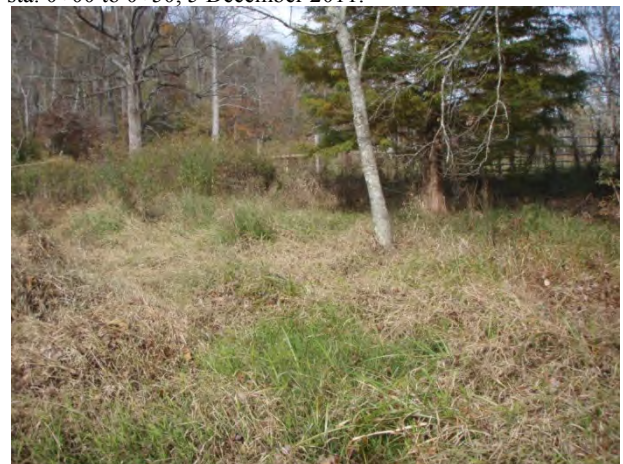
UT2 re-connected to abandoned channel, sta. 0+00 to 0+50, 29 October 2013.

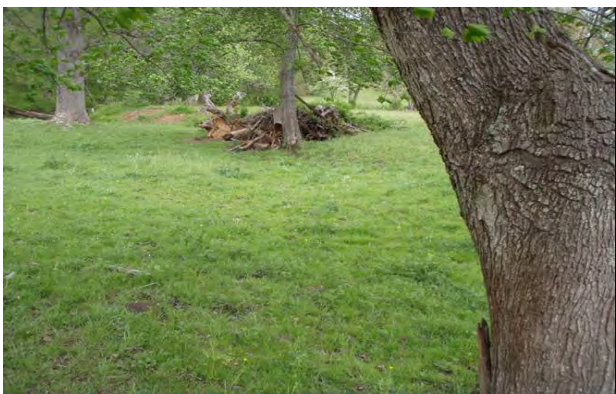
Abandoned UT2 channel east of Canterfield Lane, 26 April 2010.

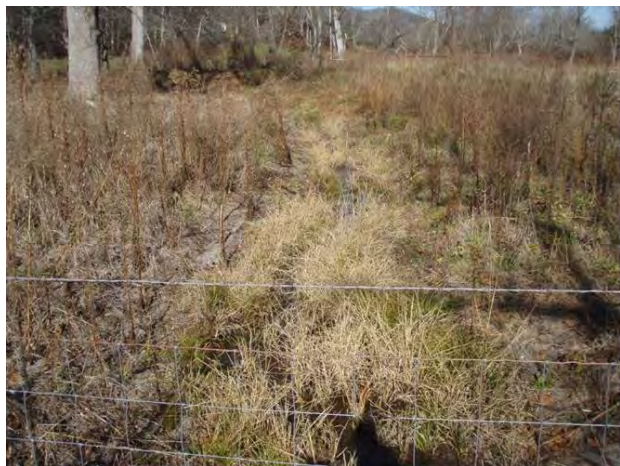
UT2 restored portion, east of Canterfield Lane, 20 November 2012.

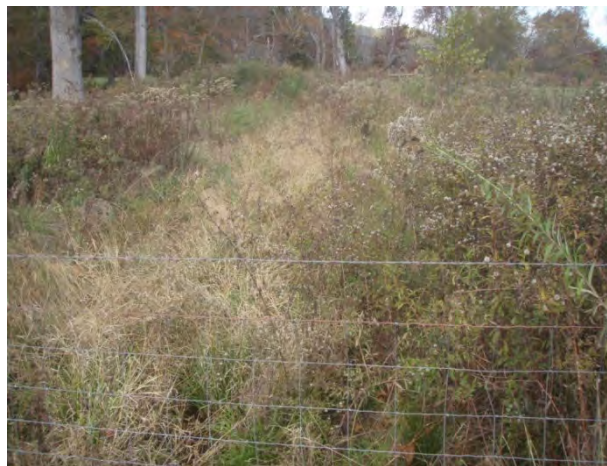
UT2 restored portion, east of Canterfield Lane, 29 October 2013.

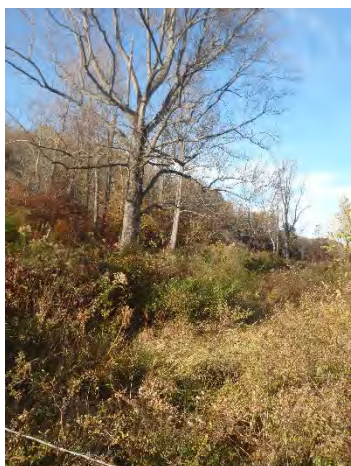
UT2 restored portion, east of Canterfield Lane, 12 November 2014.

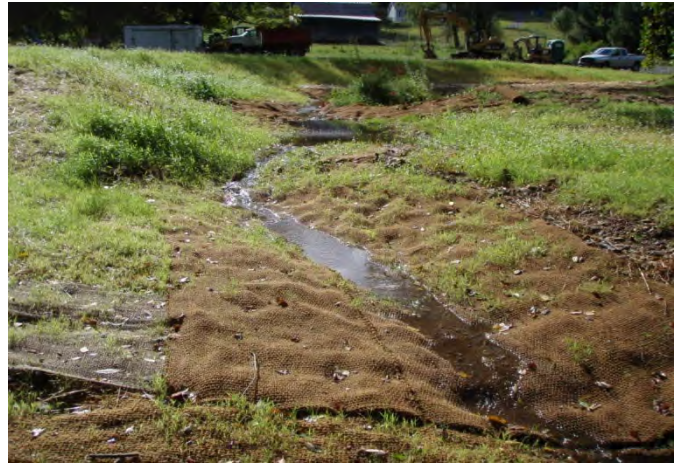
Lower portion of UT2 at confluence with SHC, facing upstream, 5 September 2011.

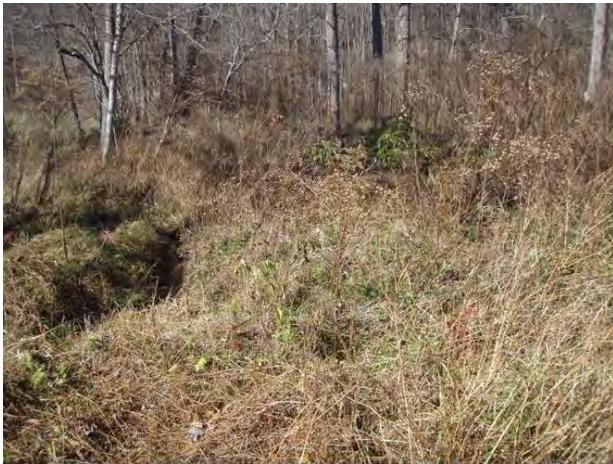
Lower portion of UT2 at confluence with SHC, facing downstream, 20 November 2012.

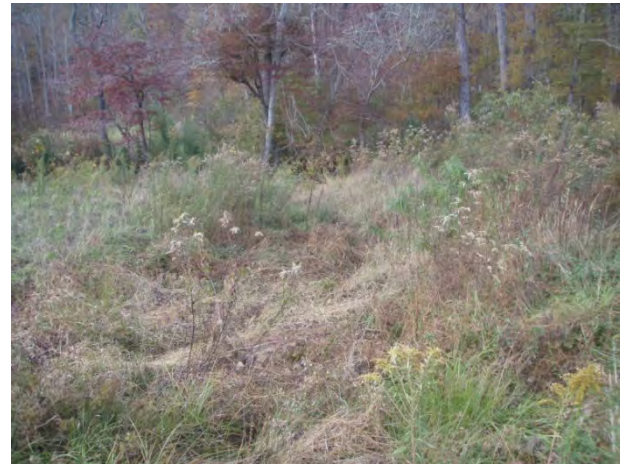
Lower portion of UT2, facing downstream, 29 October 2013.

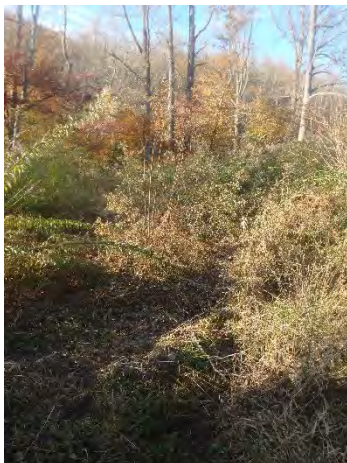
Lower portion of UT2, facing downstream, 12 November 2014.

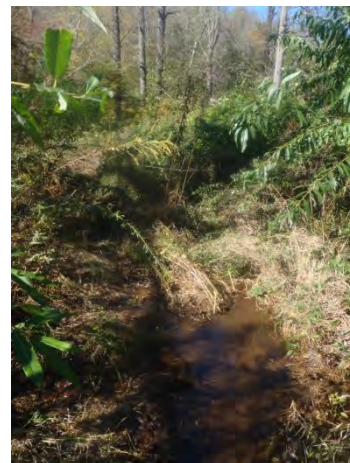
Lower portion of UT2, facing downstream, 14 October 2015.

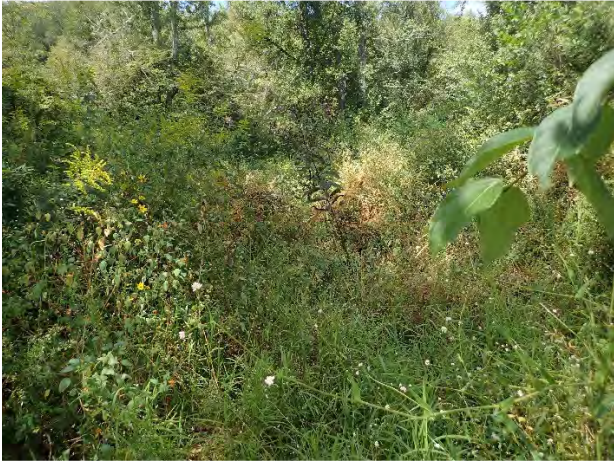
Lower portion of UT2, facing downstream, 15 September 2016.

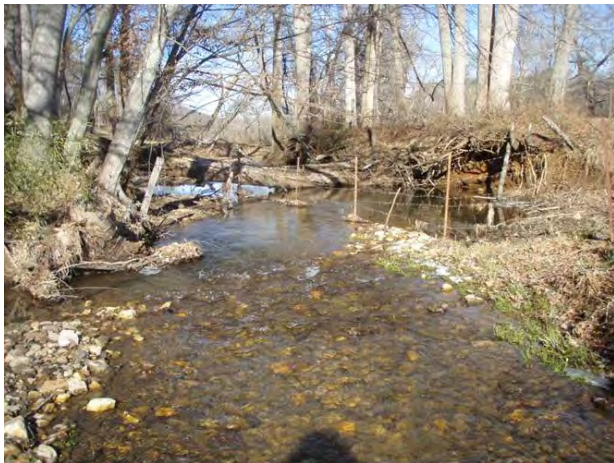
Livestock access right bank, sta. 1+00 to 1+50, facing downstream.
22 January 2009.

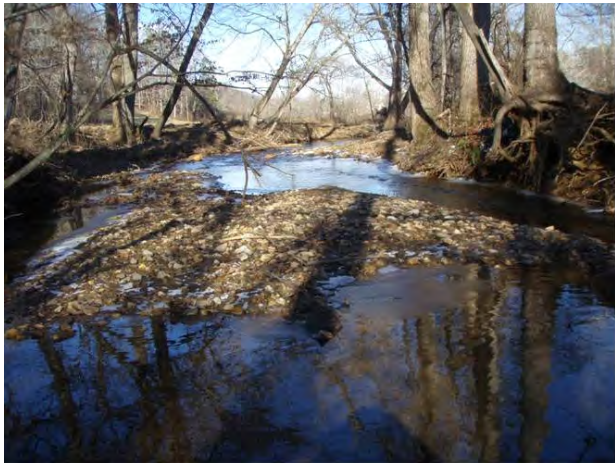
Mid channel aggradation, sta. 1+50 to 2+50, facing downstream. 22 January 2009.

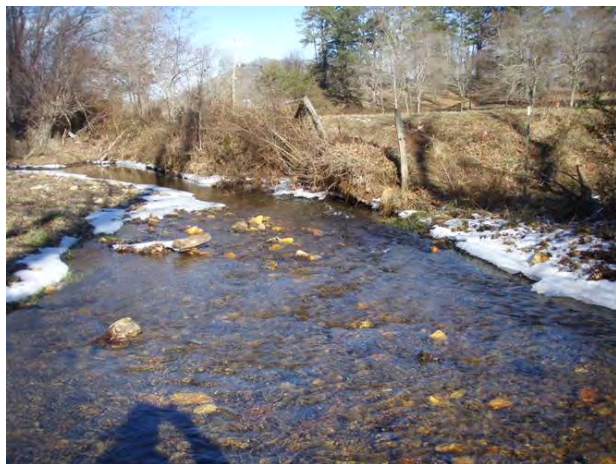
Photo Station 14

Outside meander bend bank stress, sta. 7+25 to 8+00, facing downstream, 22 January 2009.

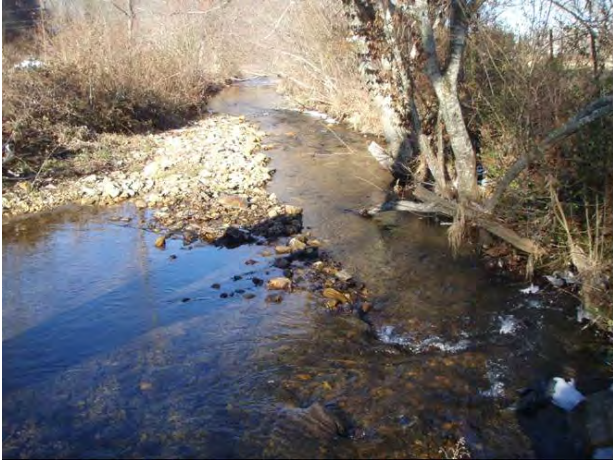
Photo Station 15

Bed aggradation and transverse bar, sta. 9+50 to 10+00, facing downstream, 22 January 2009.

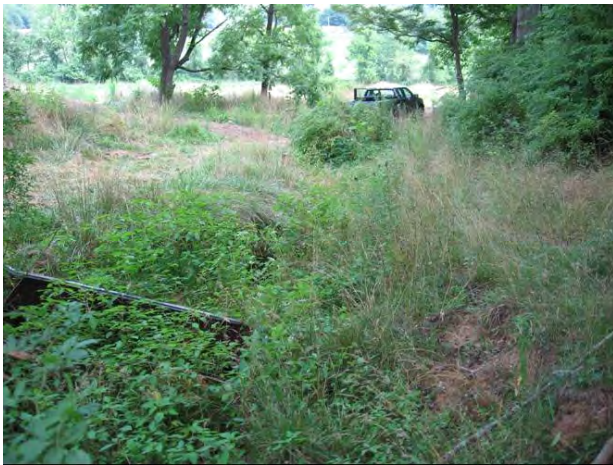
UT3 above ford, channel incision, facing downstream, 25 July 2008.

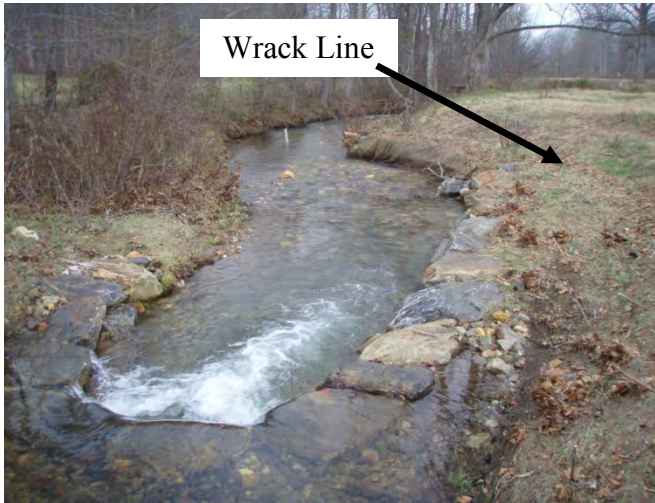
Photo 1 bankfull event on SHC, Bianculli property, sta. 6+00, 28 November 2011.

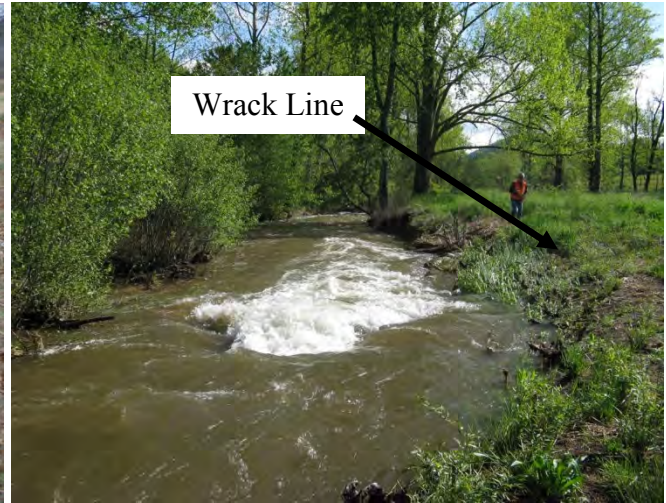
Photo 4 bankfull event on SHC, Bianculli property, sta. 6+00 06 May 2013.

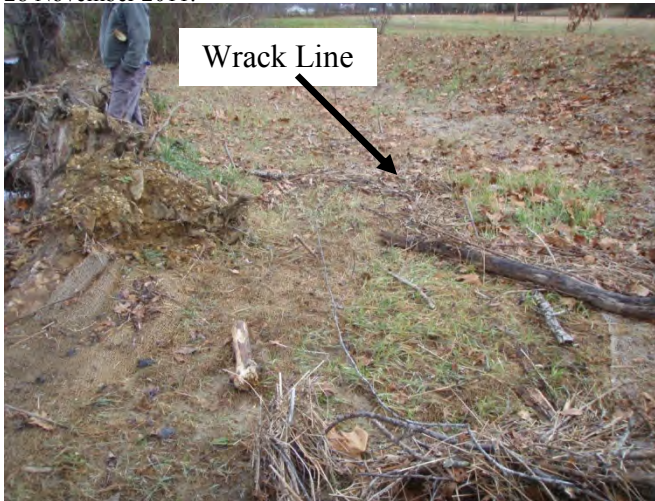
Photo 2 bankfull event on SHC, Roberson property, sta. 8+00 28 November 2011.

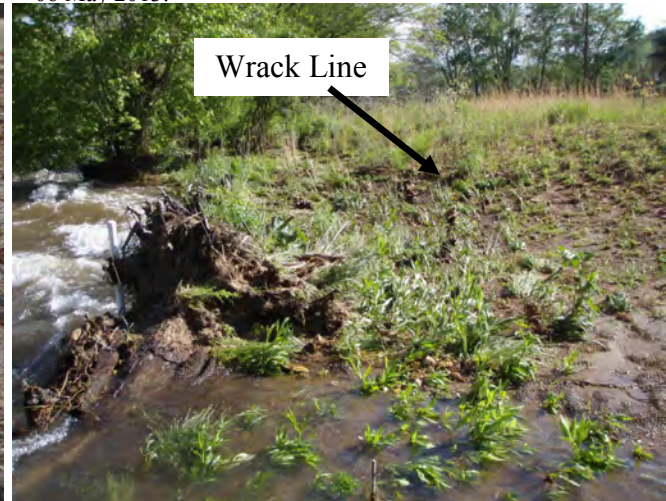
Photo 5 bankfull event on SHC, Roberson property, sta. 8+00 06 May 2013

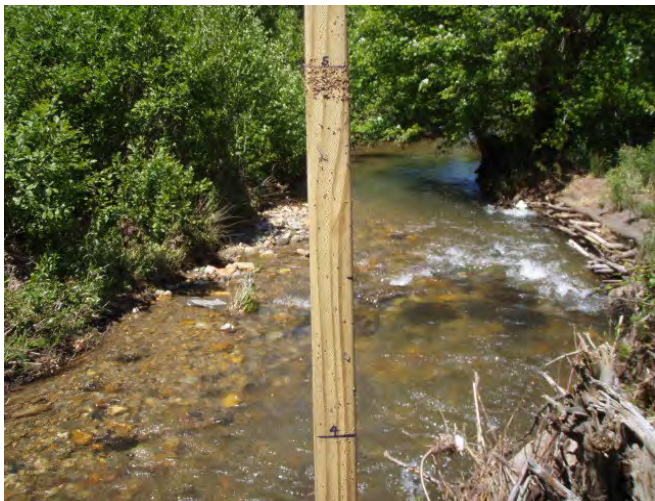
Simple crest gage verification of the 5 May 2013 bankfull event.

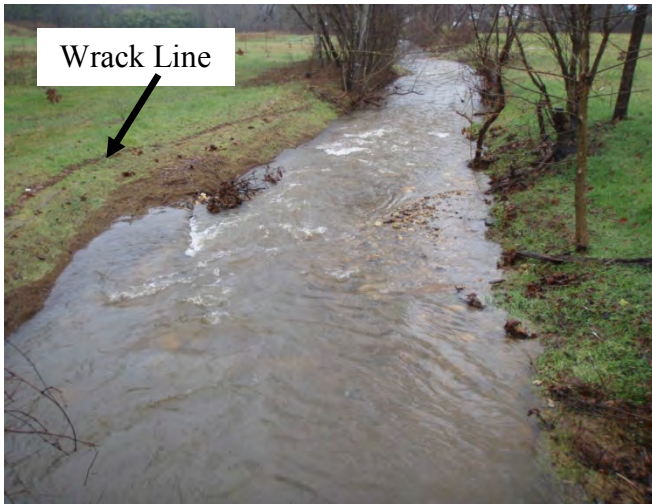
Photo 3 bankfull event on SHC, Davis property, sta. 0+50 28 November 2011.

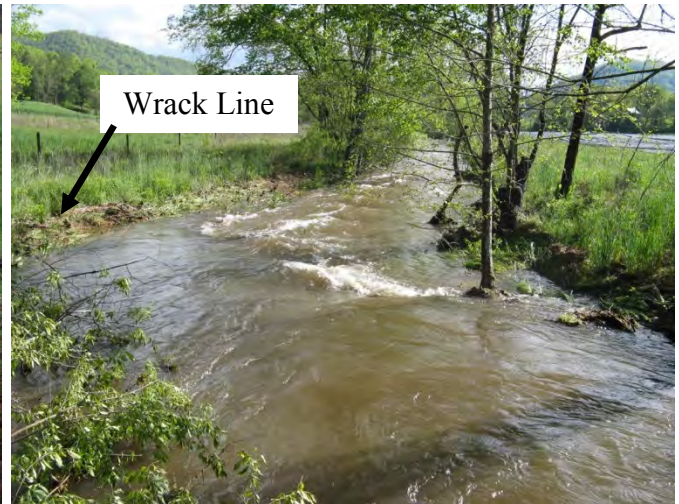
Photo 6 bankfull event on SHC, Davis property, sta. 0+50 06 May 2013.

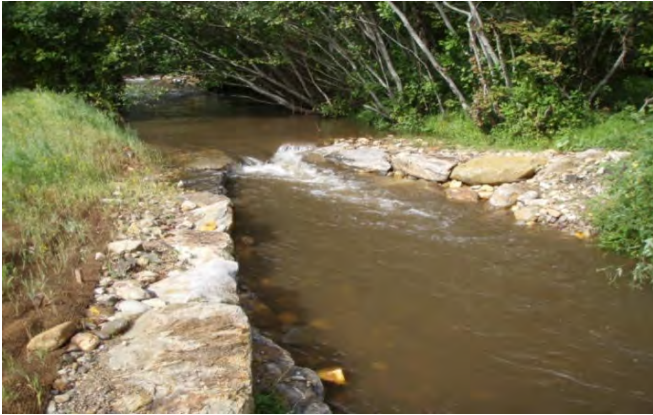
Problem Area 1

Rock vane after construction, sta. 1+50, facing upstream, 5 September 2011.

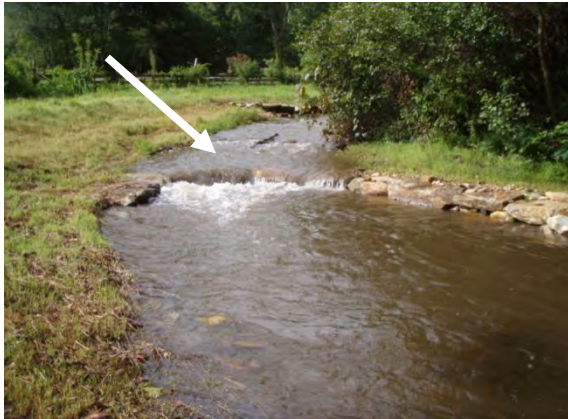
Problem Area 2

Right channel bank in stable condition, sta. 2+00, facing upstream, 5 September 2011.

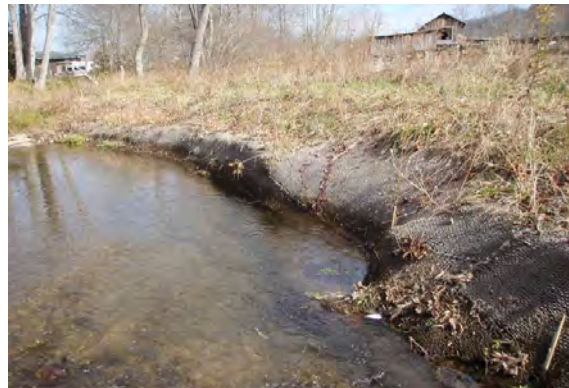
Right channel bank instability, sta. 1+75 to 2+25, facing downstream, 20 November 2012.

Right channel bank condition after 2015 repairs
sta. 1+75 to 2+25 facing upstream, 14 October 2015.
No longer considered a problem during MY4 (2015) field surveys.

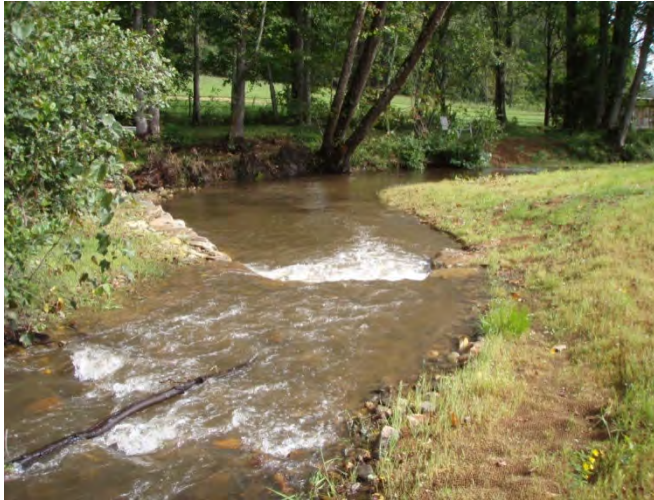
Problem Area 3

J-hook and meander post construction, sta. 2+50, facing downstream, 5 September 2011.

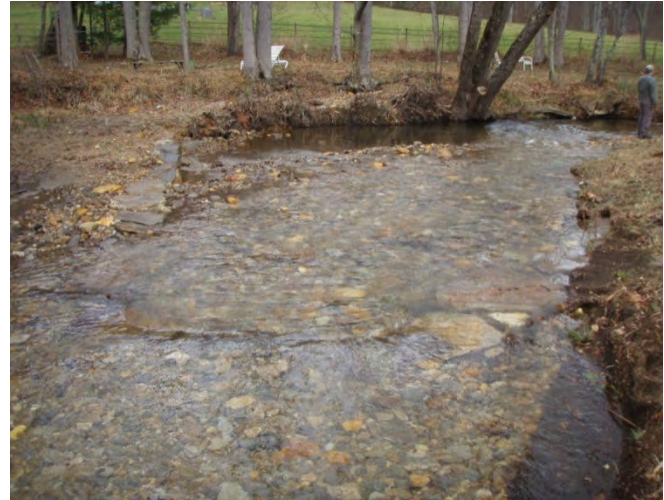
Aggradation and bar formation in meander below J-hook after flood event, sta. 2+50, facing downstream, 5 December 2011.

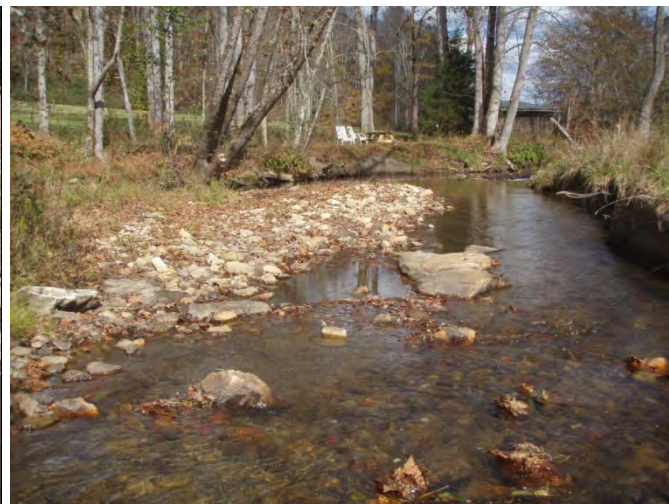
Aggradation and thalweg movement following 5 May 2013 flood, sta. 2+50, facing downstream, 29 October 2013.

Meander below J-hook sta 2+50 after summer 2015 repairs facing downstream 14 October 2015
No longer considered a problem during MY4 (2015) field surveys.

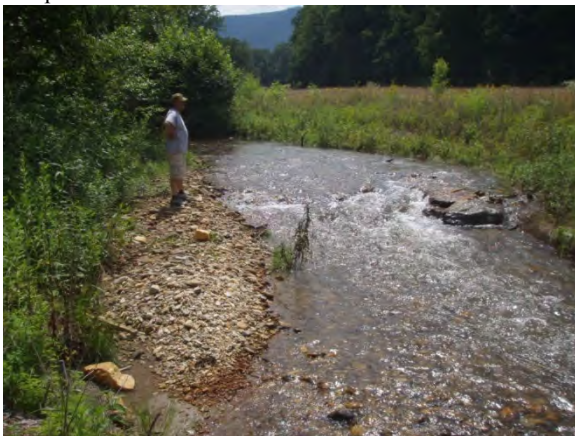
Inner berm formation below J-hook, sta. 9+25 to 9+50, following 5 May 2013 flood event, facing upstream, 18 July 2013.

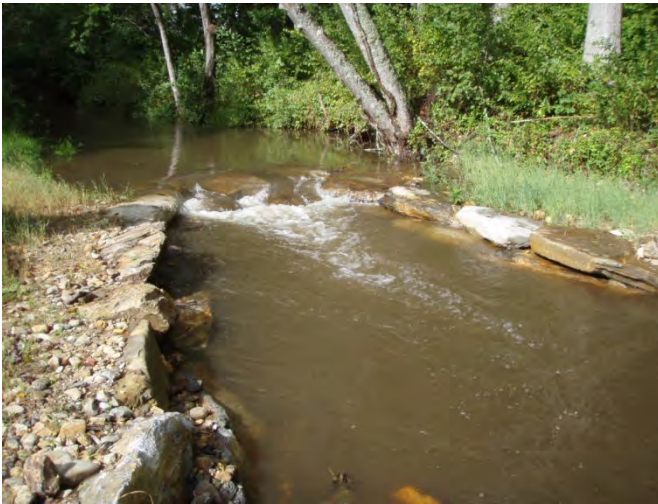
Problem Area 5

Cross vane after construction, facing upstream, sta. 0+50
14 Aug 2011.

Crossvane after summer 2015 repairs, facing downstream, sta.
0+50, 14 October 2015

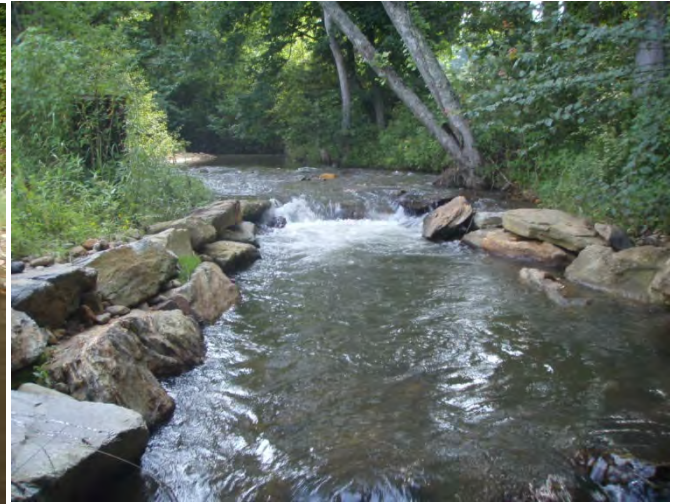
Cross vane after 5 May 2013 flood event, facing upstream,
sta. 0+50, 18 July 2013.

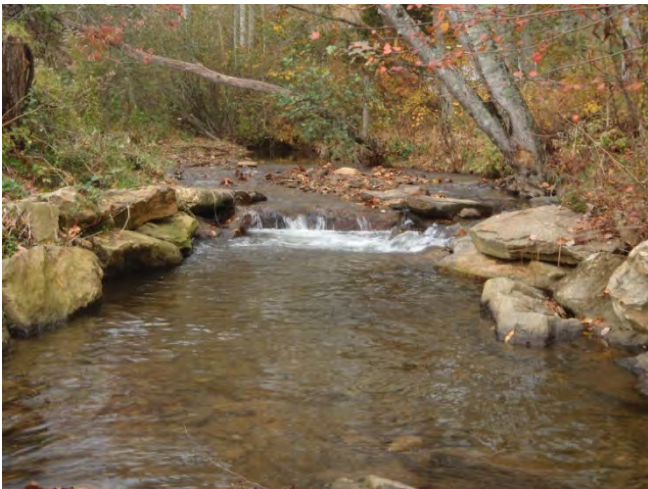
No longer considered a problem during MY3 (2014) field surveys
28 October 2014

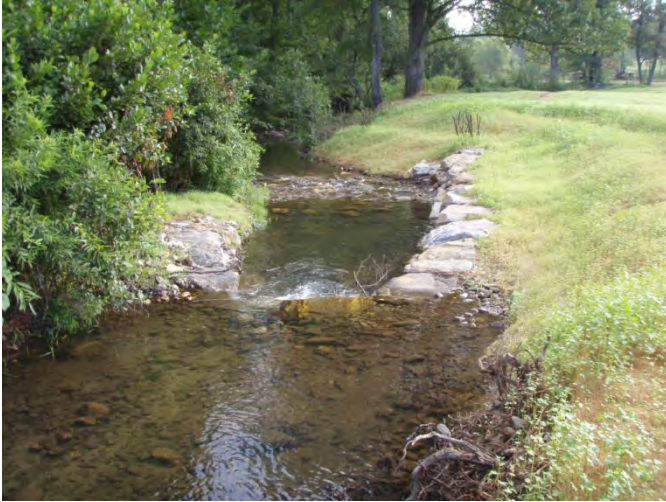
Problem Area 6

J-hook vane after construction, sta. 5+75, facing downstream, 14 August 2011.

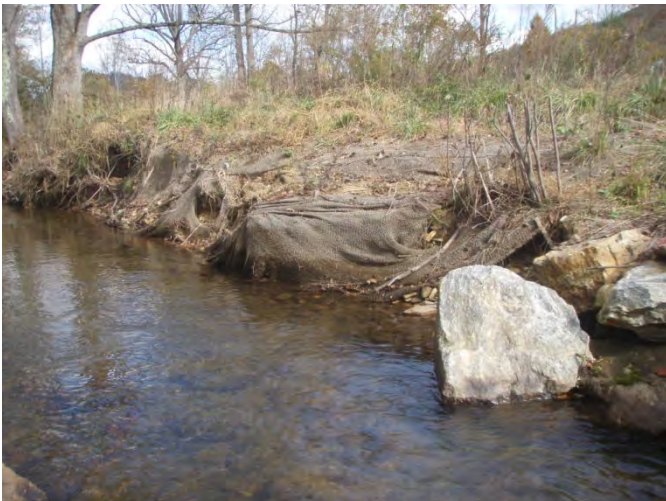
Right bank scour and erosion, sta. 6+25, facing downstream, occurred during the 5 May 2013 flood event, 29 October 2013.

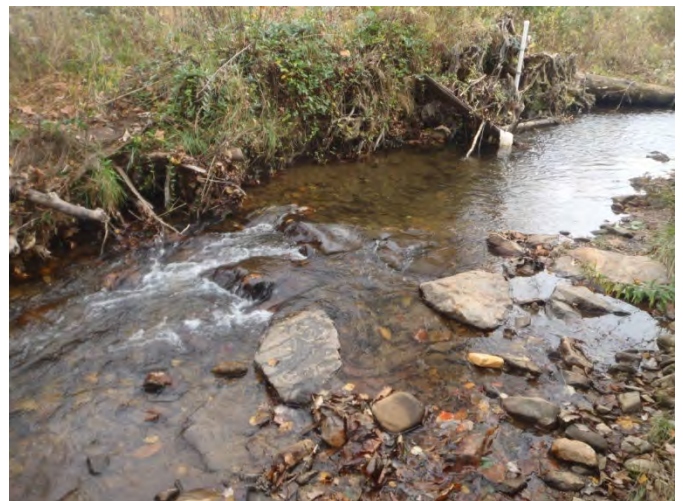
Right bank scour and erosion, sta 6+25 to 6+50 facing upstream, 28 October 2014

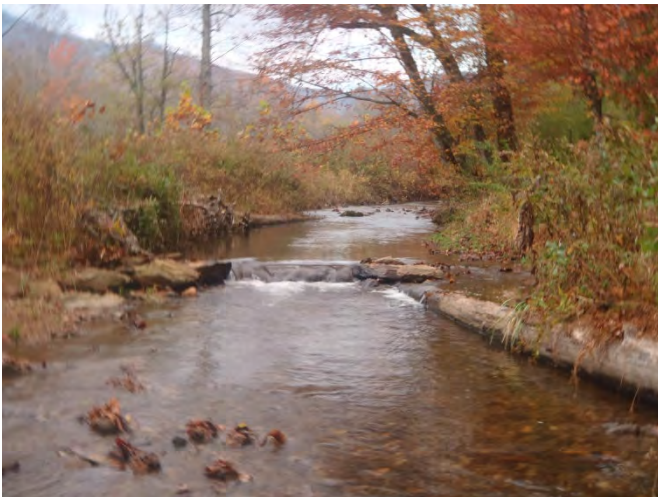
Problem Area 9

PA-09 was no longer considered a problem during MY3 (2014) surveys, 28 October 2014

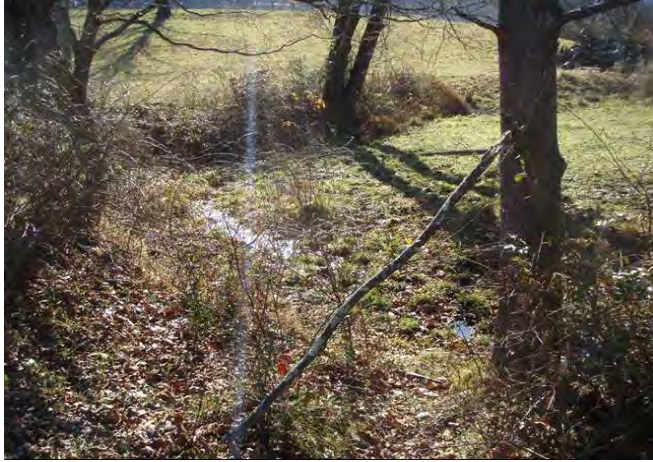
Wetland D, area of livestock access, facing upstream, 2009.

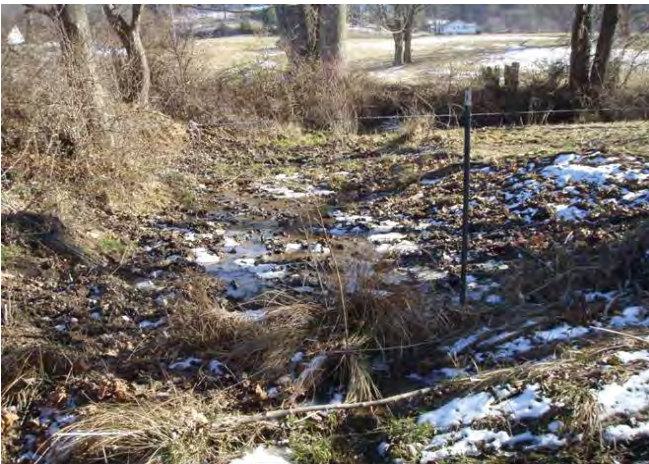
Lower portion of Wetland D, livestock impacts, facing upstream, 2009.

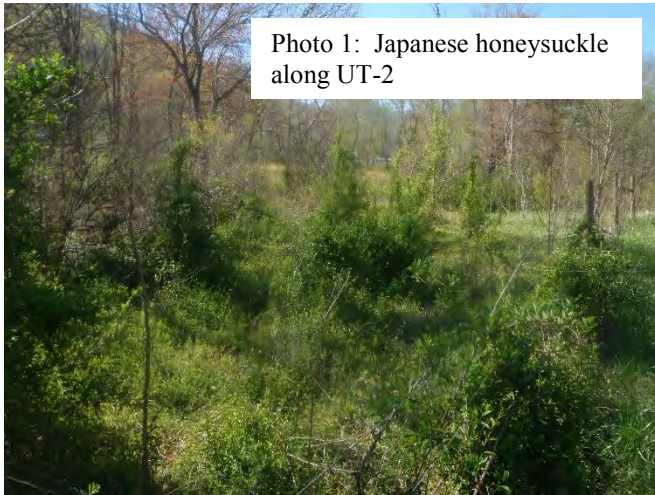
MY1-MY5 Vegetation Problem Areas Upper South Hominy Mitigation Site (DMS project number 92632)			
Feature/Issue	Station Number/Range	Probable Cause	Photo Number
Dense Japanese Honeysuckle	UT-2 Bianculli	Invasive	1
Dense Japanese Honeysuckle	UT-2 Bianculli	Invasive	2
Dense Japanese Honeysuckle	Mainstem 1 Sta. 7+25 to 8+00	Invasive	3
Mowed/cut path from easement boundary to left bank of SHC	Mainstem 2 Sta. 0+90 to 1+30	Encroachment	--
Dense Bamboo	Mainstem 2 Sta. 1+00 to 1+75	Invasive	--
Dense Japanese Honeysuckle	Mainstem 3 Sta. 5+65 to 6+40	Invasive	--
Dense Japanese Honeysuckle	UT-2 Bianculli	Invasive	--
Mowed/cut path from easement boundary to left bank of SHC	Mainstem 2 Sta. 12+55 to 12+70	Encroachment	4
Dense Multiflora Rose	UT-2 Bura/Roberson	Invasive	5

Photo 1: Japanese honeysuckle along UT-2

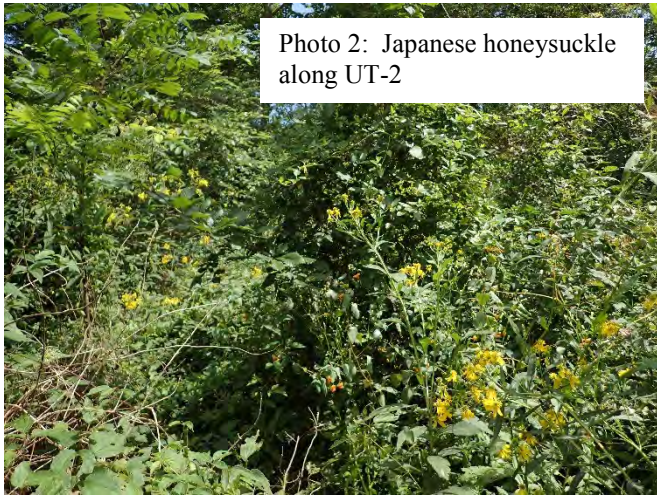
Photo 2: Japanese honeysuckle along UT-2

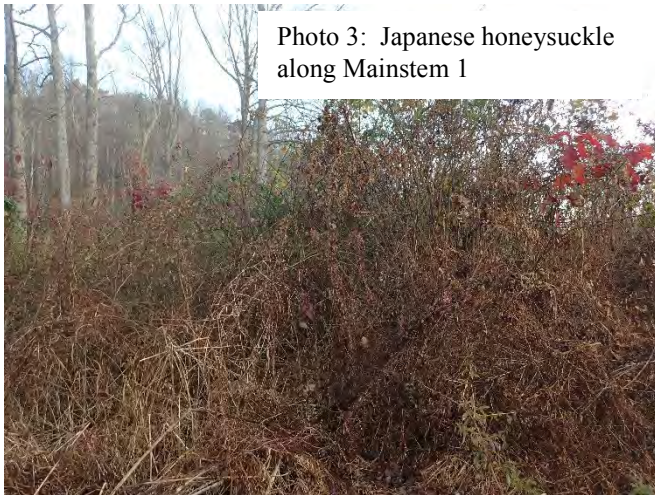
Photo 3: Japanese honeysuckle along Mainstem 1

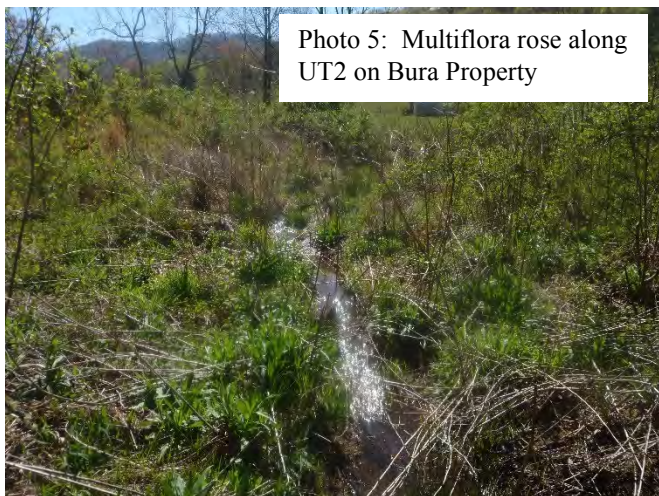
Photo 5: Multiflora rose along UT2 on Bura Property
