UT to JUMPING RUN CREEK STREAM & WETLAND
RESTORATION
MONITORING REPORT (YEAR 3 OF 5)
Cumberland County, North Carolina
EEP Project Number 92345
Monitoring Contract Number D09085S

Status of Plan: Draft
Construction Completed: 2010
Data Collected: 2012
Submission Date: November 2012

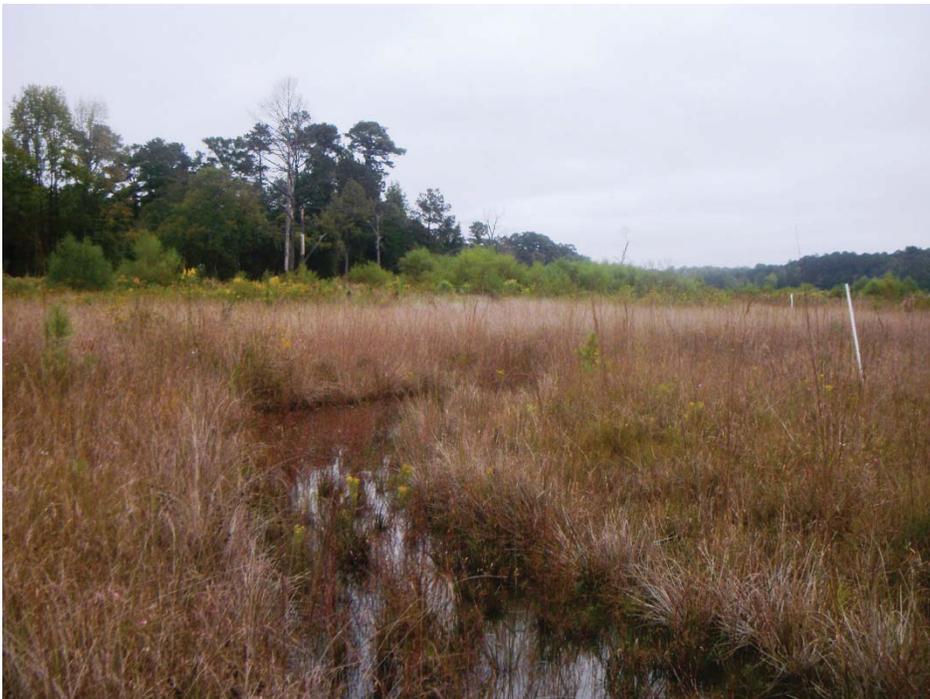
Photo B2 – (Photo Station 2) Cross-section 2 looking downstream at Station 50+30
(10/9/2012 Year 3)

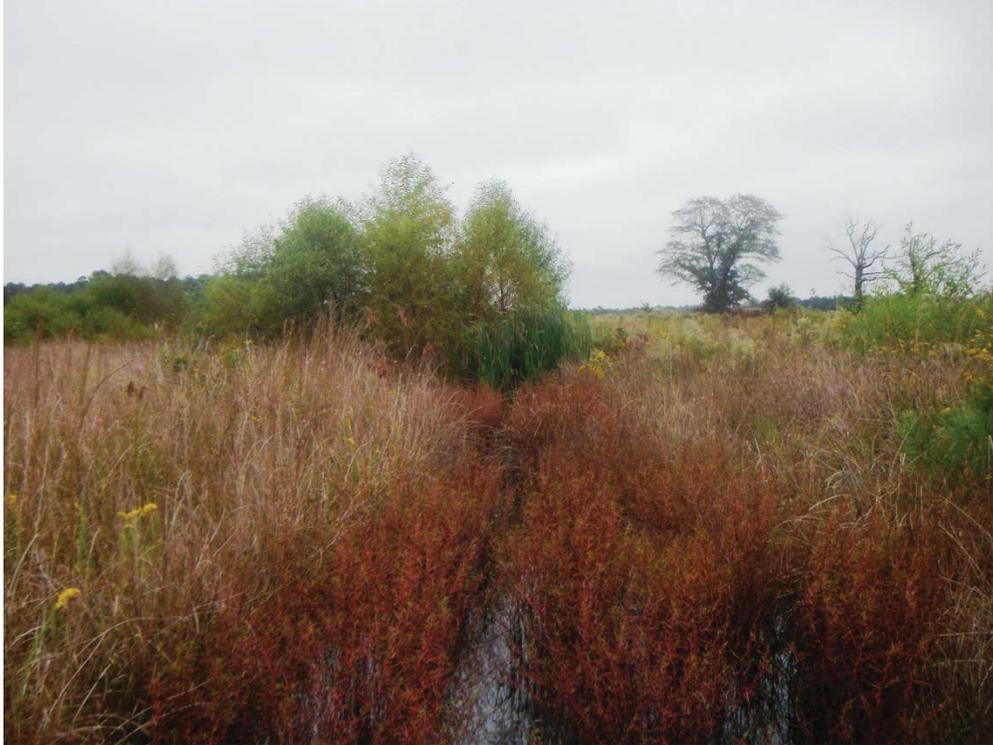
Photo B3 – (Photo Station 3) Cross-section 3 looking downstream at Station 54+98
(10/9/2012 Year 3)

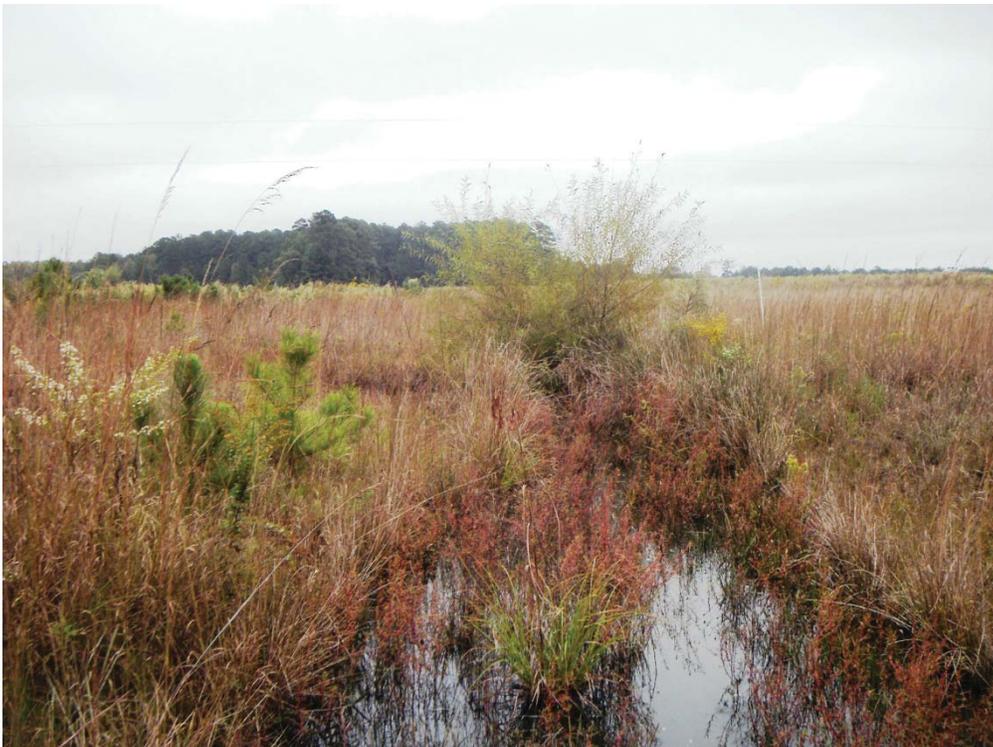
Photo B4 – (Photo Station S4) Cross-section 4 looking downstream at Station 59+09
(10/9/2012 Year 3)

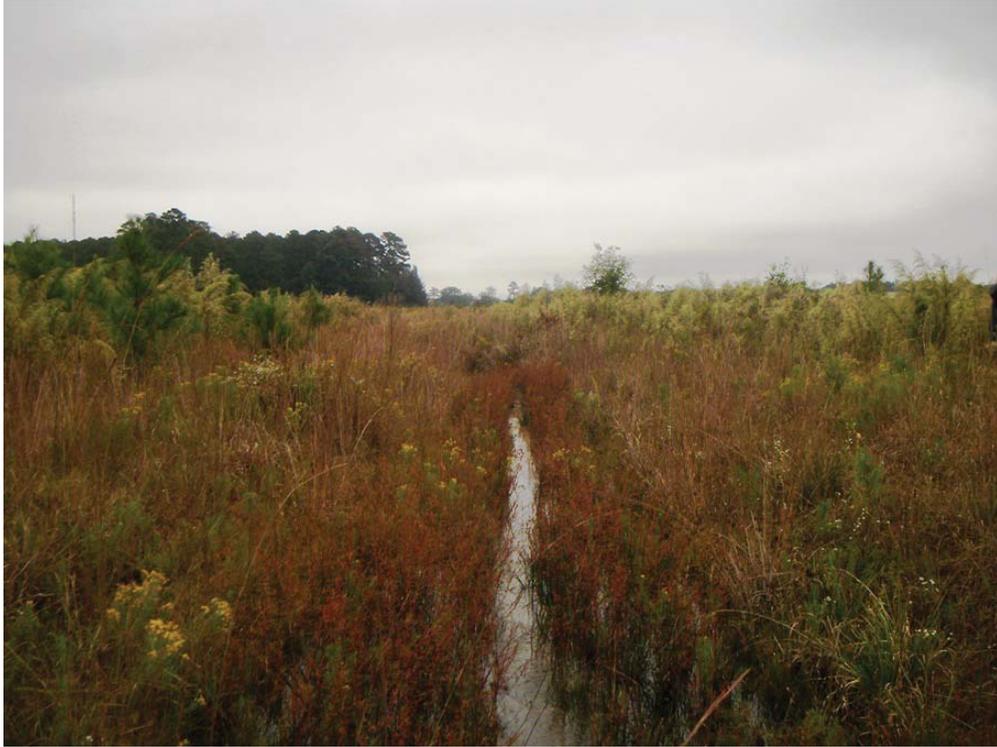
Photo B5 – (Photo Station S5) Cross-section 5 looking downstream at Station 62+87
(10/9/2012 Year 3)

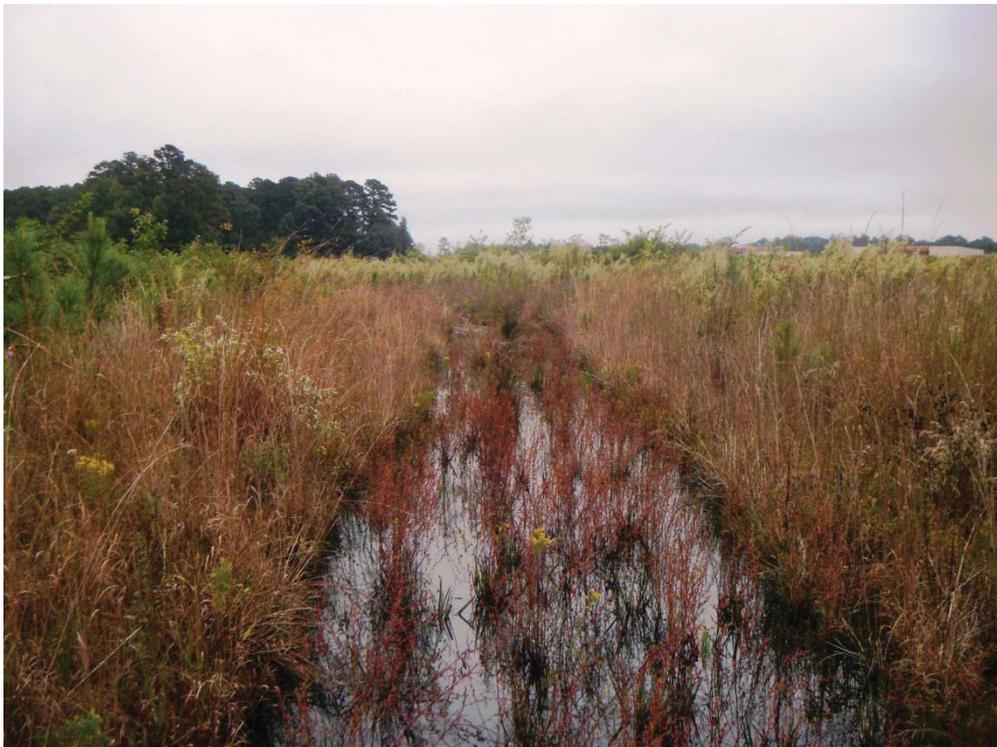
Photo B6 – (Photo Station S6) Cross-section 6 looking downstream at Station 65+44
(10/9/2012 Year 3)

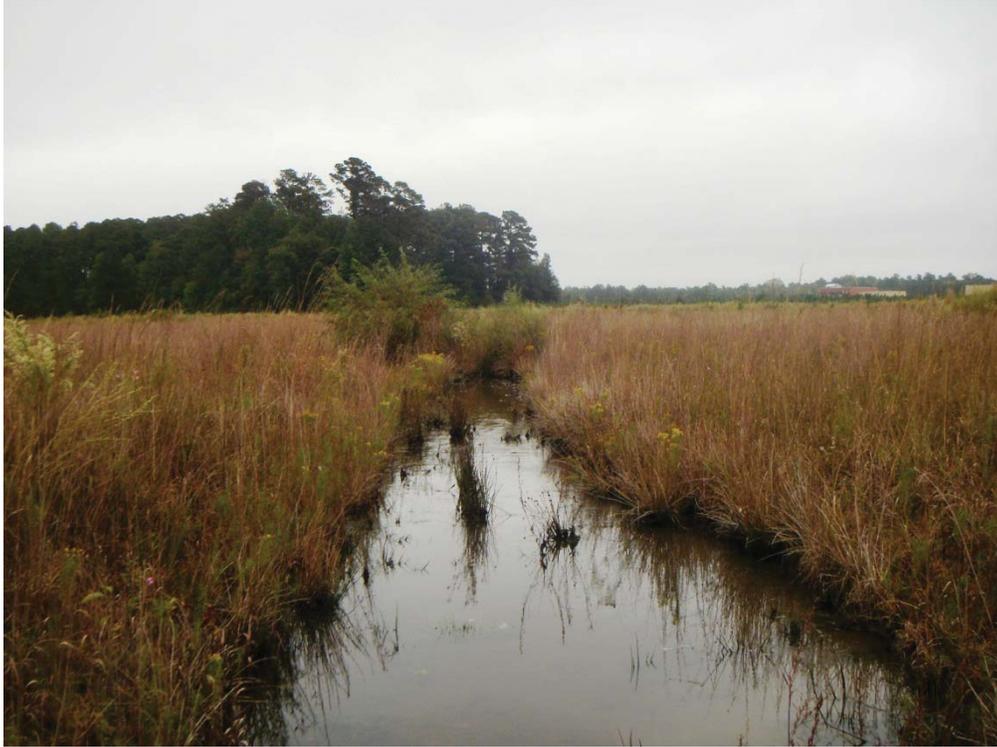
Photo B7 – (Photo Station S7) Cross-section 7 looking downstream at Station 68+24
(10/9/2012 Year 3)

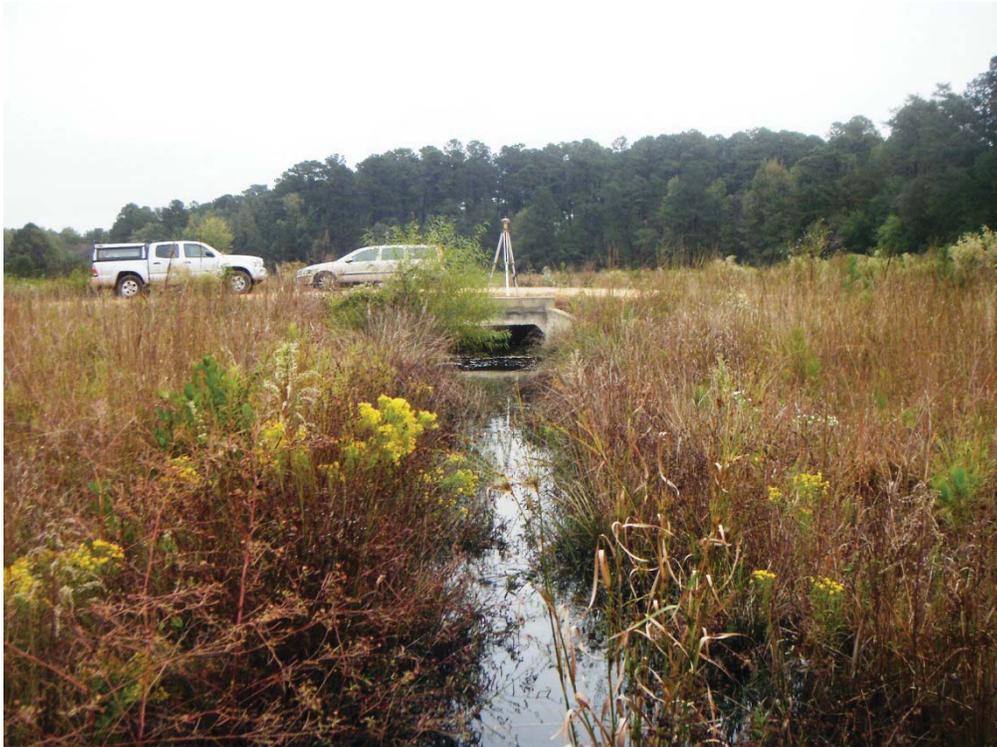
Photo B8 – (Photo Station S8) Cross-section 8 looking downstream at Station 72+84
(10/9/2012 Year 3)

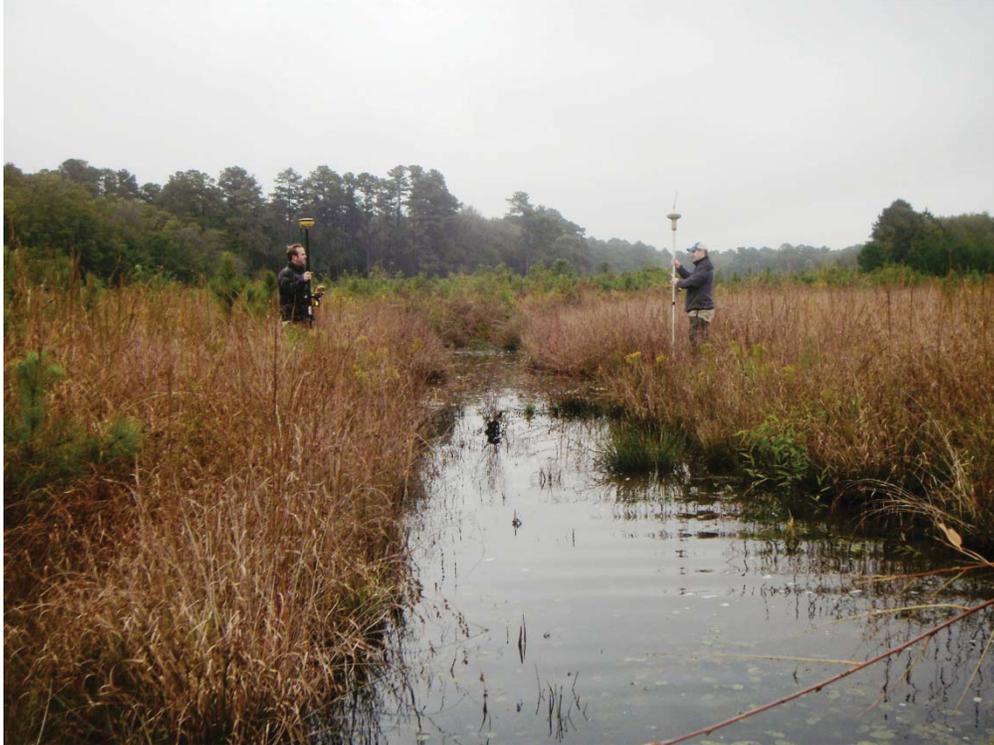
Photo B9 – (Photo Station S9) Cross-section 9 looking downstream at Station 75+30
(10/9/2012 Year 3)

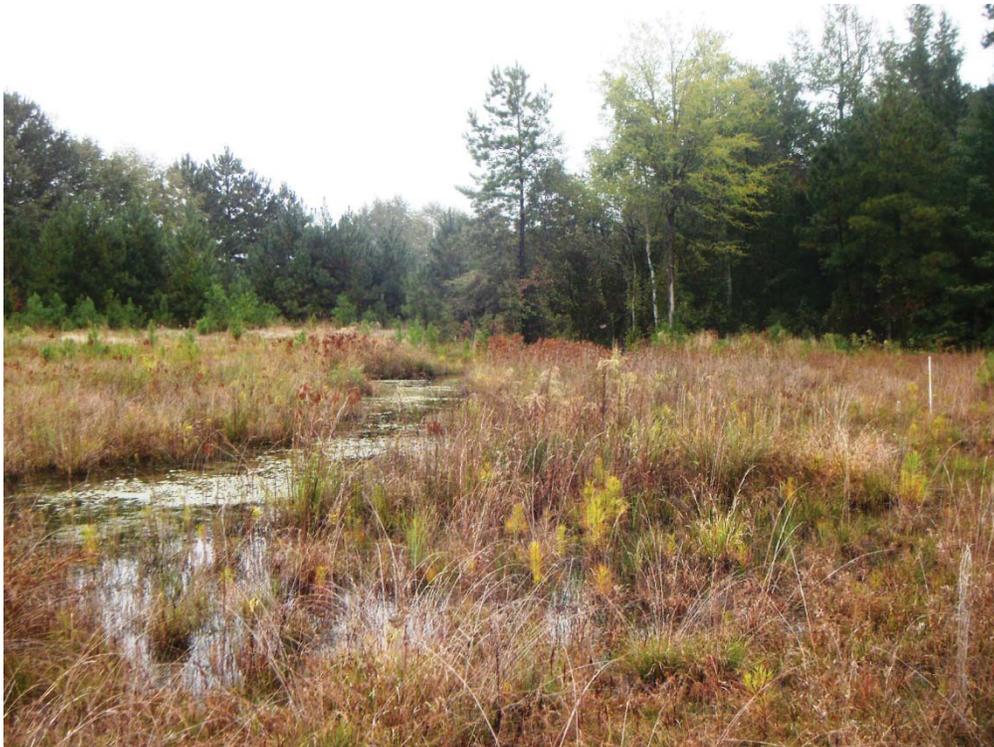
Photo B10 – (Photo Station S10) Cross-section 10 looking downstream at Station 80+45
(10/9/2012 Year 3)

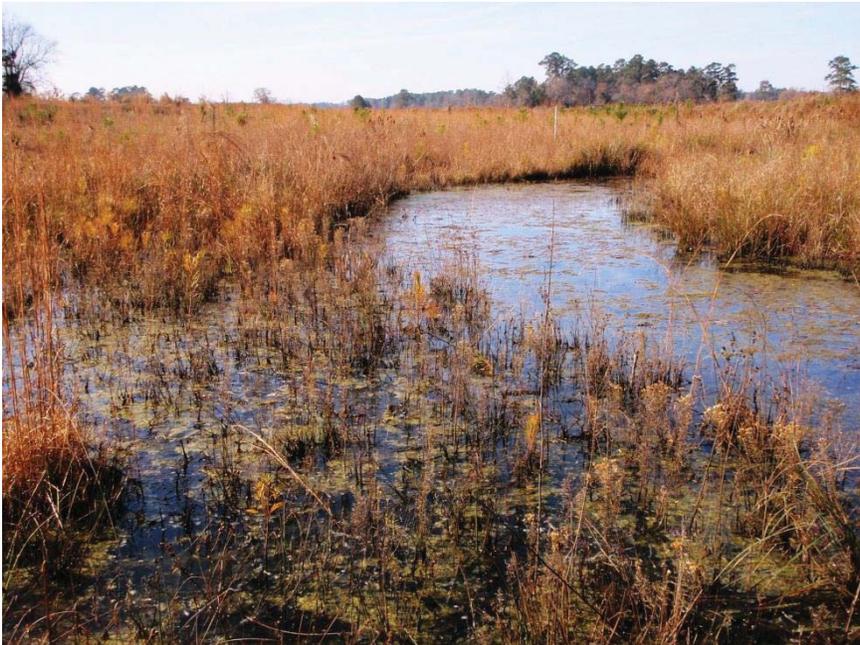
Backwater area facing upstream, well 15 located to the left outside of photo
