Randolph County, North Carolina

2011 Year 4 Monitoring Report - Final EEP Project Number: 403 USGS HUC 03030003020010 EcoEngineering Project Number: EEP-08030

UT TO SANDY CREEK

CONSOLIDATED CURRENT CONDITIONS PLAN VIEW - YEAR FOUR MONITORING

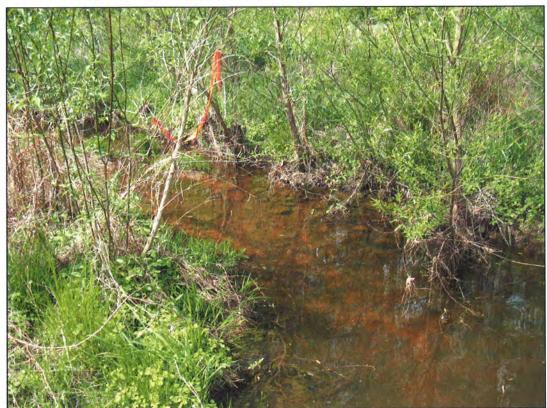
PHOTOGRAPH 22: CONSTRUCTED RIFFLE. STA: 110+58.

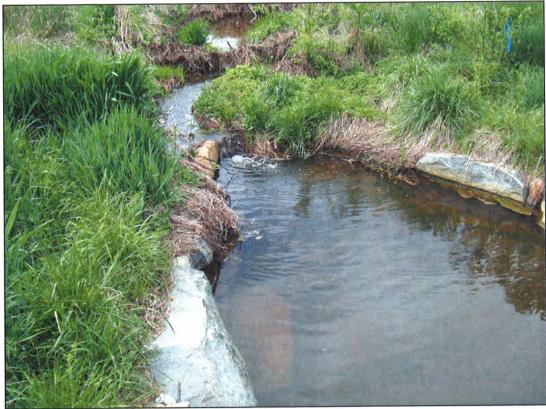
PHOTOGRAPH 24: CROSS VANE. STA: III+66.

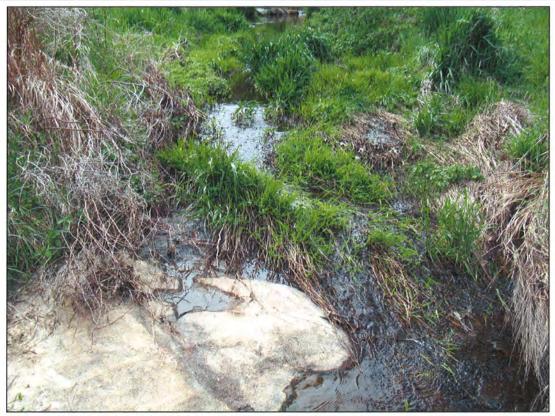
PHOTOGRAPH 25: CONSTRUCTED RIFFLE. STA: 112+15.

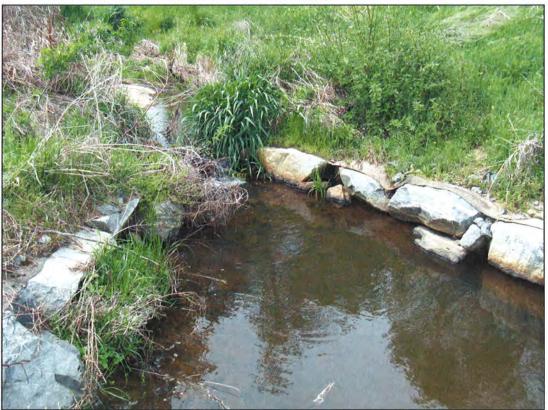
PHOTOGRAPH 26: CROSS VANE. STA: 112+70.

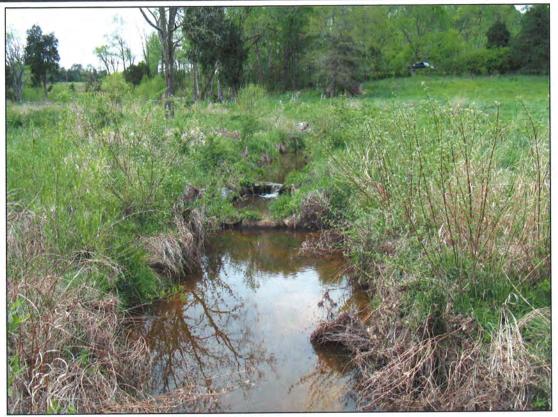
PHOTOGRAPH 27: "A" VANE. STA: 113+80.

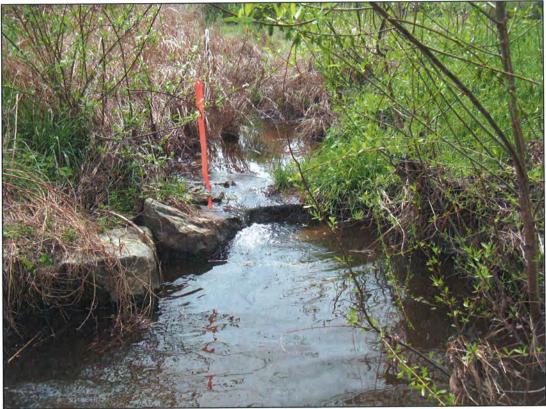
PHOTOGRAPH 28: CROSS VANE. STA: 115+15.

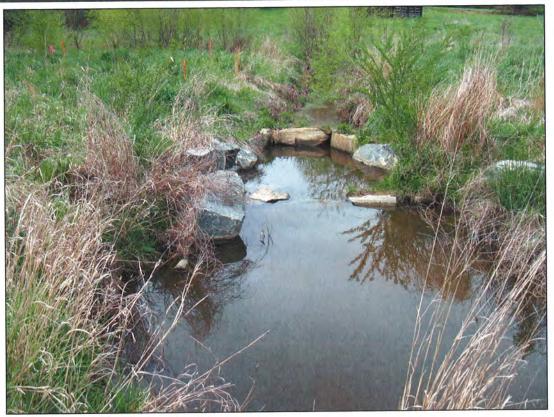
PHOTOGRAPH 29: "A" VANE. STA: 116+29.

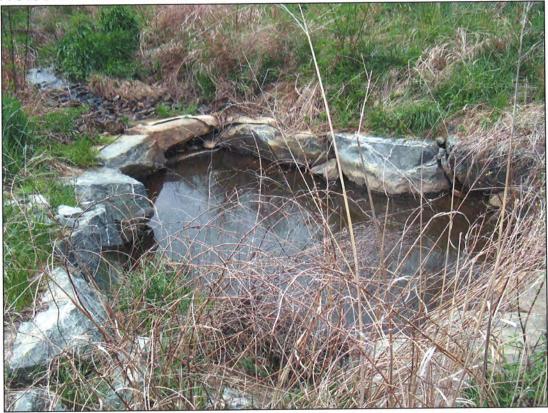
PHOTORGAPH 30: "A" VANE. STA: 117+58.

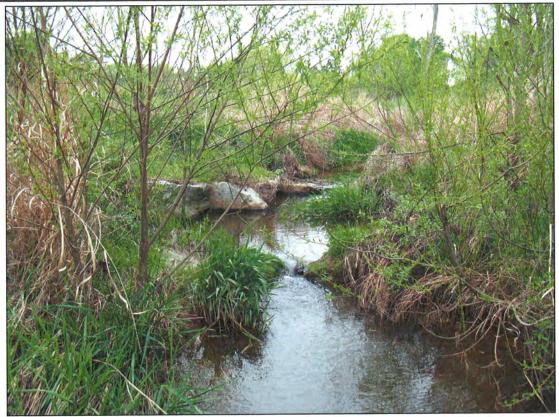
PHOTOGRAPH 31: "A" VANE. STA: 118+46.

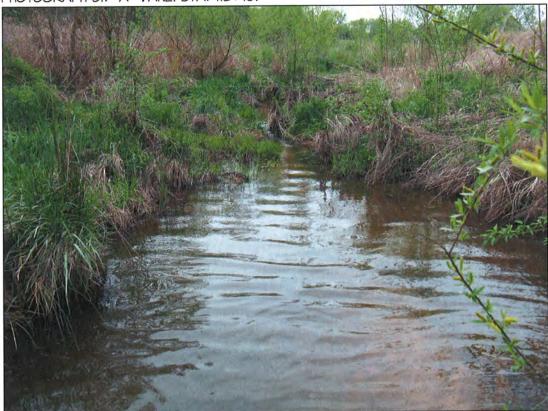
PHOTOGRAPH 32: CROSS VANE. STA: 119+07.

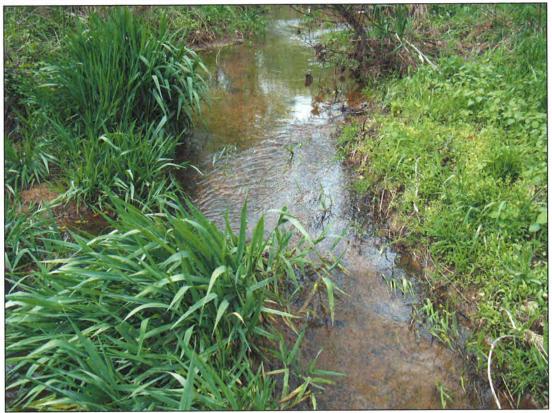
PHOTOGRAPH 33: CONSTRUCTED RIFFLE. STA: 120+25.

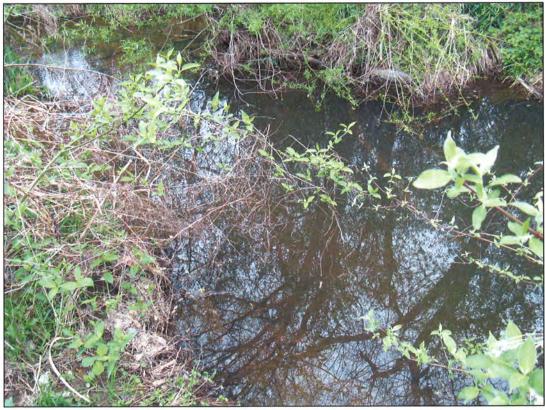
PHOTOGRAPH 36: CROSS VANE. STA: 122+00.

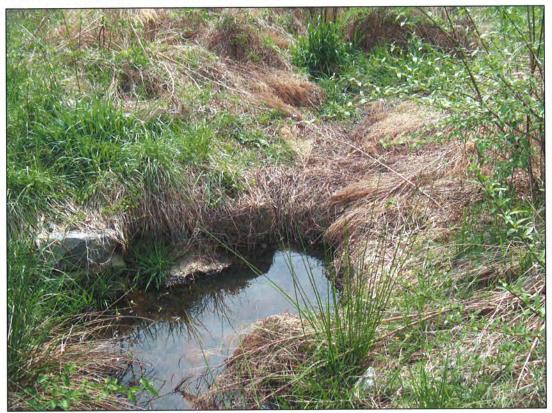
PHOTOGRAPH 38: CROSS VANE. STA: 200+57.

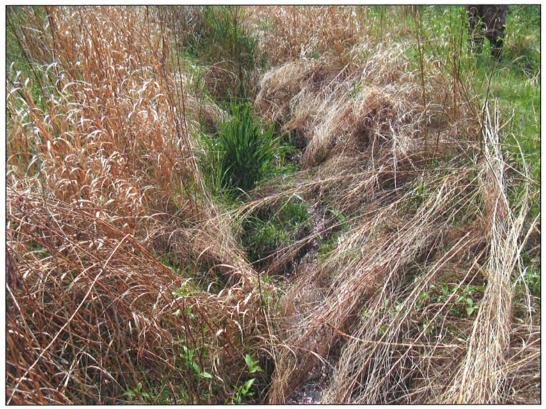
PHOTOGRAPH 39: CROSS VANE. STA: 201+16.

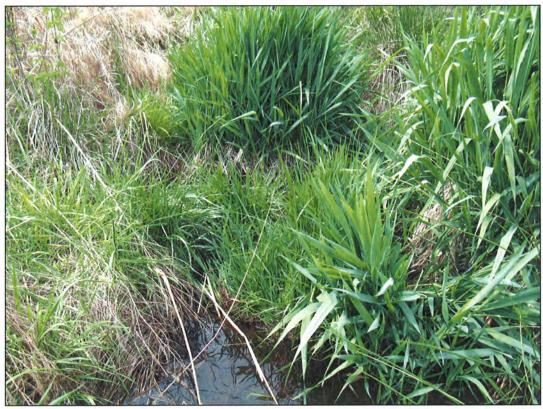
PHOTOGRAPH 40: CROSS VANE. STA: 202+64.

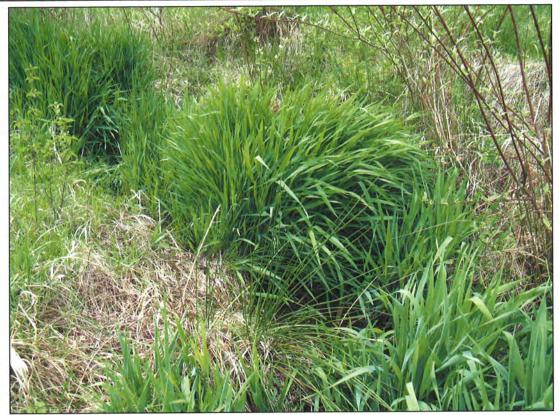
PHOTOGRAPH 41: CROSS VANE. STA: 203+15.

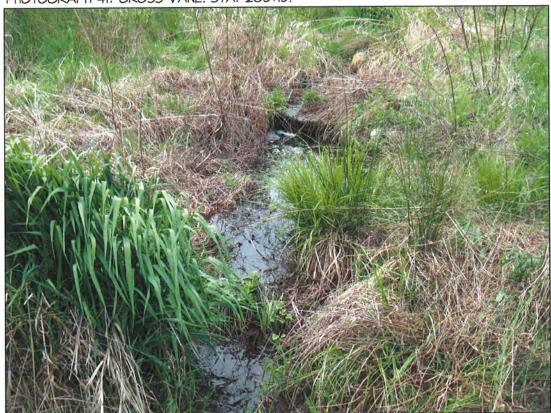
PHOTOGRAPH 42: CROSS VANE. STA: 203+58.
