MONITORING YEAR 7 ANNUAL/CLOSEOUT REPORT

VILE CREEK MITIGATION SITE

Alleghany County, NC
DEQ Contract No. 5999
DMS Project No. 96582

Data Collection Period: April – October
2023 Submission Date: December 21, 2023

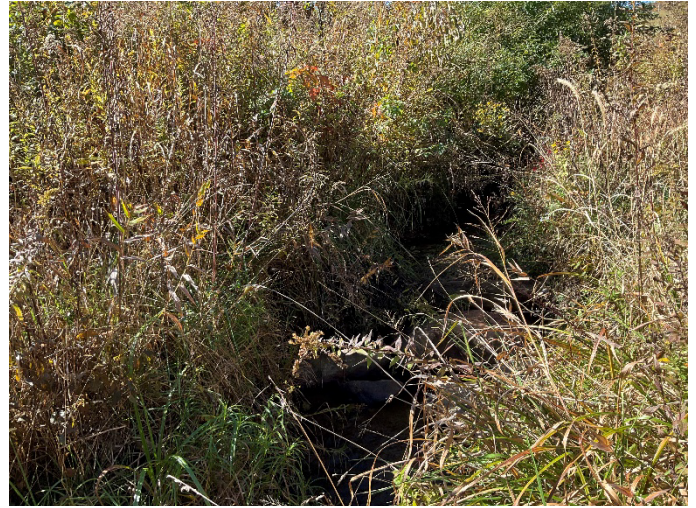
Photo 1: UT1 R1 STA 207+50 – Piping Structure 10-23-2023

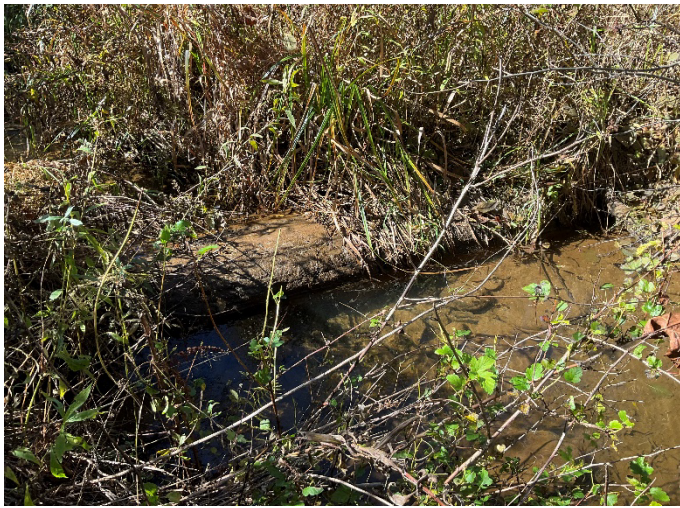
Photo 2: UT1 R1 STA 212+60 – Piping Structure 10-23-2023

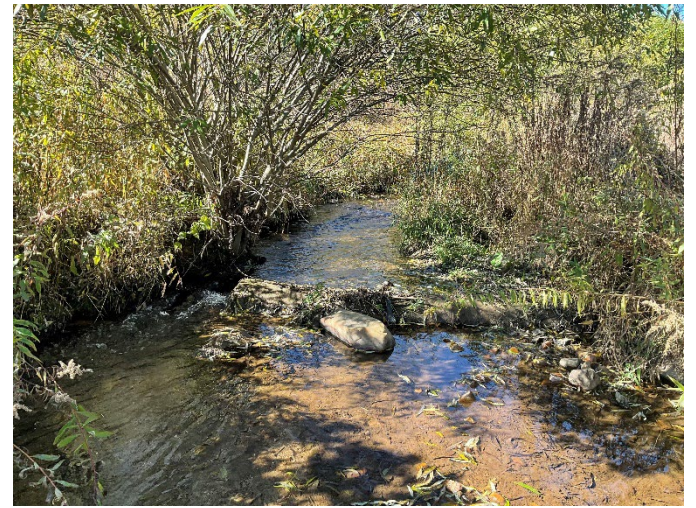
Photo 3: UT1 R2 STA 219+00 – Piping Structure 10-23-2023

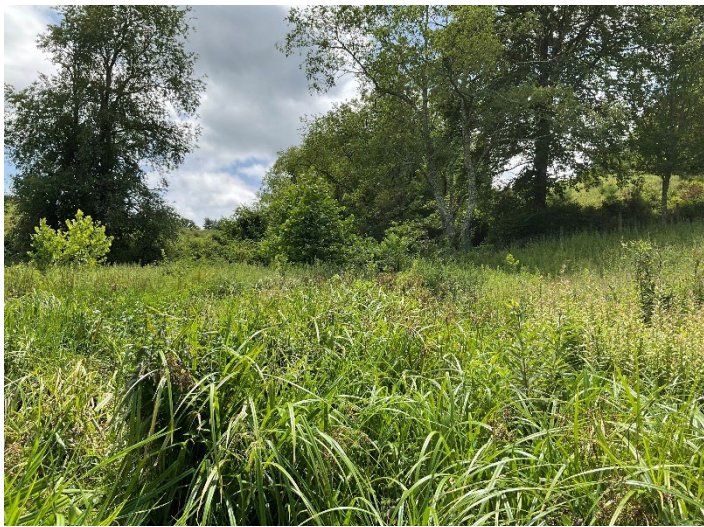
Remarks:
 Data point collected in formerly aggraded stream now wetland area. Defined channel is lost further upslope and numerous rills and sheetflow are present across the wetland. The USACE Antecedent Precipitation Tool indicates that the site experienced normal conditions in the 2 months leading up to the sampling date and wetter than normal conditions at the time of sampling. Data point is representative of Wetland A23.

Photo 1 – UT1B Wetland A23 (07/20/2023)

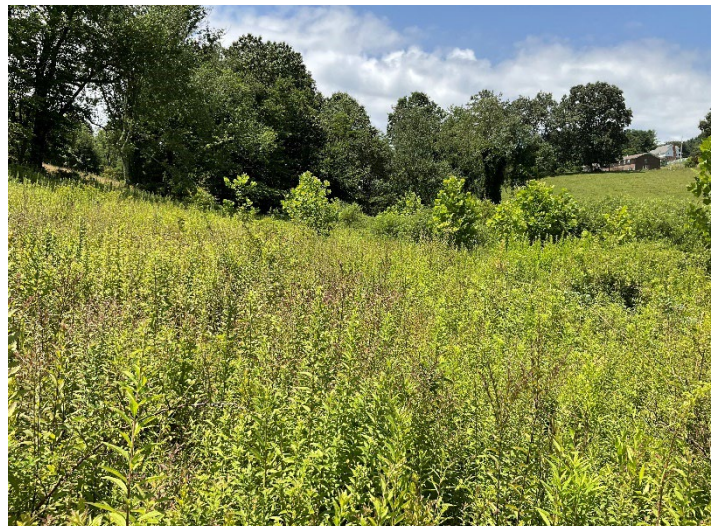
Remarks:
 Data point collected on upland hillside adjacent to Wetland A23. The USACE Antecedent Precipitation Tool indicates that the site experienced normal conditions in the 2 months leading up to the sampling date and wetter than normal conditions at the time of sampling.

Photo 2 - UT1B Wetland A23 upland (07/20/2023)

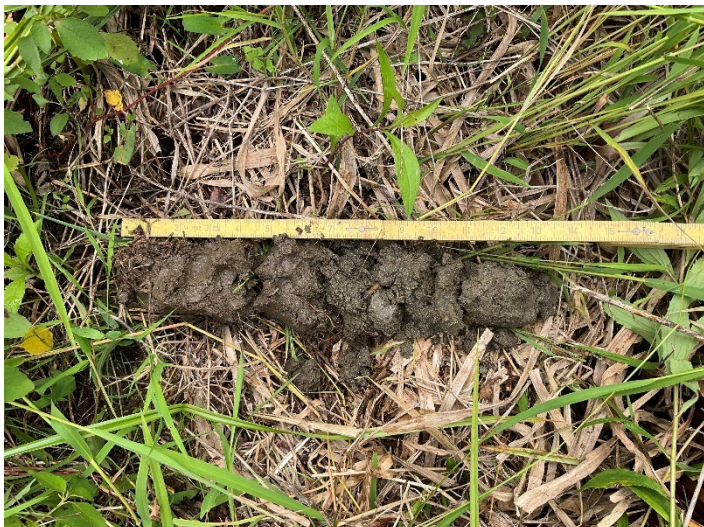
Depth (inches)	Matrix		Redox Features				Texture	Remarks
	Color (moist)	%	Color (moist)	%	Type ¹	Loc ²		
1-6	2.5Y 3/2	100					Loamy/Clayey	
6-12	2.5Y 4/1	98	10YR 4/6	2	C	M	Loamy/Clayey	Prominent redox concentrations

Photo 3 – UT1B Wetland A23 soil sample (07/20/2023)

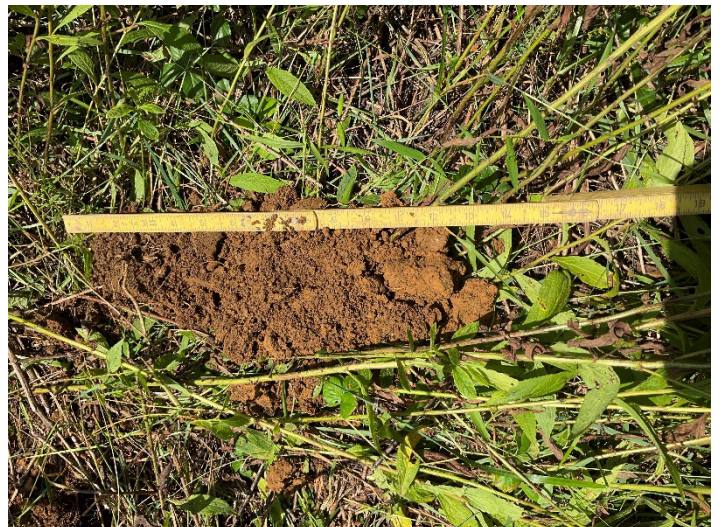
Depth (inches)	Matrix		Redox Features				Texture	Remarks
	Color (moist)	%	Color (moist)	%	Type ¹	Loc ²		
0-12	10YR 4/6	100					Loamy/Clayey

Photo 4 - UT1B Wetland A23 upland soil sample (07/20/2023)

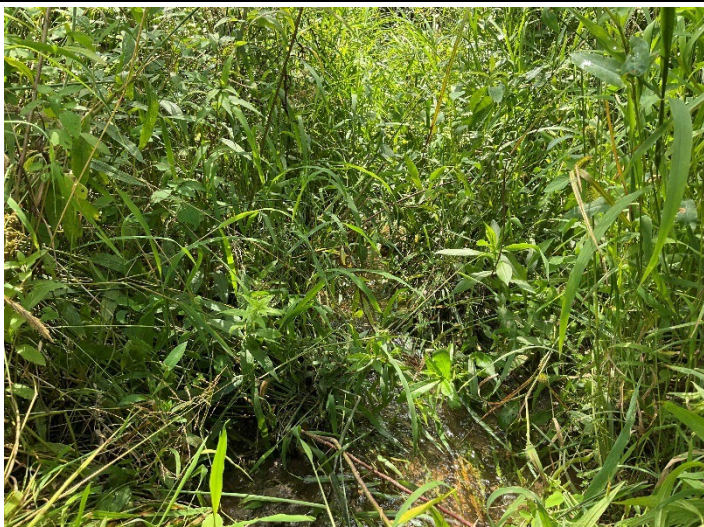
Photo 5 – UT1B current stream (07/20/2023)

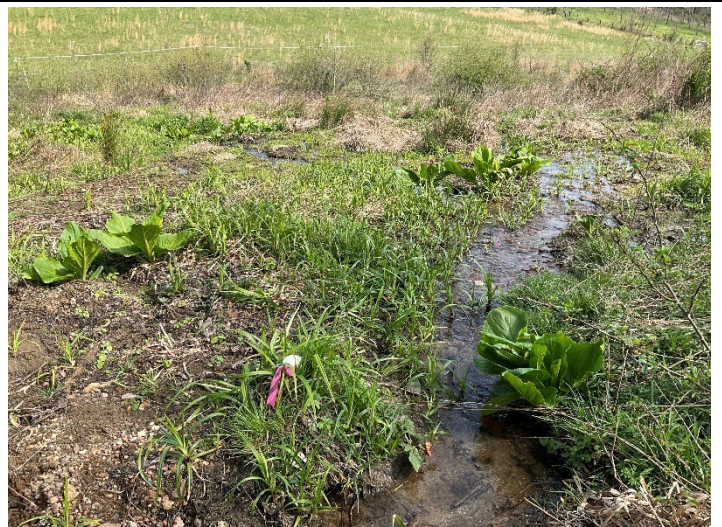
Photo 6 – UT1B GWG (04/20/2023)

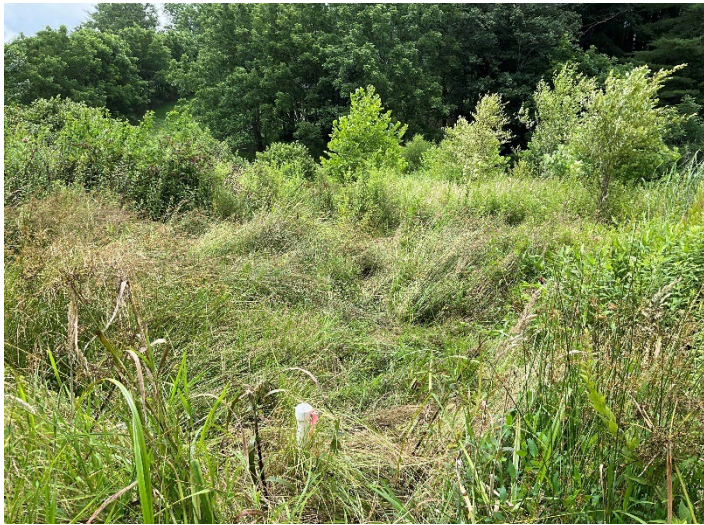
Photo 7 – UT1C Wetland B23 (07/20/2023)

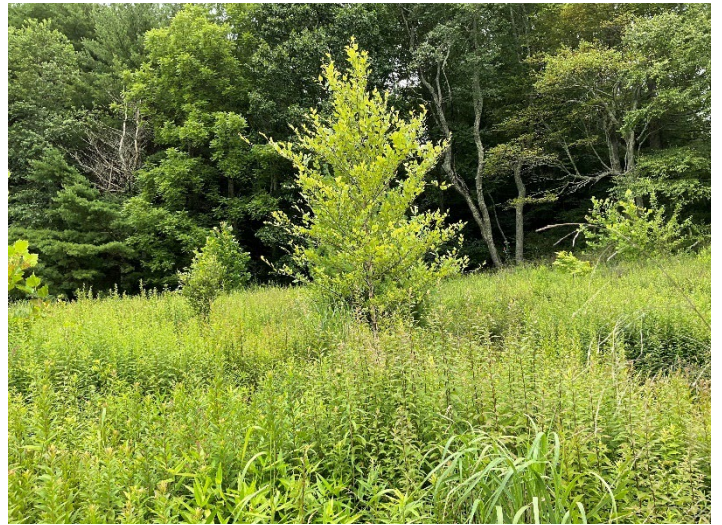
Photo 8 - UT1B Wetland B23 upland (07/20/2023)

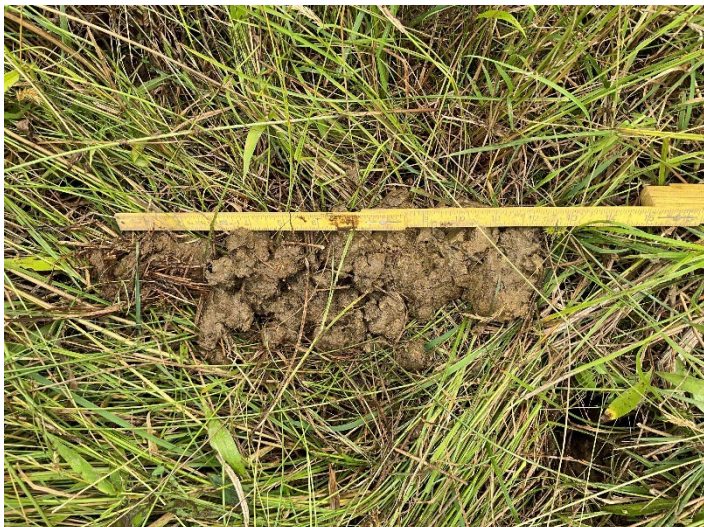
Photo 9 - UT1C Wetland B23 soil sample (07/20/2023)

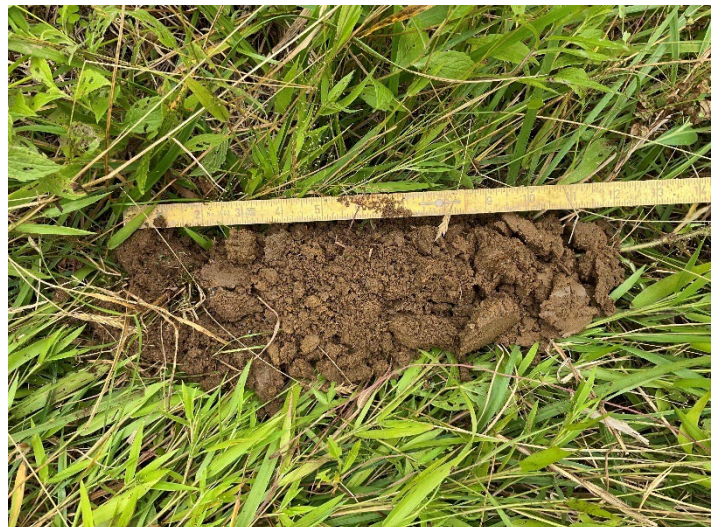
Photo 10 - UT1B Wetland B23 upland soil sample (07/20/2023)

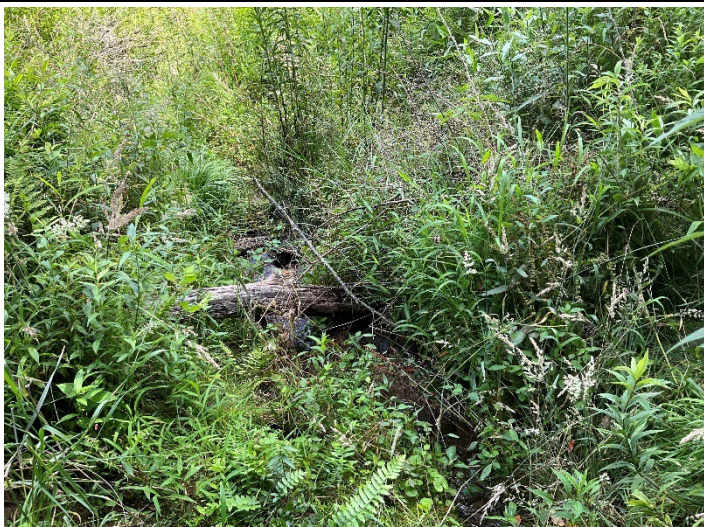
Photo 11 – UT1C current stream (07/20/2023)

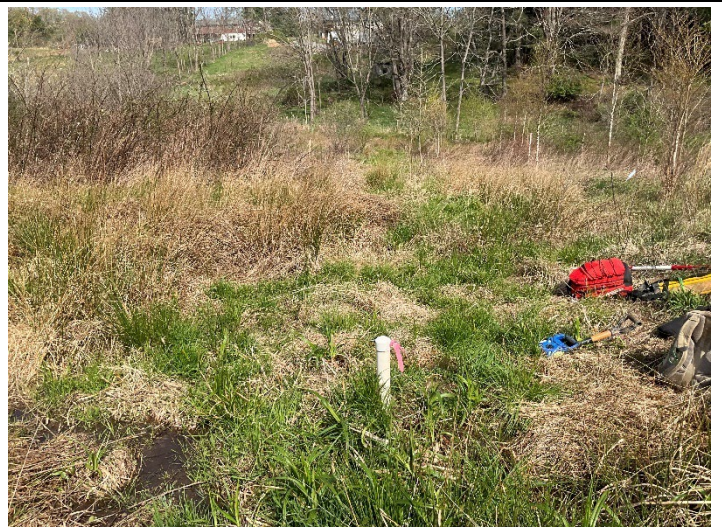
Photo 12 – UT1C GWG (04/20/2023)
